Project Data

Location	Prairie Home, MO
Completion	June 2021
Project Type	HDD Full Encapsulation
Products Used	Denso Bore-Wrap®

Project Details

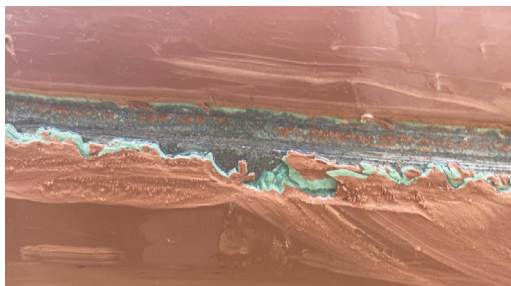
An aging pipeline crossing under a creek was being replaced due to corrosion from the exposure of soil erosion. The pipeline operator opted to install the pipe by HDD 50 feet deeper than the original line. The line being pulled in was 12 in diameter and nearly 1,200 feet long. During the initial drilling, it was discovered that the ground had been found to contain cobble and the rocks in the area were fracturing into shards. The contractor opted to install Denso Bore-Wrap® over the welds to protect them from damage from the pull in. After the pipe was pulled through bore hole, it was found that the mainline of the pipe had experienced significant damage to the FBE coating that caused bare steel to be exposed. However, the welds that were protected with the Denso Bore-Wrap®, had no damage.

Mainline coating damaged on first pull through without using any Denso Bore-Wrap® on pipeline.

The pipeline operator decided to extract the newly installed line, repair the damaged coatings, and wrap the entire HDD section with Denso Bore-Wrap®. The contractor wrapped the entire string of pipe in 2 days and prepared the hole for another installation. This time, the installation was under continual observation from the operating company's project manager. All parties were in attendance during the HDD installation as there were concerns of the condition of the coating as it exits the bore hole. The Denso rep on-site however was watching confidently knowing that the pipe was protected by the most robust ARO wrap on the market.

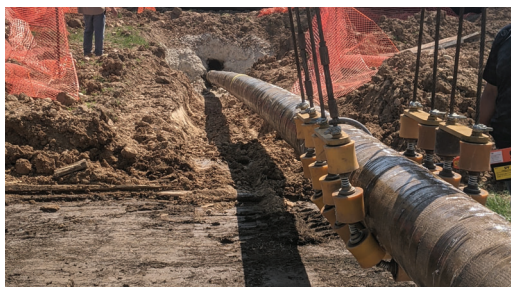
1,200 feet of pipe encapsulated in Denso Bore-Wrap® to protect the mainline coating prior to HDD installation.

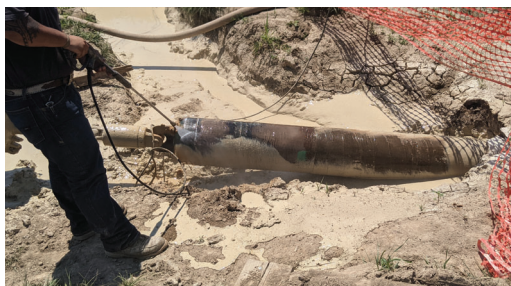
When the pipe exited the hole, the contractor quickly disconnected the drill rig and pulled the pipe out 50 feet to begin the spray cleaning to clear off the drilling mud for inspection. The Denso Bore-Wrap® was completely intact with only negligible damage visible to just the outermost layers. The success of the Denso Bore-Wrap® in protecting the pipeline's coating on this project spurred the drilling contractor to request additional product information so he could present and offer it to every project in which they encounter cobble.

Pipeline with Denso Bore-Wrap® exiting drilled hole and being cleaned for inspection.
