# CASE STUDY

## TRADITIONAL PIPE COATINGS FAILURE

## HDD Pipeline Protection

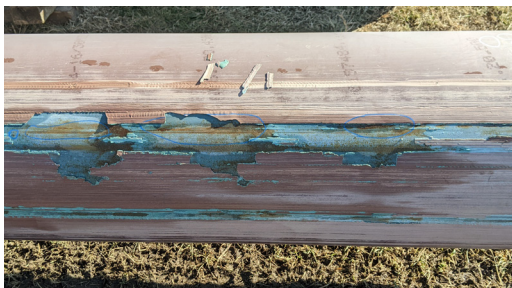
Traditional ARO coating failure on HDD install.

With incredible resources, tools, design specialists, and years of experience, there is a component of every single HDD that cannot be controlled. That is the ground content that exists along the pathway. While core samples can tell you what you may face, it is never the whole story. The pipe pictured was installed by a leading pipeline company following their design path and passing through their chosen soils while attempting to install the pipe beneath a road in Arkansas. After completing the drill hole, reaming it to the appropriate diameter and pulling the pipe in using their standard practices, the pipe arrived on the other side of the hole with incredible amounts of visible damage to the pipeline coating and some deformation of the steel. The company elected to pull the pipe back out and take another approach. They utilized a commonly applied ARO coating solution as their field joint coating protection. However, that coating had also failed in those areas. In an attempt to solve the problem, they reached out to one of the distributors of Denso products and were offered Denso Bore-Wrap as a solution. Bore-Wrap is a shear, abrasion, impact, and gouge (SAIG) resistant coating protection specifically designed to withstand the threats from HDD installation.

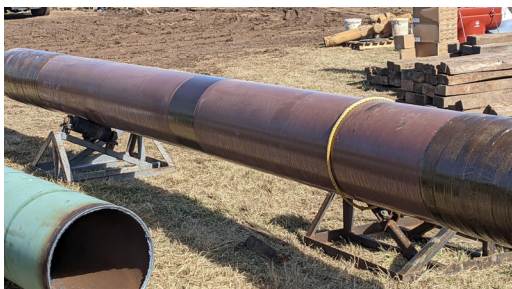
Test pull pipe with 3 options for protection.

The Denso representative reviewed the conditions and recommended a product trial to evaluate the level of protection needed for the pipe and the anti-corrosion layer to survive the installation. The operator also wanted to reassess their historical option at the same time. The decision was made to pull in 2 joints of pipe. On the test pull, the leading section was wrapped in 4 layers of Bore-Wrap. Behind that, the operator applied their historical epoxy solution for coating protection, then on the trailing side, the minimum 2 layers of Bore-Wrap was applied.

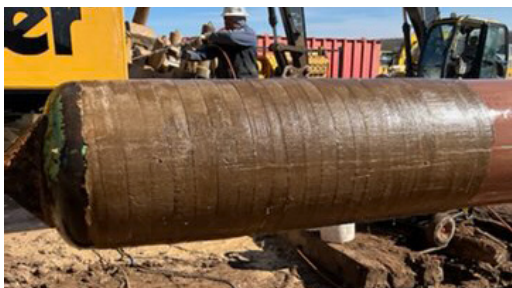
Pull-head after installation with 4 layers of Bore-Wrap.

Pulling the pipe into the same hole that caused the initial damage, we could see how much additional protection was necessary to have the anti-corrosion coating intact after installation. On the leading edge of the pipe, the 4 layers of Bore-Wrap shows almost no wear damage at all, with only a slight scratch visible along the side. Immediately following the layers of Bore-Wrap, the damage originally seen in this HDD became evident again. When the scratching got to the operator's selected epoxy solution, "the way we always do it" as they said, the epoxy was removed entirely, leaving only a shadow of where it had been with several scratches into the plant-applied ARO. Finally, the scratches reached the minimum layers of Bore-Wrap. And again, the Bore-Wrap SAIG protection did its job. A small bit of Bore-Wrap took some damage at the leading edge before the sources of the gouging and impacts bumped up onto the body of the Bore-Wrap, and the damage was eliminated along the remainder of the length.

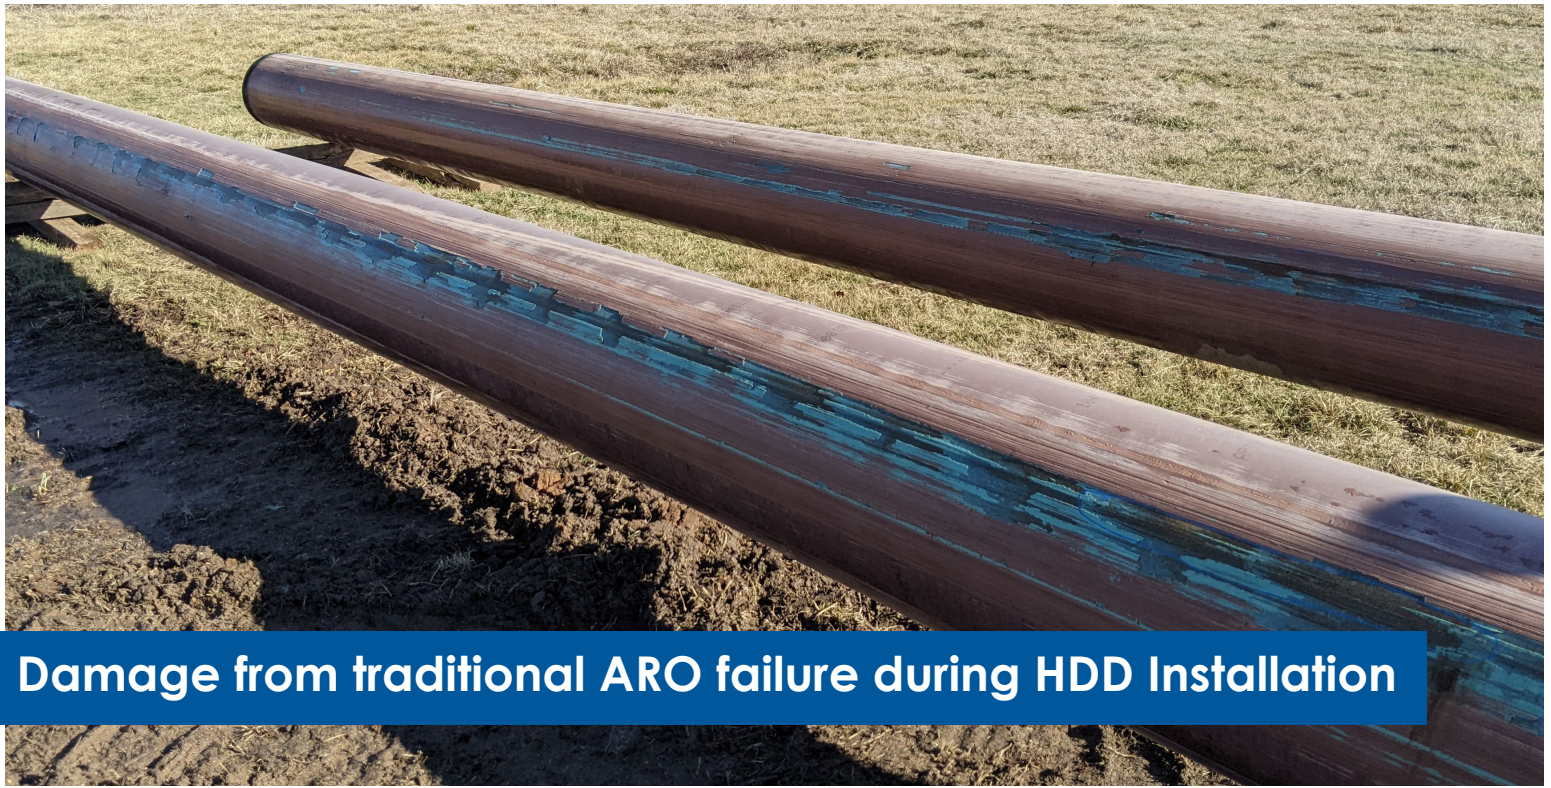
## Damage from traditional ARO failure during HDD Installation

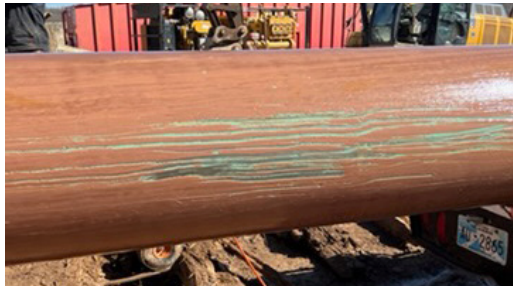
Test pull damage without a SAIG protection.

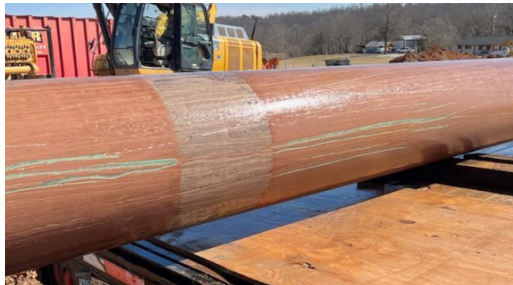
Competitor ARO completely missing.

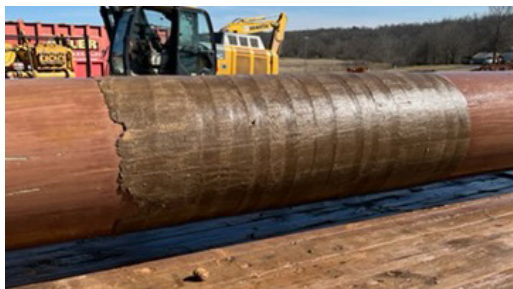
Bore-Wrap in 2 layers protects the anti-corrosion from damage.

Bore-Wrap offers a fast, field-applied, durable and easy solution to a significant issue faced in the HDD market. This company could have saved several hundred thousand dollars in rework by adding 2 layers of Bore-Wrap to the pipe before the installation took place.
