### Project Data

<b>Location</b>	Mexico
<b>Started / Completion</b>	October 2011 / October 2013
<b>Project Type</b>	Pipeline Coating Rehabilitation
<b>Products Used</b>	Denso ViscoWrap HT & Viscotaq PE Outerwrap

### Project Details

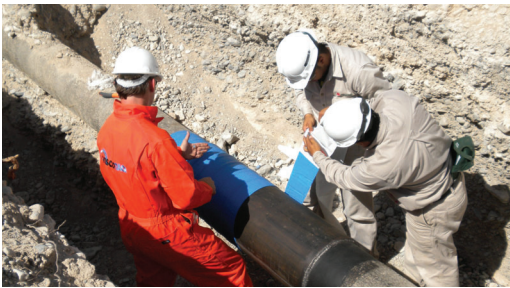
The Viscotaq system was easily installed over difficult pipeline legacy coatings with SP2 surface preparation.

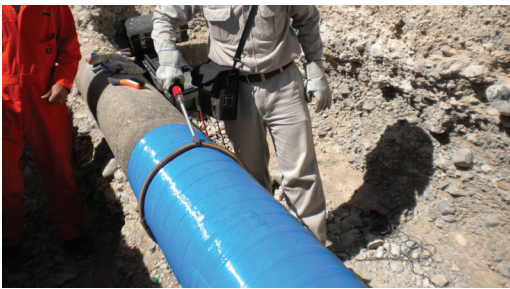
Following rehabilitation, the cathodic protection system was able to function normally again.

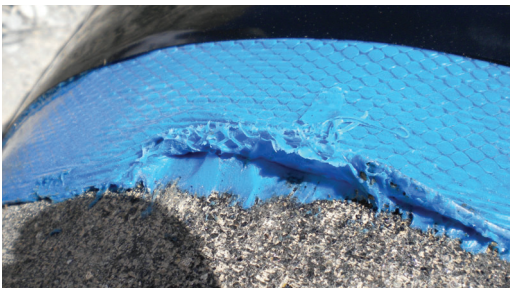
The ViscoWrap HT shows strong adhesion to any of existing pipeline coatings.
