Project Data

Location	New York
Completed	2005
Project Type	Timber Pile Rehabilitation
Products / Systems Used	Denso Fiber-forms

New York's Battery Maritime Building received a \$58 million renovation in which Denso's SeaShield™ Fiber-Forms were used to rehabilitate the timber piles supporting the slips. The building is listed on the National Register of Historic Places built in 1909 in the "Iron Age" with vaulted arches and ornamental structures steel. The building has over 140,000 square-feet and offers rare waterfront views of Manhattan and The Statue of Liberty.

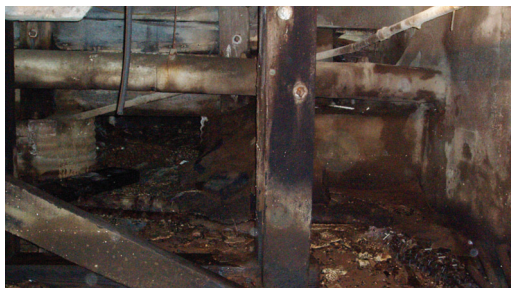
The unprotected timber piles that received marine borer damages.

In service for over 95 years, the timber piles had received marine borer damage, which threaten the structural integrity of the slips. The pile repair system chosen was concrete encapsulation with rebar and fiberglass forms. This major rehabilitation called for more than 5,000 linear feet of timber pile repair with Denso Fiber-Forms. The fiberglass forms provide a strong rigid form to allow concrete to be pumped into the annulus space between the jacket and timber pile.

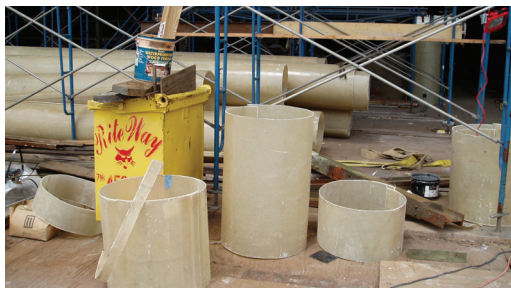
Uninstalled SeaShield™ Fiber-Forms being prepped and awaiting install.

Denso's Fiber-Forms used for the Battery Maritime Building were custom fabricated to 3/16" thick utilizing woven-roven construction. Installation included installing a reinforcement cage around the piles and then installing the fiberglass forms. The concrete was then pumped into the annulus space and to provide ease of application the forms were fabricated in a translucent color to allow the contractor to view the concrete level during the pumping operation. The complete repair will provide years of maintenance free structural integrity to the timber piles.

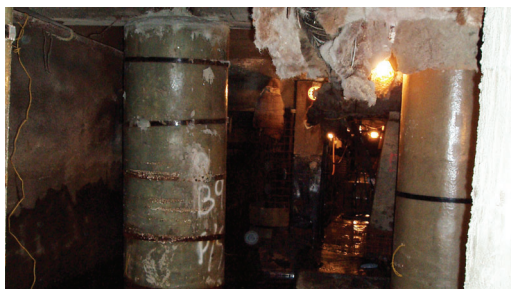
Completed Denso Fiber-Forms installation to the timber piles.
