Volume 31 - Number 4

The rehabilitation of the Maitlands River Pipebridge, South Africa. Pipebridge being cleaned of old coating ready for the application of the Denso Steelcoat System - See story pages 8-9

LEADERS IN CORROSION PREVENTION & SEALING TECHNOLOGY

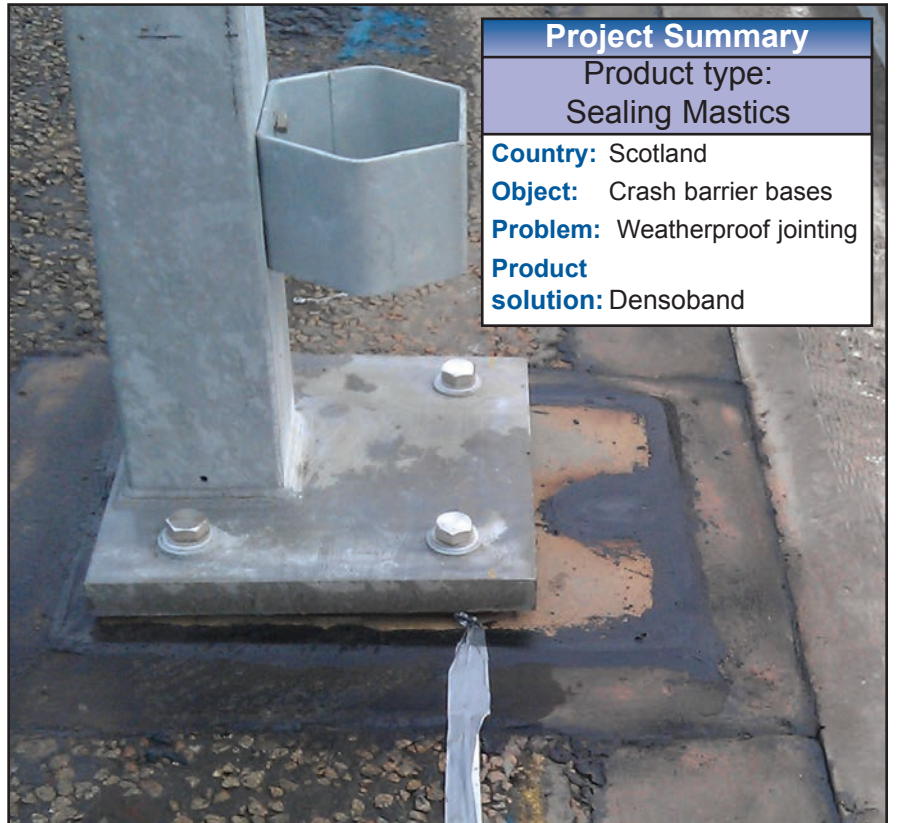
Densoband forms a flexible weatherproof seal between the crash barrier bases and surrounding asphalt.

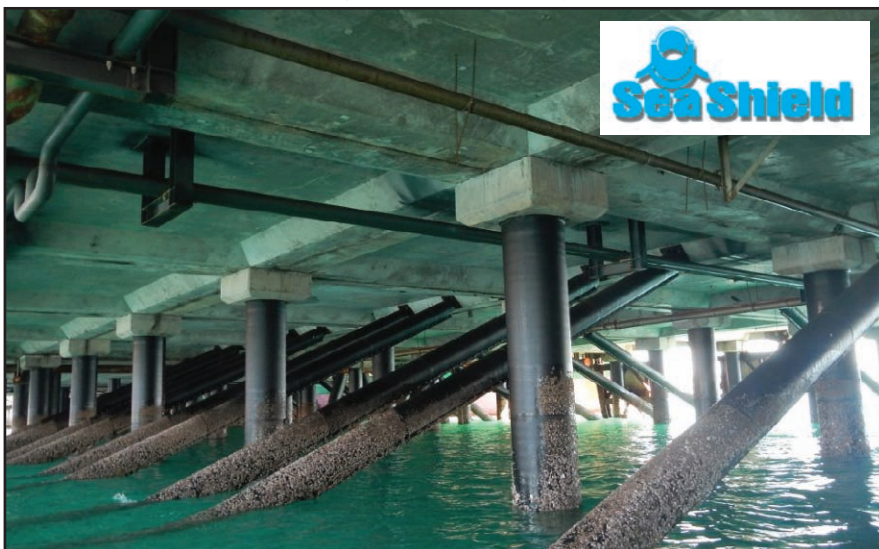
View underneath the MOF Wharf showing the SeaShield 2000FD system applied to the steel piles.

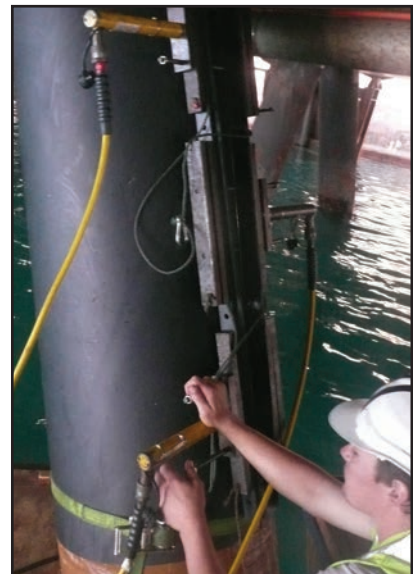
Application of the SeaShield 2000FD Jackets.

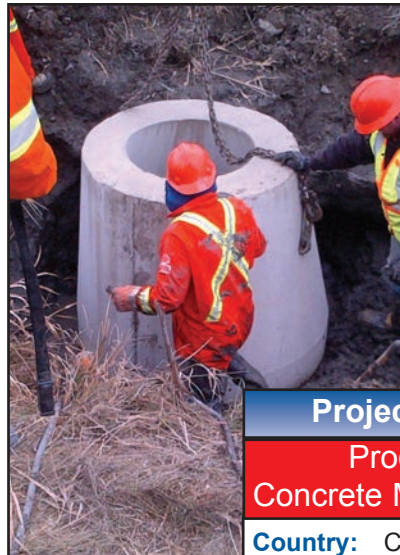
A new manhole chamber prior to wrapping with Denso Tape.

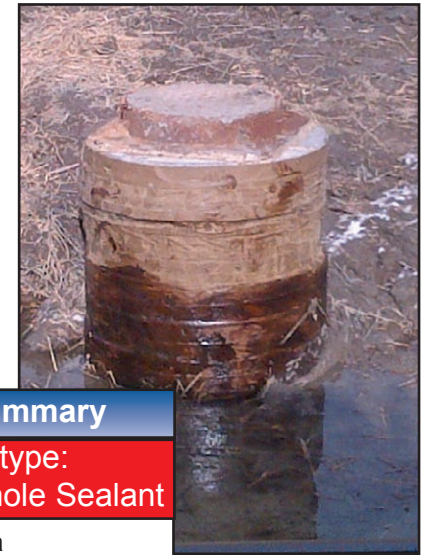
Manhole chamber wrapped with Denso Tape.

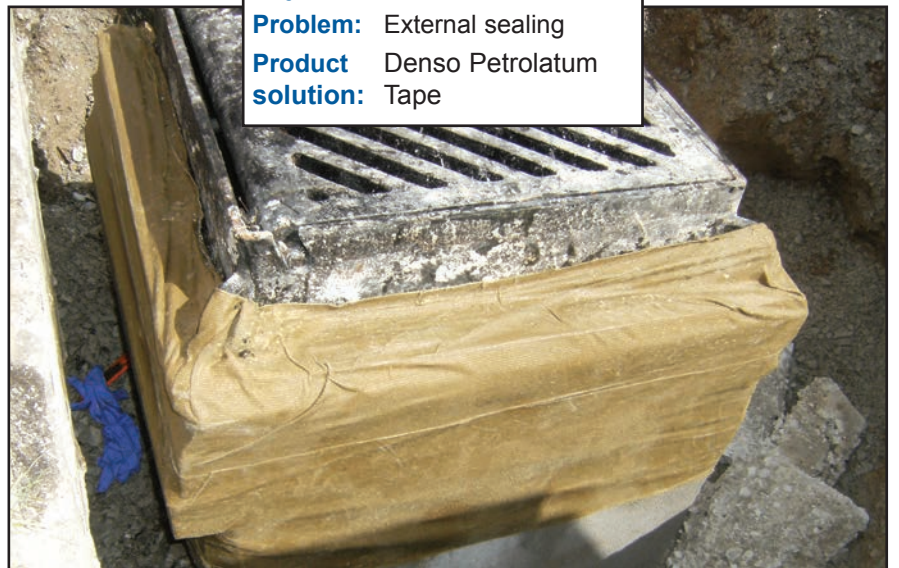
A manhole chamber in Barrie Ontario is exposed for repair is wrapped with Denso Tape.

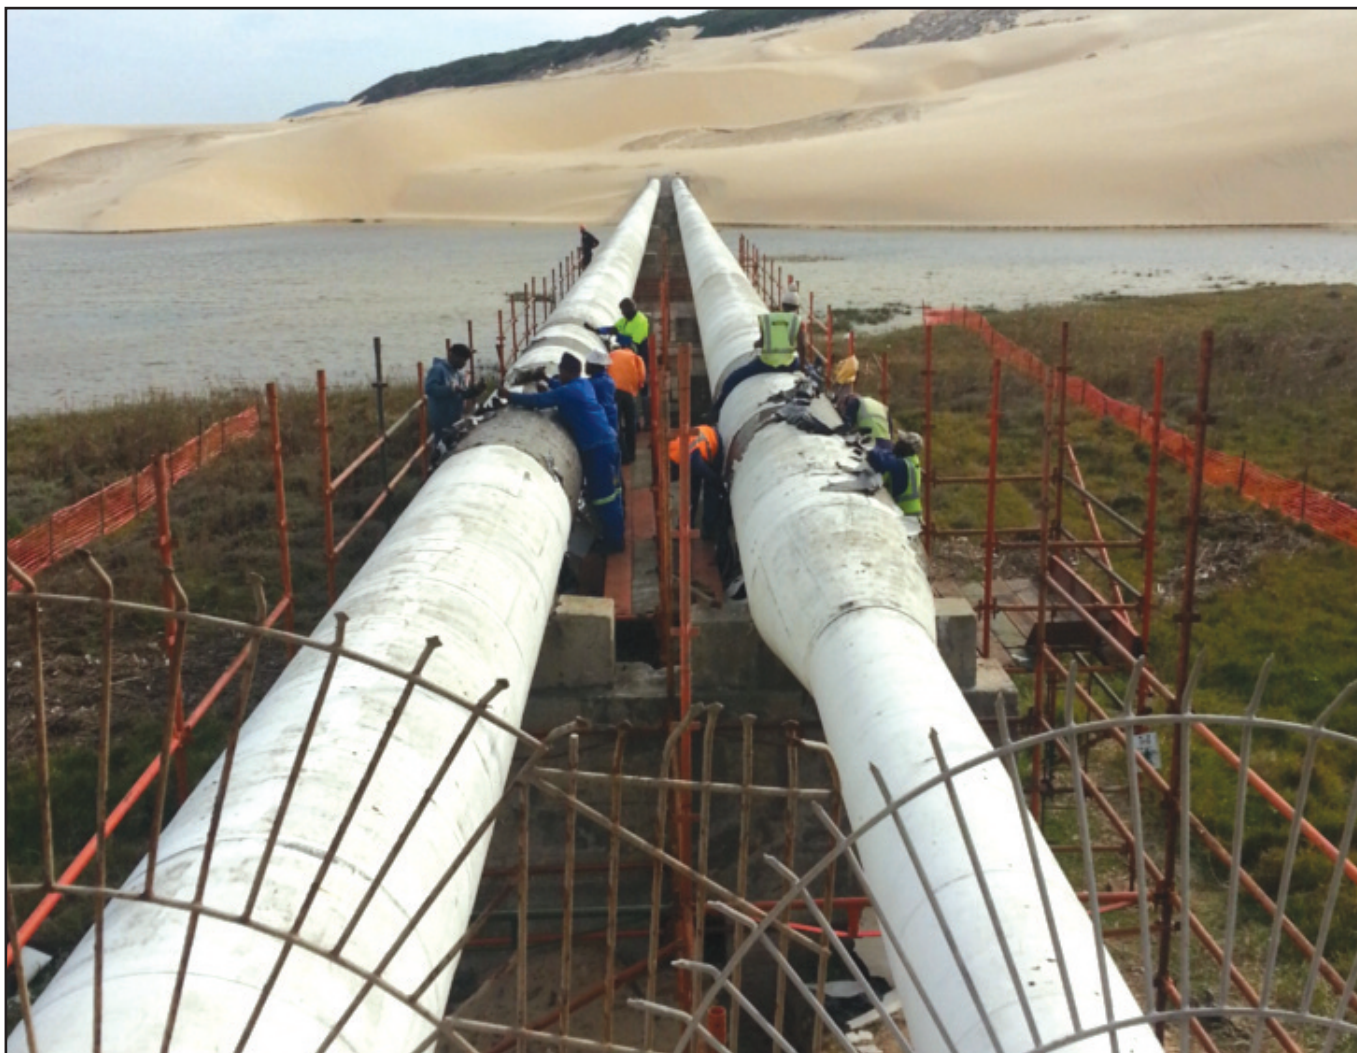
The pipebridge during the early stages of having the original wrapping removed.

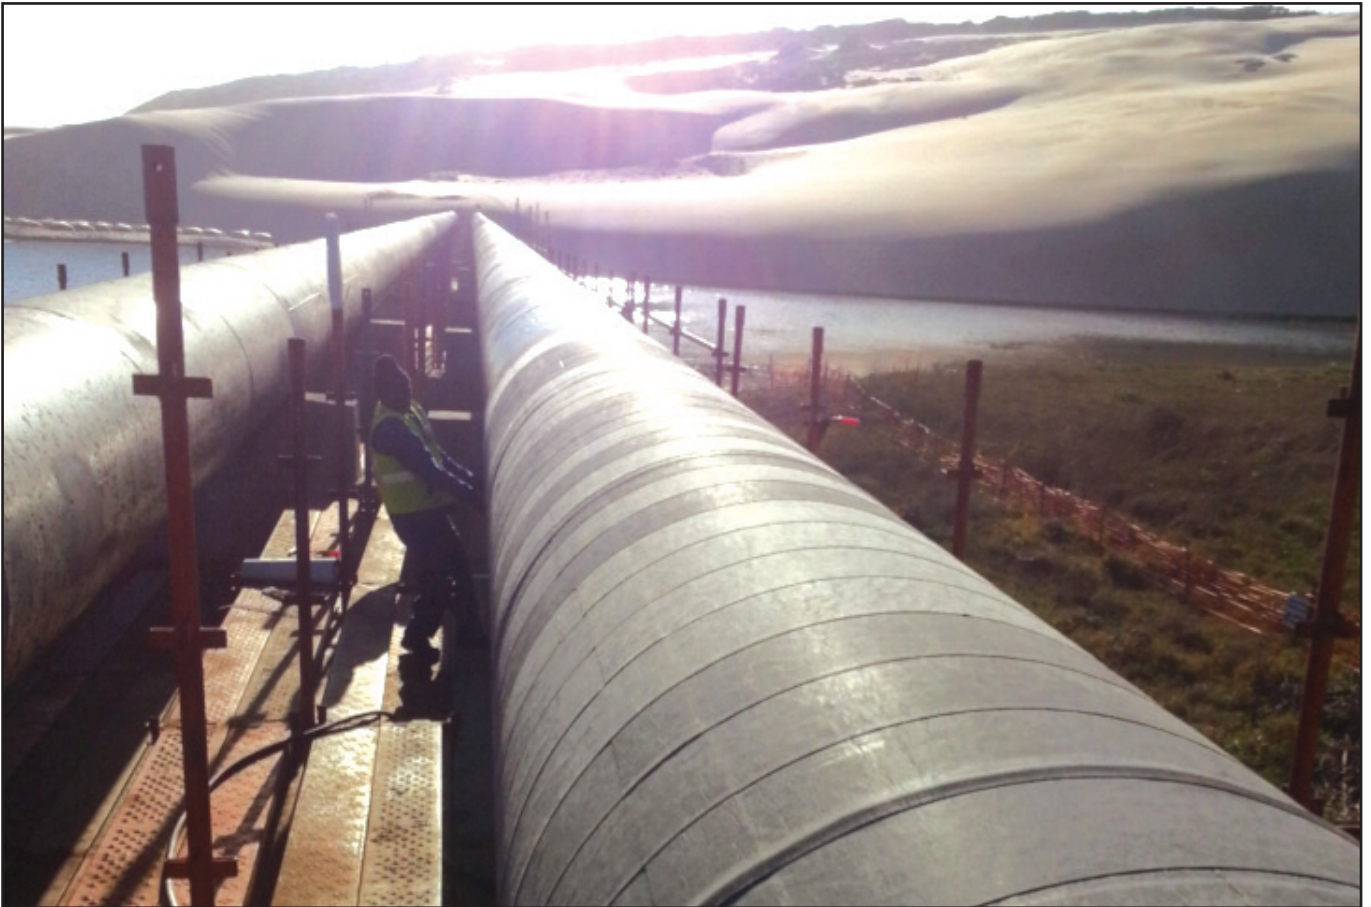
Application of the new Denso Steelcoat 500 system.

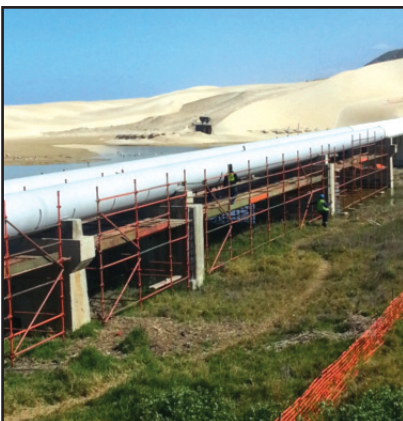
Application of the Steelcoat System progressing along the pipebridge

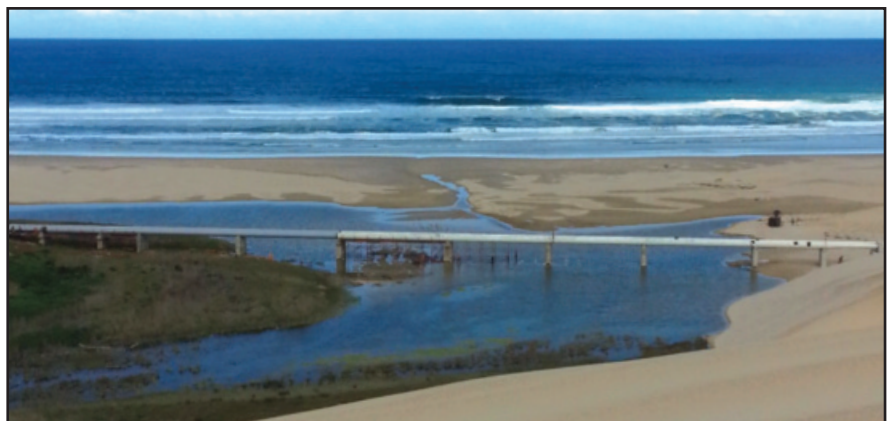
A view from a nearby sand dune shows exactly how close to the ocean the pipebridge is and the harsh environmental conditions the Denso Steelcoat 500 System needs to perform under.

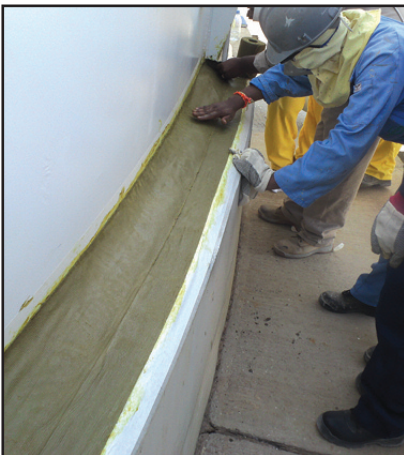
1. After cleaning and then priming with Denso Hi-Tack Primer the Denso Hi-Tack Tape is applied.

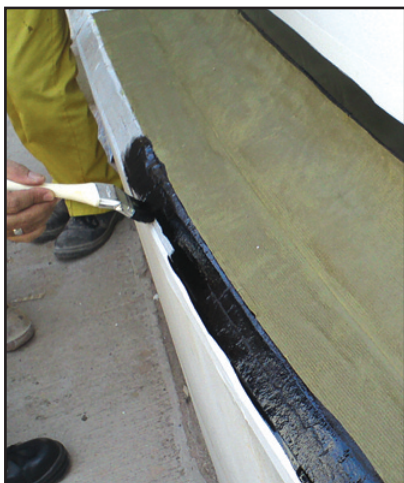
2. Denso Primer D is applied to the masked area before the application of the Ultraseal RT Tape.

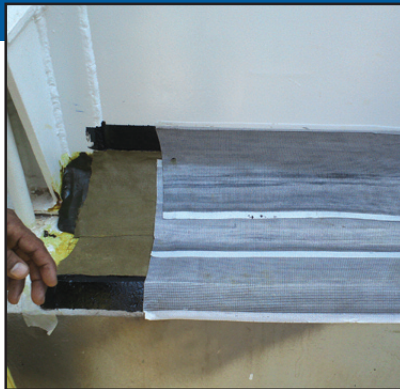
3. The Denso Ultraseal RT Tape is applied in weatherboard style

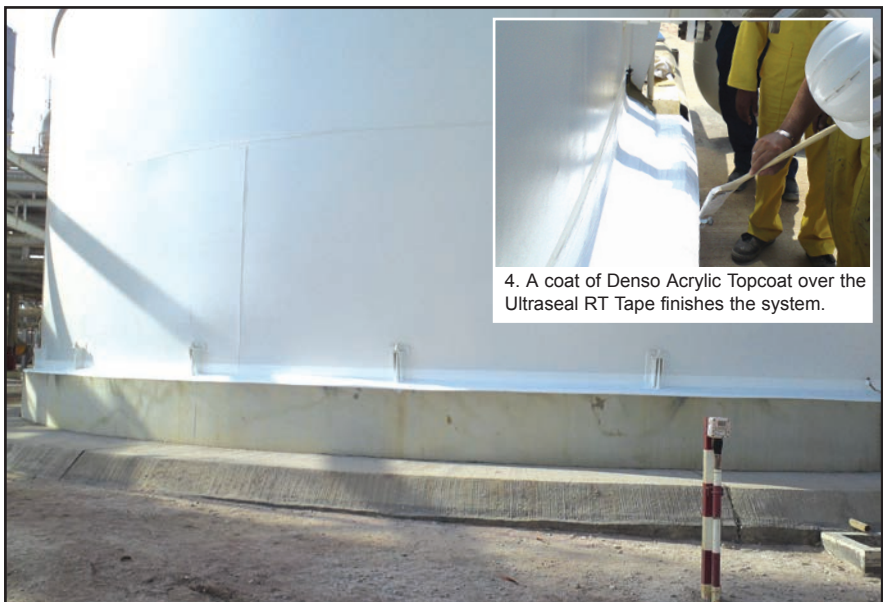
4. A coat of Denso Acrylic Topcoat over the Ultraseal RT Tape finishes the system.

5. The finished Steelcoat System provides a neat long-lasting flexible weatherproof seal to the problem area.

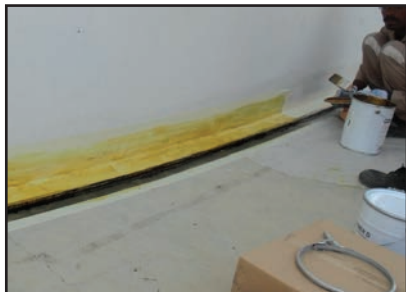
1. After cleaning the vulnerable area is primed with Denso Hi-Tack Primer.

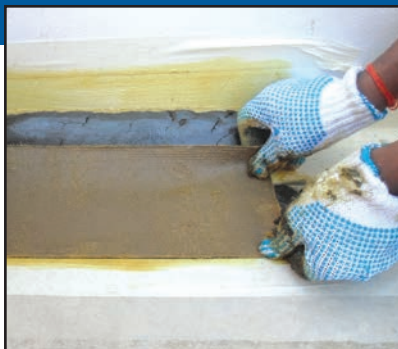
3. A layer of Denso Hi-Tack Tape is applied.

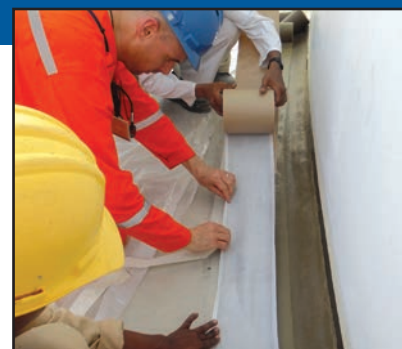
5. The Denso Ultraseal RT Tape is applied in weatherboard style.

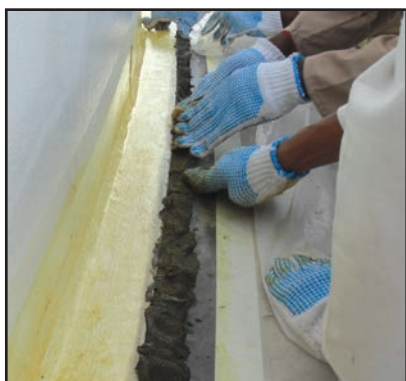
2. All voids are filled with Densyl Mastic.

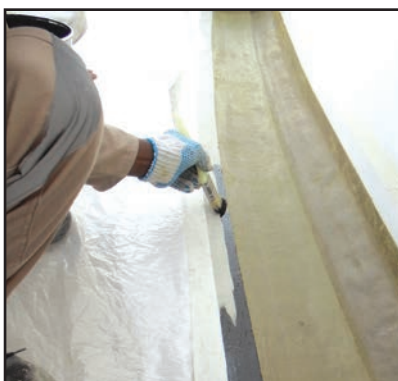
4. Denso Primer D is applied to a masked area before the application of Denso Ultraseal RT Tape.

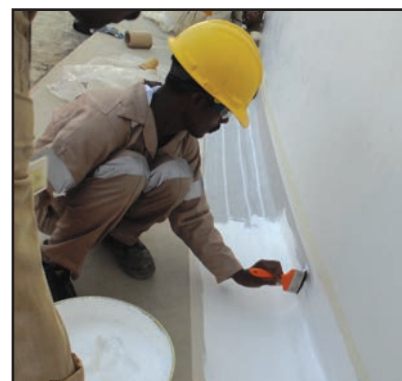
6. A coat of Denso Acrylic Topcoat is applied over the Denso Ultraseal RT Tape.

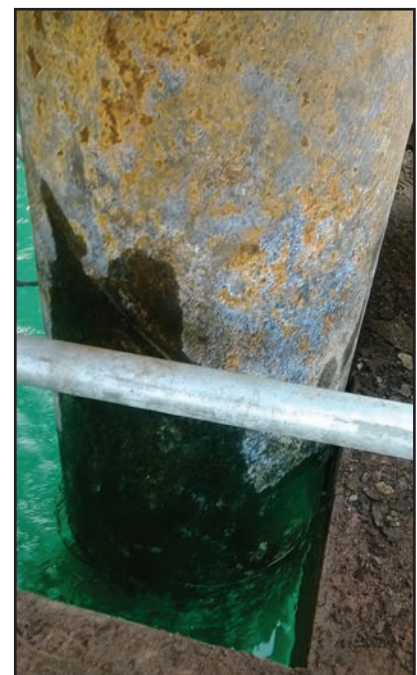
The piles after cleaning to remove all loose flaking material, marine growth etc.

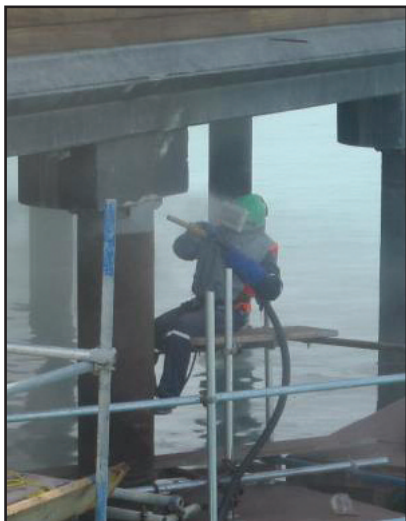
Abrasive blast cleaning of the top of the pile area to be coated with Denso Rigspray.

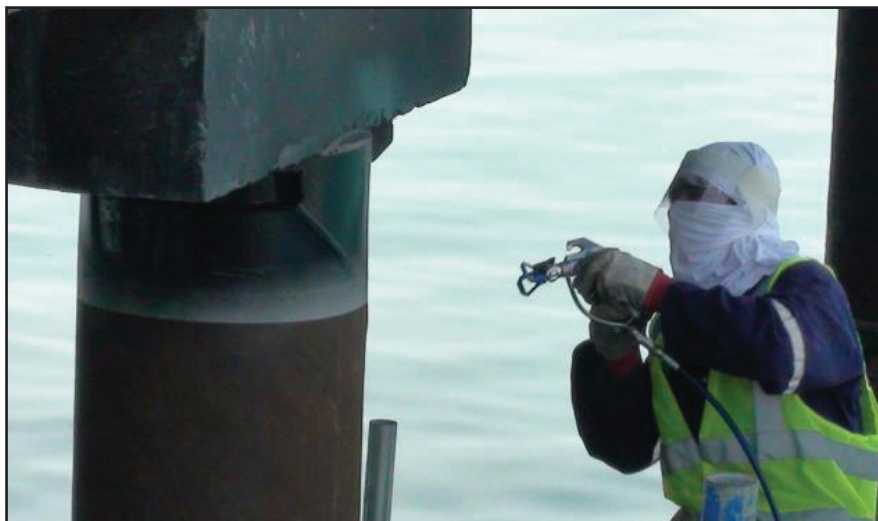
Denso Rigspray was applied by spray in two coats to a total thickness of 1200 microns.

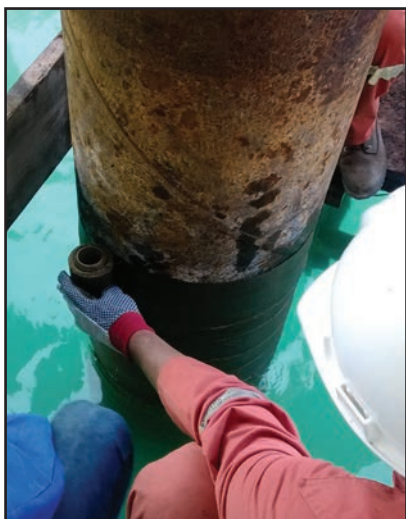
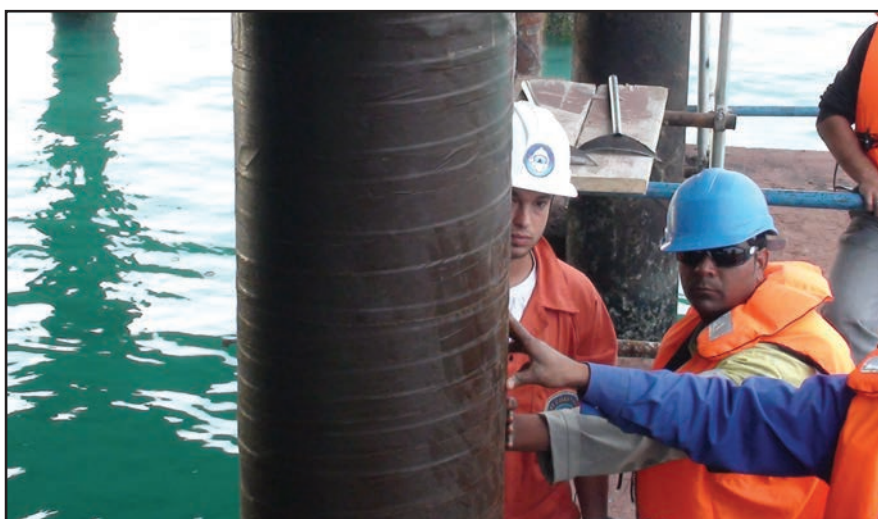
Denso SeaShield 2000 FD application begins with a circumferential wrap of Denso Marine Piling Tape to the previously cleaned pile surface.

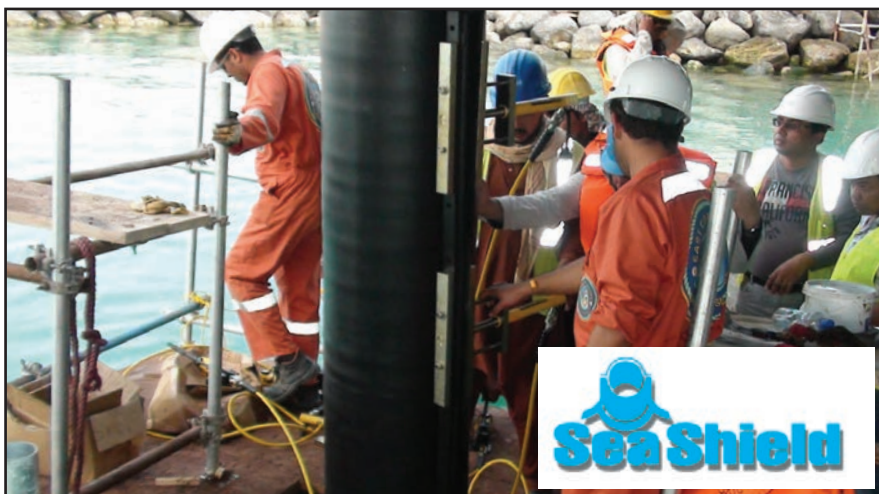
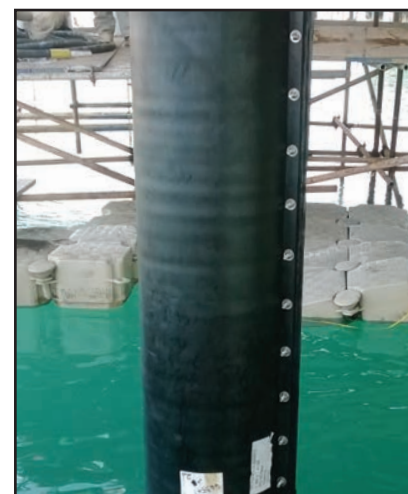
The SeaShield 2000 FD Jackets are then placed over the pile and bolted together to complete the system.

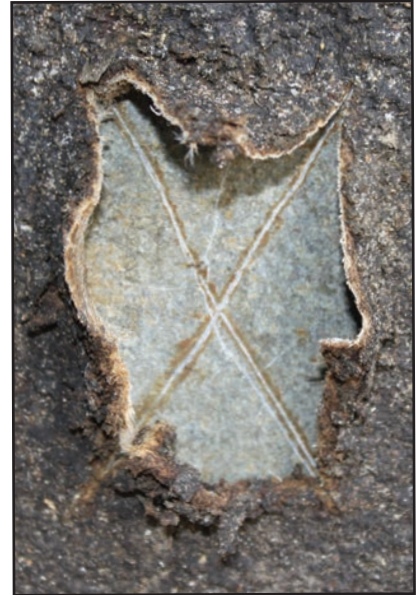
The removal of a small patch of the Denso Tape coating for an inspection of one of the support I-Beams reveals the steel to be in excellent condition after 37 years.

The petrolatum tape coating had been in service for over 37 years in a wet/humid corrosive environment. It was found after removing the Denso Petrolatum Tape, the steel was in perfect condition with no corrosion.

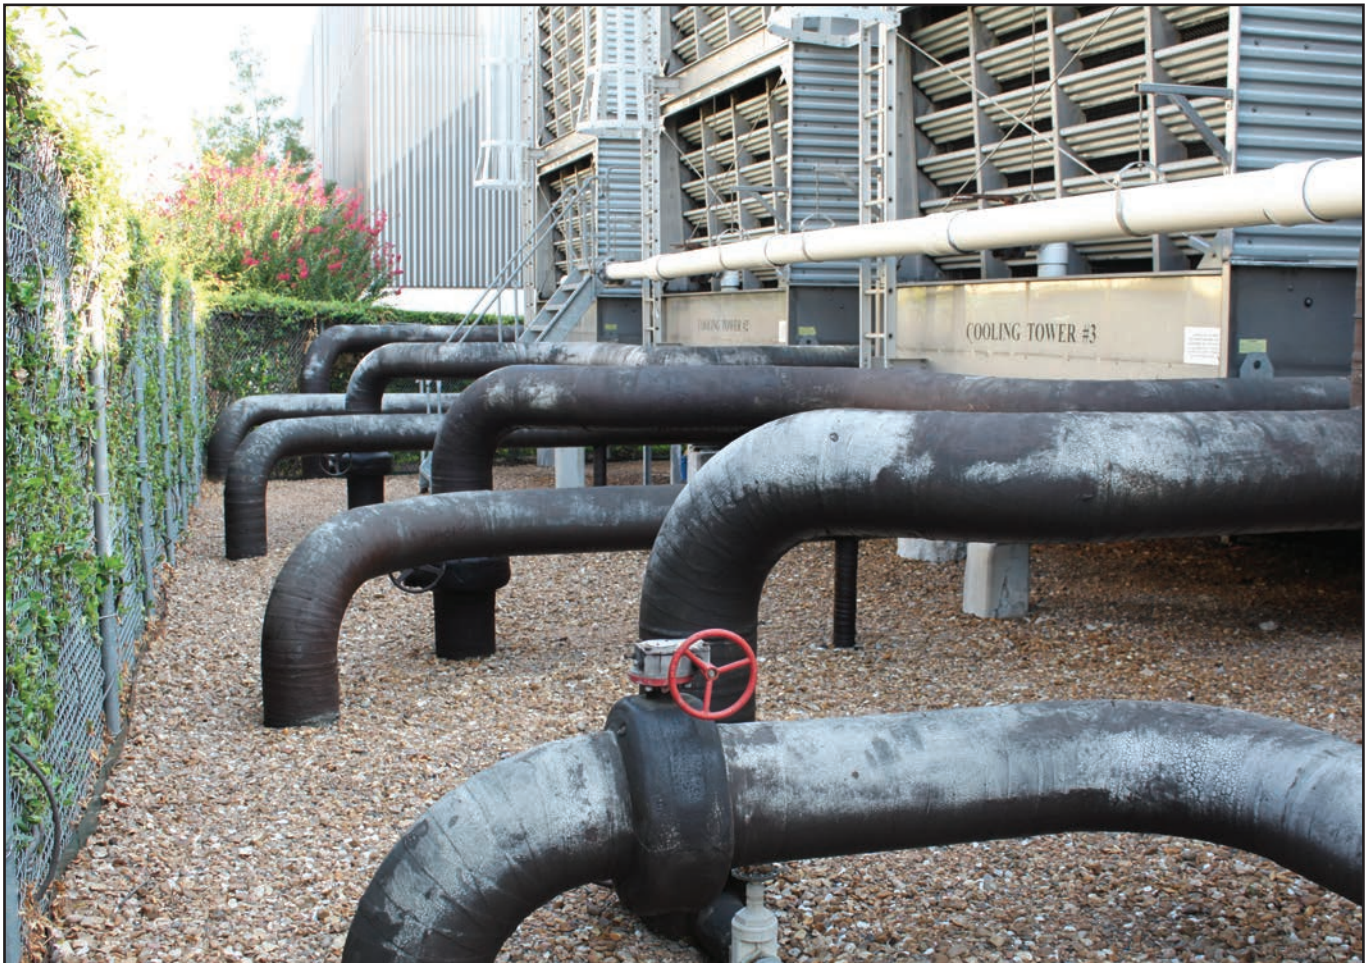
The cooling tower pipework in its original 1977 Denso Petrolatum Tape coating after 37 years in service.

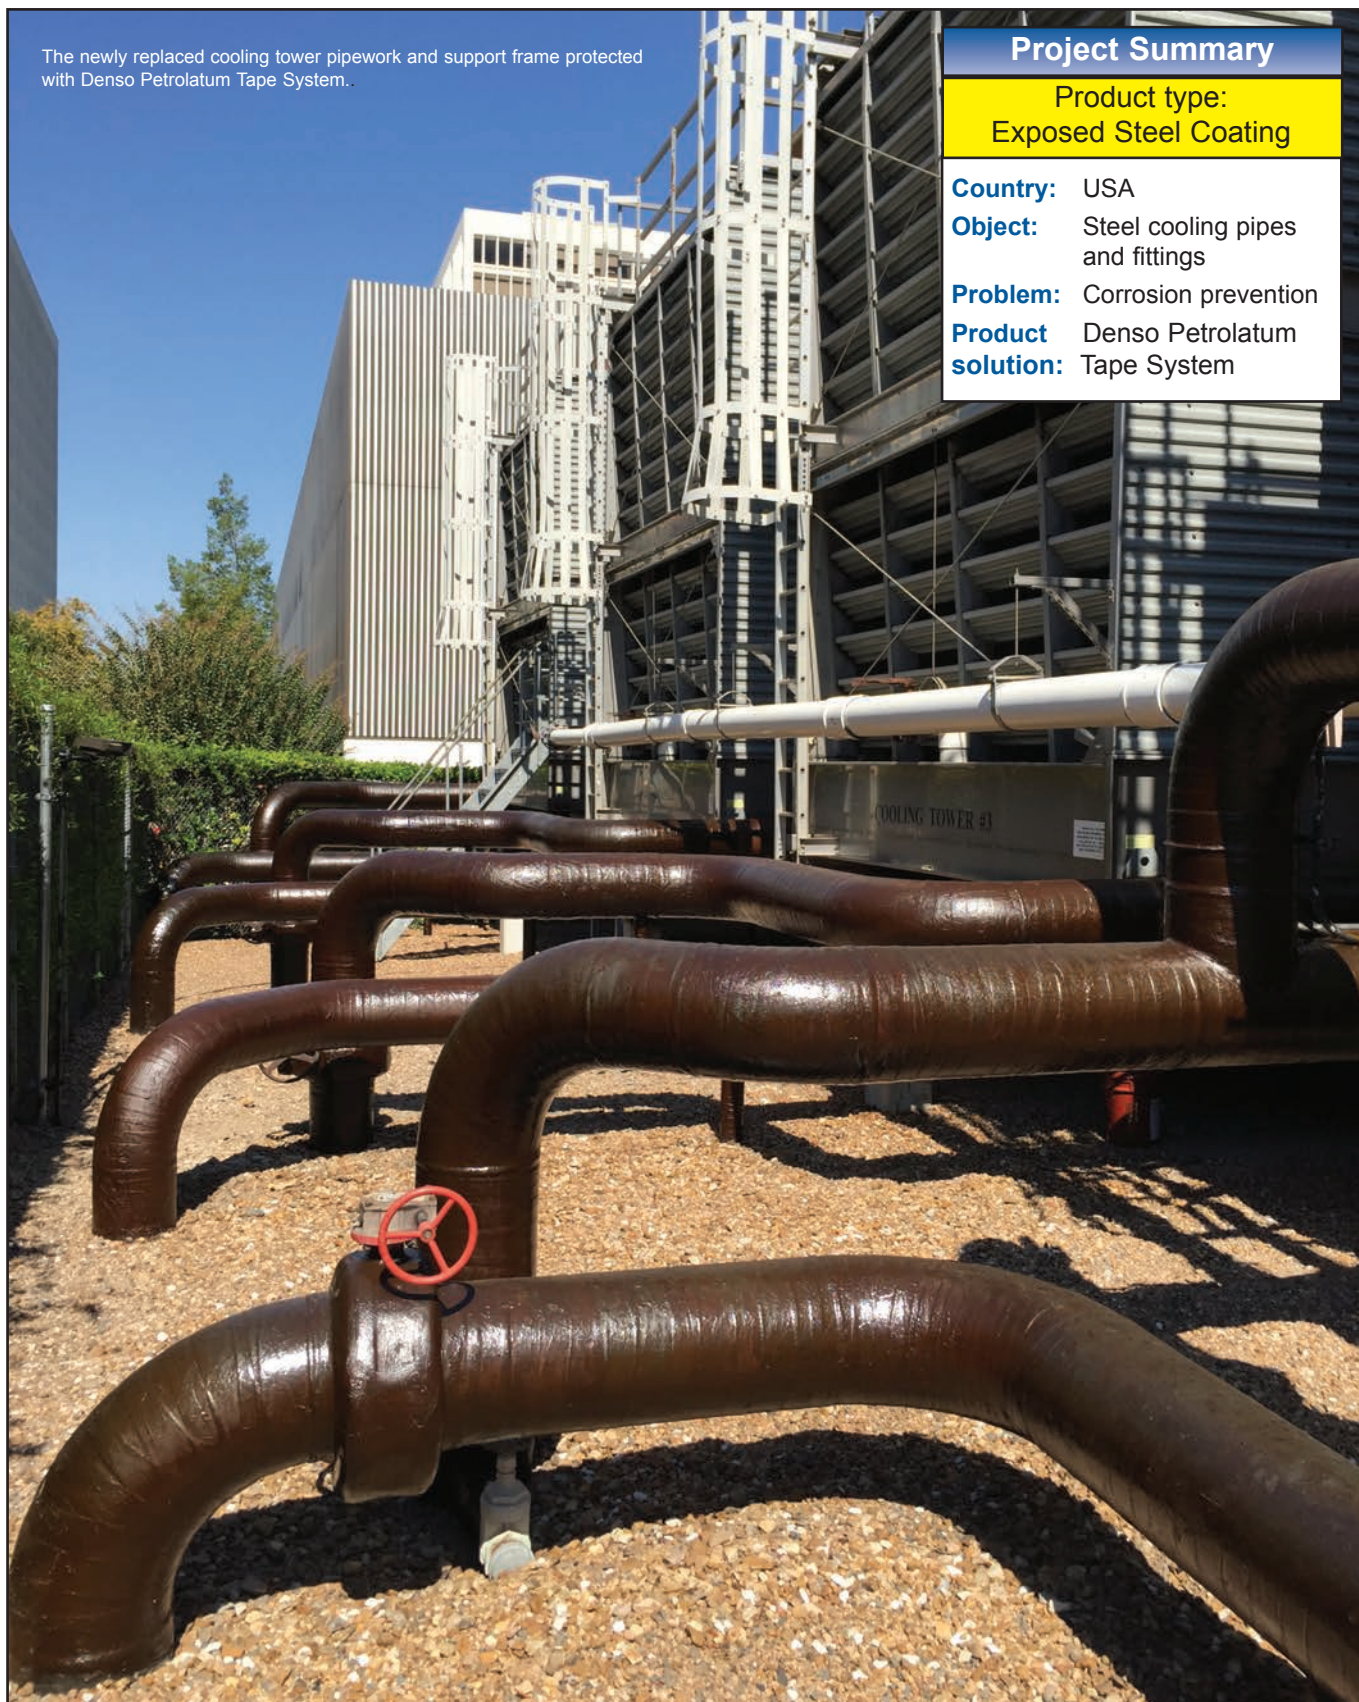
The newly replaced cooling tower pipework and support frame protected with Denso Petrolatum Tape System.

Since the coating system exceeded the life of the cooling tower the engineers specified that all pipes, valves, fittings and structural steel be protected with the Denso Petrolatum Tape System again.
