# CASE STUDY

## AMERICAN GENERAL BUILDING - 2014

## Cooling Tower Protection

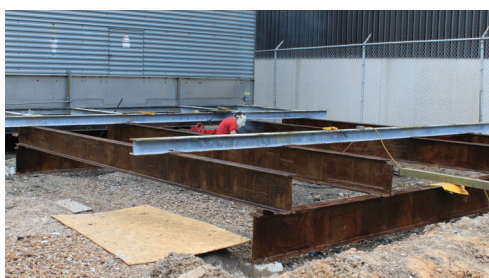
The maintenance crew completing the wrap protection system to the cooling tower frame work.

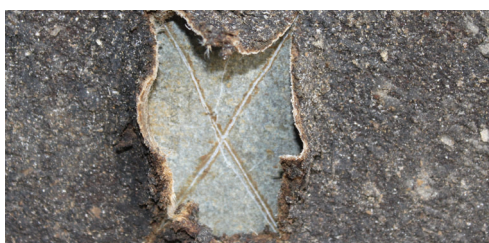
Inspection of the I-Beam, with Densyl Tape protecting since 1977, revealed the surface underneath to be in excellent condition with no corrosion.

In 1977 American General applied the Denso Petrolatum System to protect their cooling tower framework and piping. After years of service the cooling towers had to be replaced. This provided the perfect opportunity to inspect Denso's Petrolatum Tape System. The petrolatum tape coating had been in service for over 37 years in a wet/humid corrosive environment. It was found after removing the Denso Petrolatum Tape, the steel was in perfect condition with no corrosion. Since the coating system exceeded the life of the cooling tower the engineers specified that all pipes, valves, fittings and structural steel be protected with the Denso Petrolatum Tape System. Denso has a long list of successful case histories as we have been manufacturing petrolatum products for over 85 years.
