CASE STUDY

LOUISIANA TECH UNIVERSITY TESTING

Timber Pile Rehabilitation

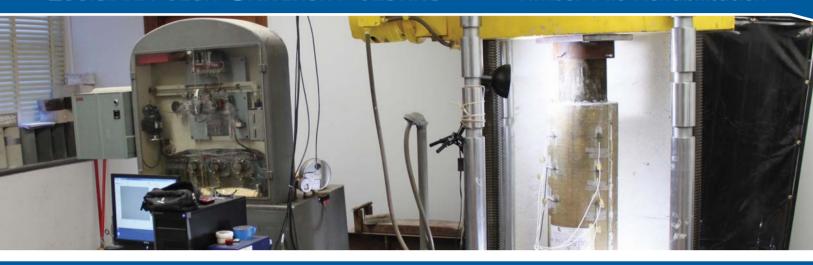
Hourglass shaped timber piles prior to installation of repair system.

Repaired timber piles with the SeaShield Series 400 system.

Compression testing of timber piles.

Test Setup: Five each 8 "diameter x 4 ft. long timber piles with fiberglass reinforced jackets, grout and carbon fiber grid. To simulate deterioration, five of the piles had a hourglass-shaped varying depth cut into them at mid-span. There were two more piles that were used as baseline controls, one specimen was a plain timber pile with no repairs and the other had a hourglass-shaped cut into them at mid-span with no repairs. The repairs were installed 8" above and below the hourglass area. The objective was to evaluate the behavior of the mid section repair of a deteriorated timber pile and quantify the additional axial compressive strength from the repairs vs. the baseline control specimens.

Results: The results of showed that the repair will increase the axial capacity of the damaged pile from 198% to 483%. The ratios between the peak loads of repaired piles and undamaged pile varied from 1.03 to 1.22, which means that the repair not only restores the original axial capacity of the pile but also enhances it by 3% to 22%.

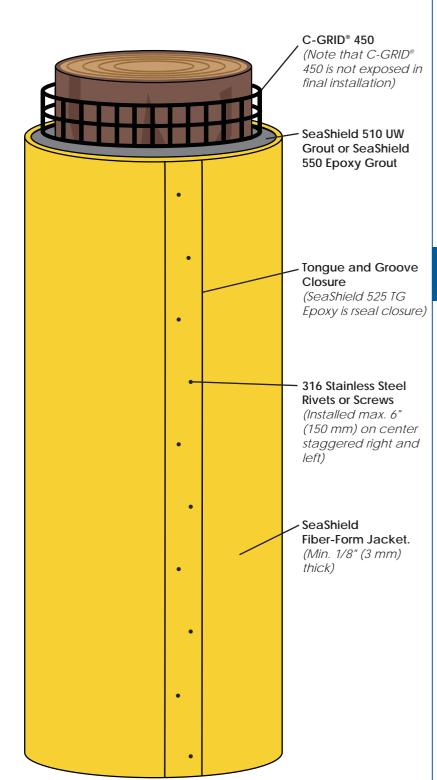
Hourglass shaped timber pile setup with the SeaShield C-Grid® 450, the first step installation with the SeaShield Series 400 Sya

The SeaShield C-Grid® 450 with spacers that provides strength to timber piles prior to the SeaShield grout being poured.

Completed SeaShield Series 400 System with freshly poured SeaShield 510 UW Grout protecting and strengthening a timber pile.
