CASE STUDY

OIL REFINERY

Pipeline Touchpoint Protection

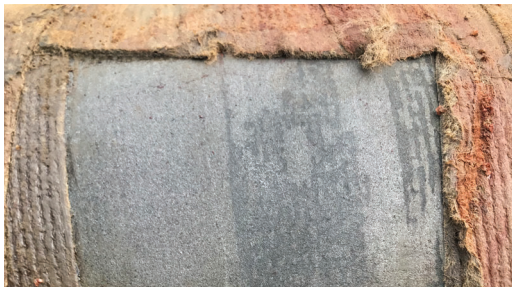
After 1 year, a field trial splashzone test with petrolatum tape & Glass Outerwrap reveals steel surface in perfect condition with no corrosion.

The solution proposed by Denso was to use the Denso Petrolatum Tape System comprised of Denso ColorTape, Denso Glass Outerwrap UV, and the Denso FRP Spacer. The engineering team at the refinery proposed a "splash zone" test program to simulate the environment. A sample piece of pipe was blasted to a near white SSPC SP-10 finish, and left partially submerged in salt water for 1 year. After 1 year the pipe was removed and inspected to reveal the surface was still near-white showing no corrosion at all. After the successful test program, the Denso Petrolatum Tape System was approved.

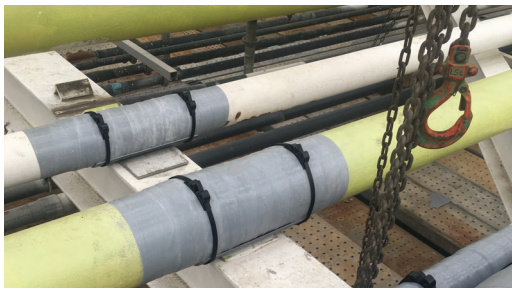
Denso ColorTape, Denso Glass Outerwrap UV, and FRP Spacer held in place by strapping.

After a quick hand tool cleaning (SSPC SP 2), the Denso ColorTape was spirally wrapped with a 55% overlap providing a corrosion barrier which chokes out all oxygen and moisture. For additional mechanical and long-term UV protection the Denso Glass Outerwrap UV was then spirally wrapped over the Color Tape. The FRP Spacer was then fastened in place with strapping to provide an abrasion barrier between the Petrolatum Tape System and the pipe support.

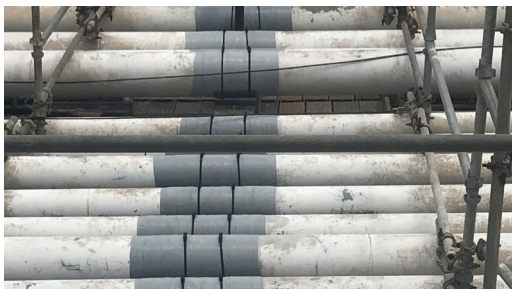
Complete system was installed on over 500 individual touchpoints throughout 7 separate dock sites in the refinery.
