## New York Tank

# CASE STUDY

**Tank Lining Protection**

Pipeline storage company, 220' fuel oil tank, outside Albany, New York, on the Hudson River.

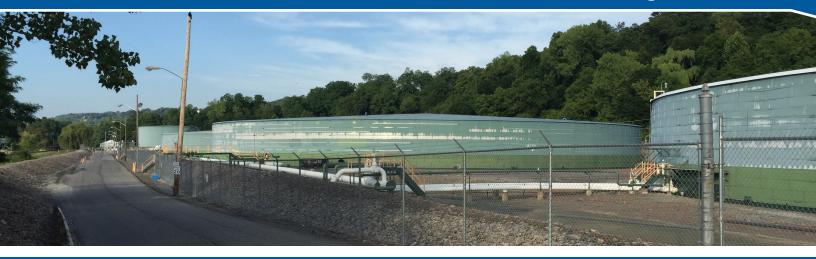
Adhesion test, 2500 psi to 2800 psi

System 400 primer @ 4 to 5 mils dft, 30 to 35 mils dft of 476F single leg.

A large pipeline company wanted a system that would allow them keep their existing floor for another 10 to 20 years instead of replacing it. It was decided to sweep -blast the existing lining and apply rehabilitation coat, instead of removing it.

The 400/476F was recommended for this project for this reason. The 400 primer/sealer bites into the swept blasted existing coating, creating an excellent bond to anchor the 476F. The 467F was then applied over the 400 primer at 30 to 35 mils dft in one coat. The 476F sprays and builds very well creating an epoxy reinforced glass barrier system. The 476F is an epoxy phenolic epoxy that is very chemical resistant, has good heat resistance and has good abrasion resistance. After the lining was cured, adhesion tests were performed to check the mechanical and chemical bond to the existing substrate. The readings were anywhere from 2300 psi to 2800 psi. The owners can expect the lining service life to meet their needs.
