Denso Steelcoat 400 and 700 Systems used on the Ercebridge pipebridge near Darlington
- see story pages 4-5.

Volume 28 - Number 2

SeaShield & Steelcoat Protection for Jetty Piles

Denso Steelcoat Systems Give Quality Finish as well as Quality Protection

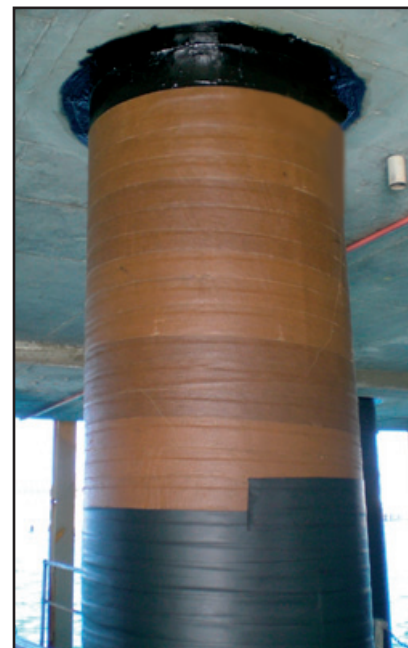
Above: Application of the SeaShield 80 System underway showing completed Steelcoat 100 System at the top of the pile.

Left: Some completed piles in the background. bitumen adhesive tape.

A decision was made to investigate alternative means of protecting the various types of piling at this location and after trialling various options the Seashield 80 system was chosen. This system consisted of Petrolatum Primer and Tape overwrapped with PVC backed

A second concern was corrosion at the pile / concrete interface, this was addressed by applying the Steelcoat 100 System consisting of a High Tack Primer and Tape over coated with a specially formulated brush applied Elastomeric Membrane, The Seashield 80 system was then installed so as to overlap the Steelcoat 100 ensuring complete long term protection against corrosion and significantly reducing ongoing maintenance costs.

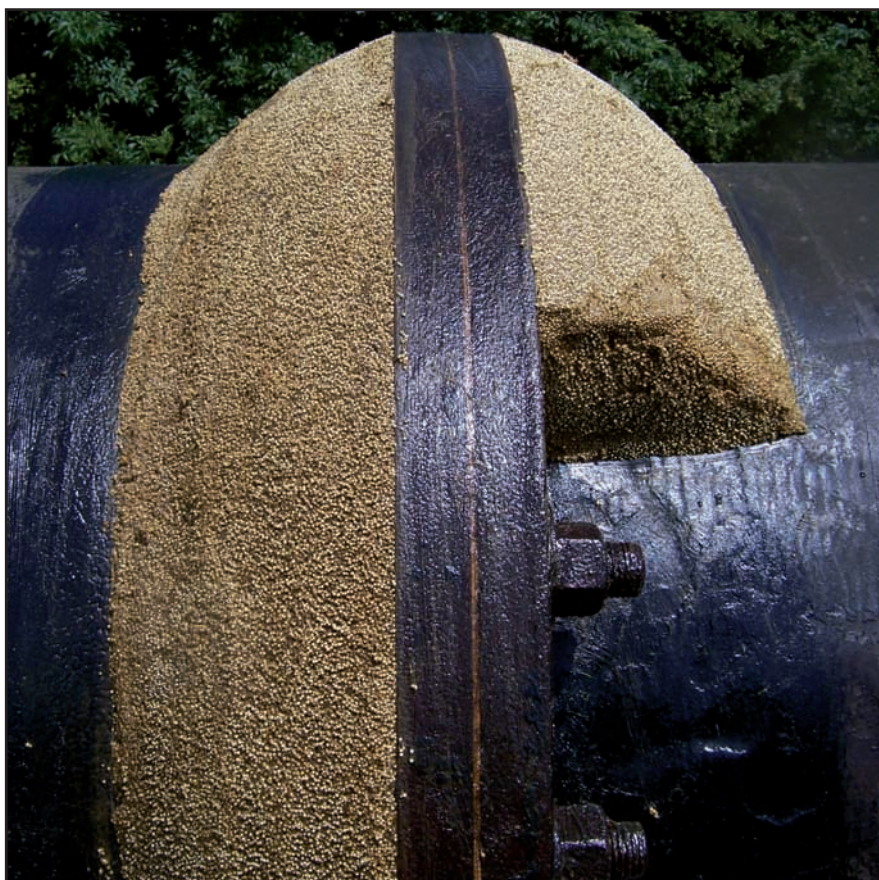
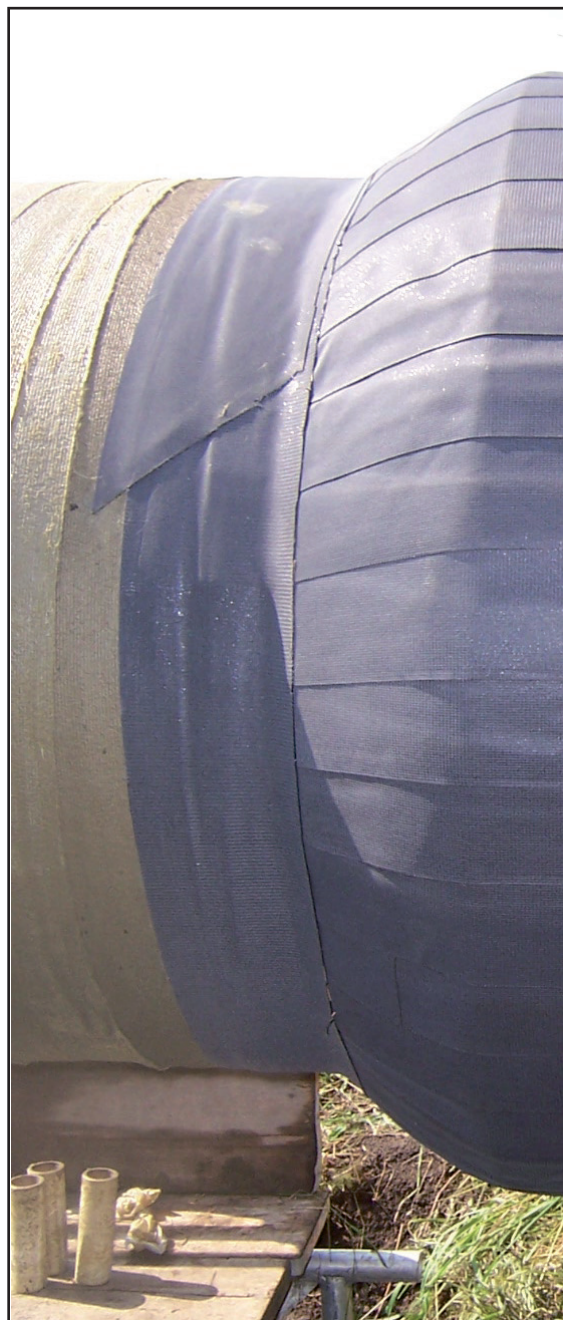
Below left: Close up of how Denso Profiling Mastic is used on the flange joints to smooth contours prior to wrapping with tape.

Below centre: Close up of Denso Ultraseal Tape application to the flange joints. Each horizontal strip of tape is overlapped onto the one below in a weatherboard fashion to give extra resistance against weather penetration.

Below right: The finished pipebridge and anti-vandal guards coated with Denso S.T. Epoxy.

After wire brushing to remove previous coatings, the contractors applied Denso Hi-Tack Primer to all surfaces, Denso Profiling Mastic to the flange joints and then Denso Hi-Tack Tape followed by Denso Ultraseal Tape to both the pipe joints and barrels using 55% overlap.

Finally two coats of Denso Acrylic Topcoat were applied over the Denso Ultraseal Tape.

The anti-vandal guards were coated with the Steelcoat 700 System which comprises two coats of Denso ST Epoxy followed by a coat of Denso Weathershield to give it extra ultra violet resistance.

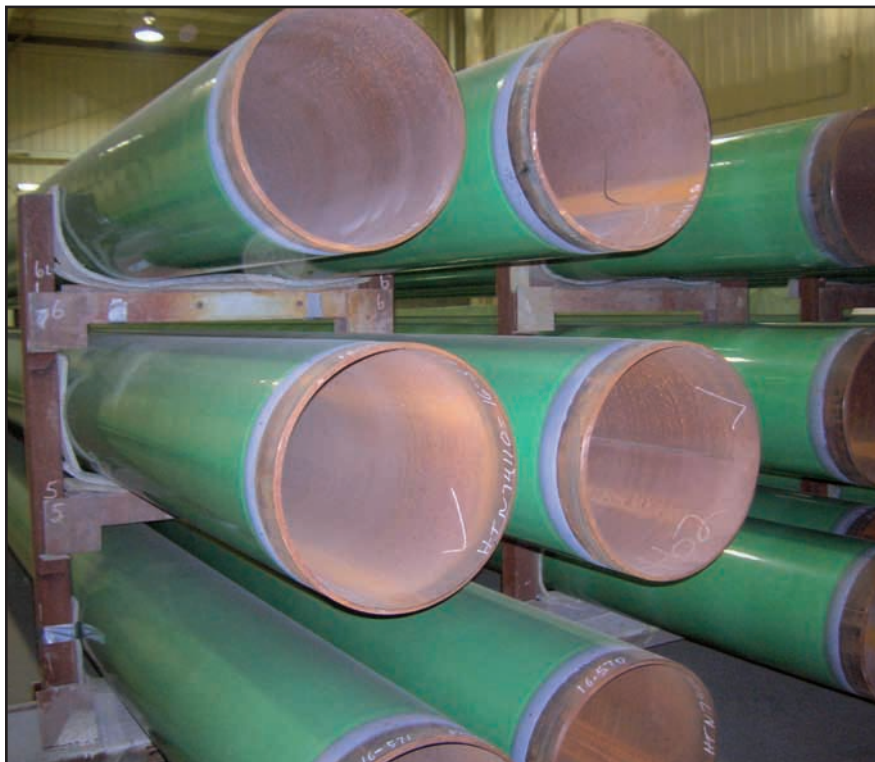
Jet fuel pipelengths stockpiled prior to installation at the airport.

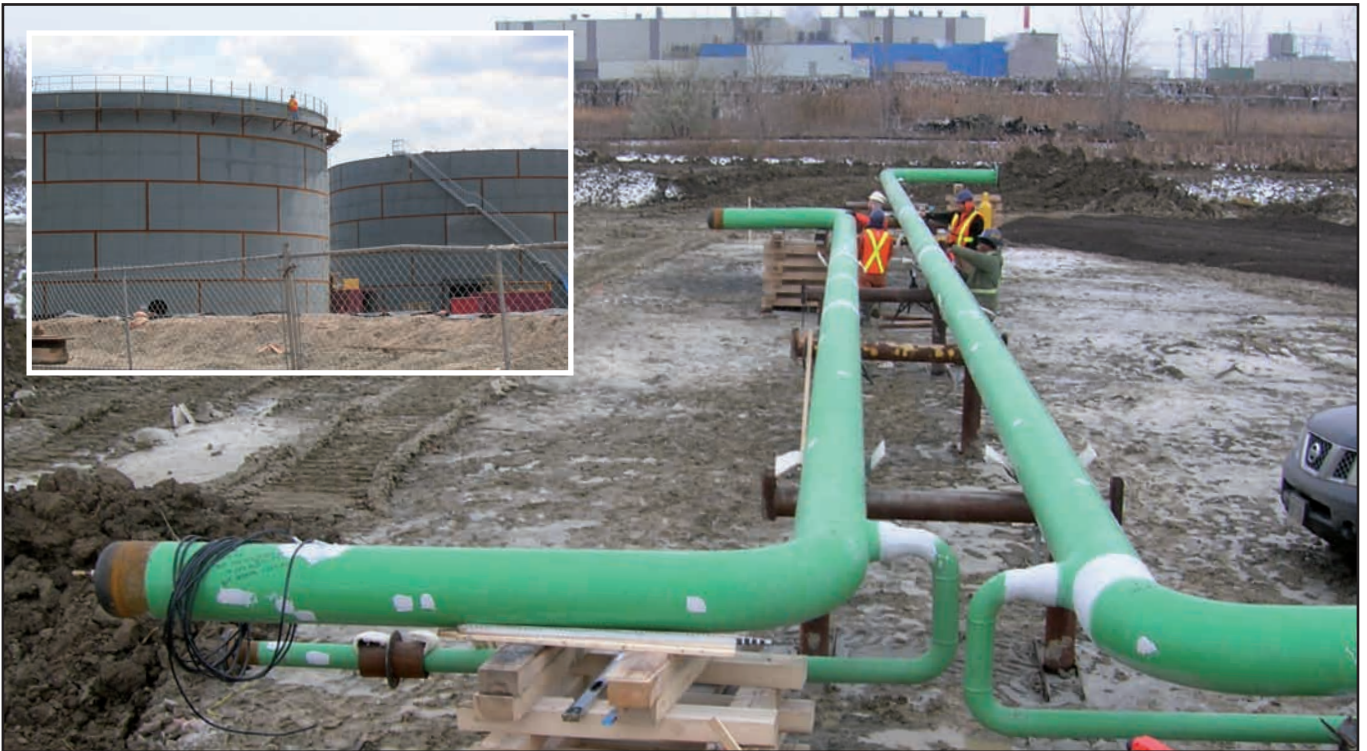
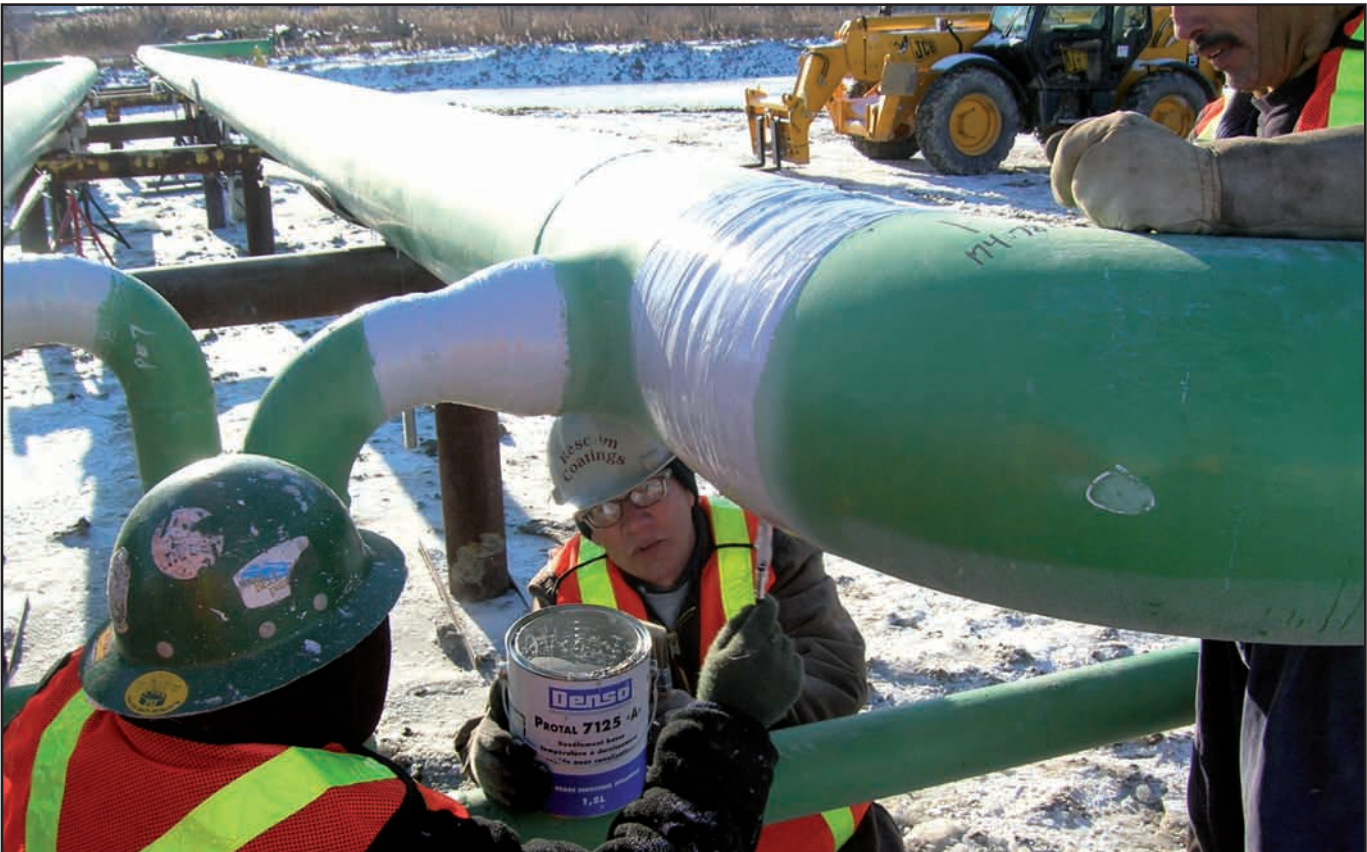
Above and below: With no preheating necessary, the girth welds can easily be coated with Protal 7125 at temperatures of -15°C .
Inset above: New jet fuel tanks being constructed approximately 5km from the airport

With the new airport terminal now in place, there was a need for additional offsite jet fuel tanks and the associated piping required to carry fuel approximately 5kms into the airport. Field repairs and girth welds being coated at minus 15°C were protected using Denso Protal 7125. The 7125

fast cure, low temperature coating allowed construction crews to continue their work without the delay of preheating. This has kept the project on-time and on-track and worked extremely well during the cold winter months. The project continues on now through the summer with 100's of lengths of Denso Protal 7250 protected pipe being installed. The pipeline installation has also provided approximately 1000

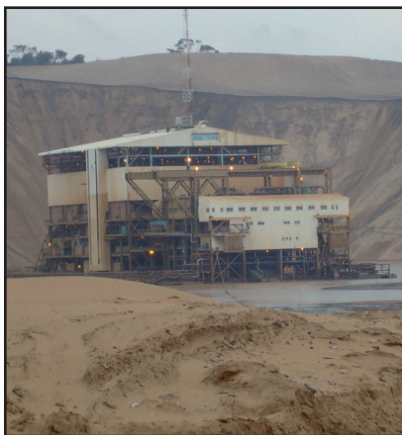
The dredger and concentrator plant.

A large artificial freshwater pond is created in the dunes on which they float the dredger and concentrator plant, burrowing into the mining face of the dune.

As the sand face is undermined, it collapses into the pond forming a slurry which is sucked up and pumped to a floating concentrator.

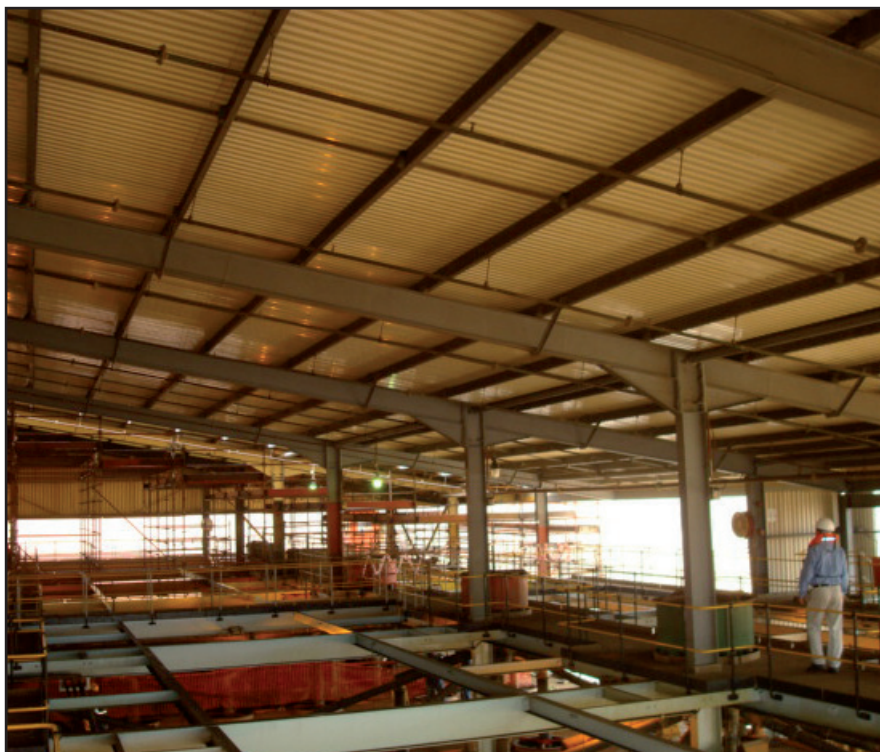
The roof structure of the dredger is protected against the highly corrosive environment with the Denso Steelcoat 400 System.

the coastal environment, corrosion is a serious concern. To combat this, the Steelcoat 400 System was selected to protect the roof structure of the dredger, as at the highest point the structure is exposed to the prevailing winds and salt sea air.

PJ Painters, Denso's applicators of the Steelcoat System for many years, are the resident contractors on site and are currently applying the 3500 sq.m. of Steelcoat 400.

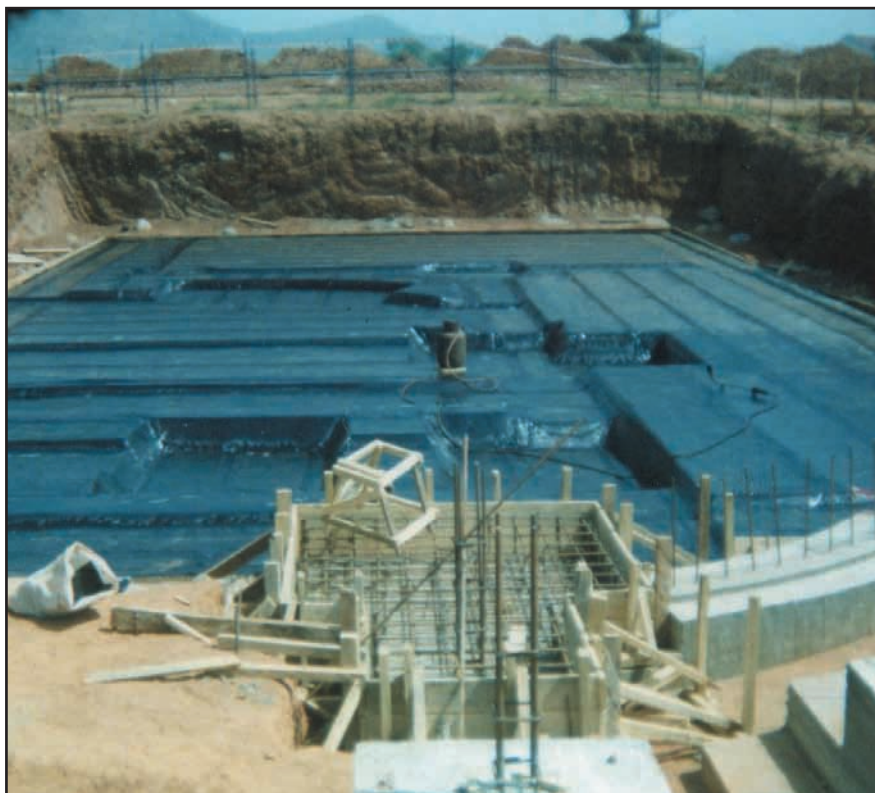
Above: Shell Ltd, Federal Capital, Abuja.

Constructed by main contractors, Costain (West Africa) Plc and structural engineers Morgan Omonitan & Abe. Denso 3000 SA Waterproofing Membrane was used.

Denso SA Waterproofing Membrane has been used for tanking the substructure of three major buildings recently constructed in Nigeria. The products were supplied and applied by Denso agents, Masterproofer Ltd, Lagos

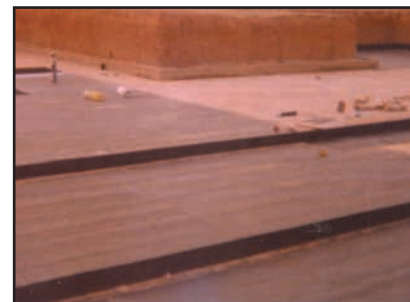
Above: Central Bank of Nigeria, Katsina.

Constructed by main contractors, Cappa and D'Albert Plc and structural engineers Civ-Struct Associates. Denso 3000 SA Waterproofing Membrane was used.

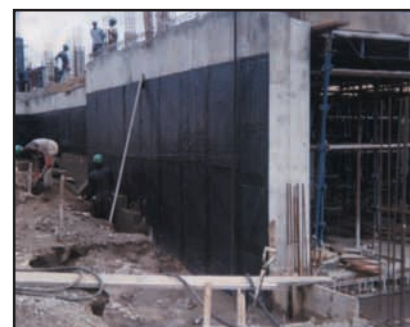
Above: Protea Hotel, Victoria Island, Lagos.

Designed by architects Design Group Nigeria. Constructed by main contractors, Grinaker-LTA Construction Ltd and structural engineers Ove Arup & Partners Nigeria. Denso 1000 SA Waterproofing Membrane was used.

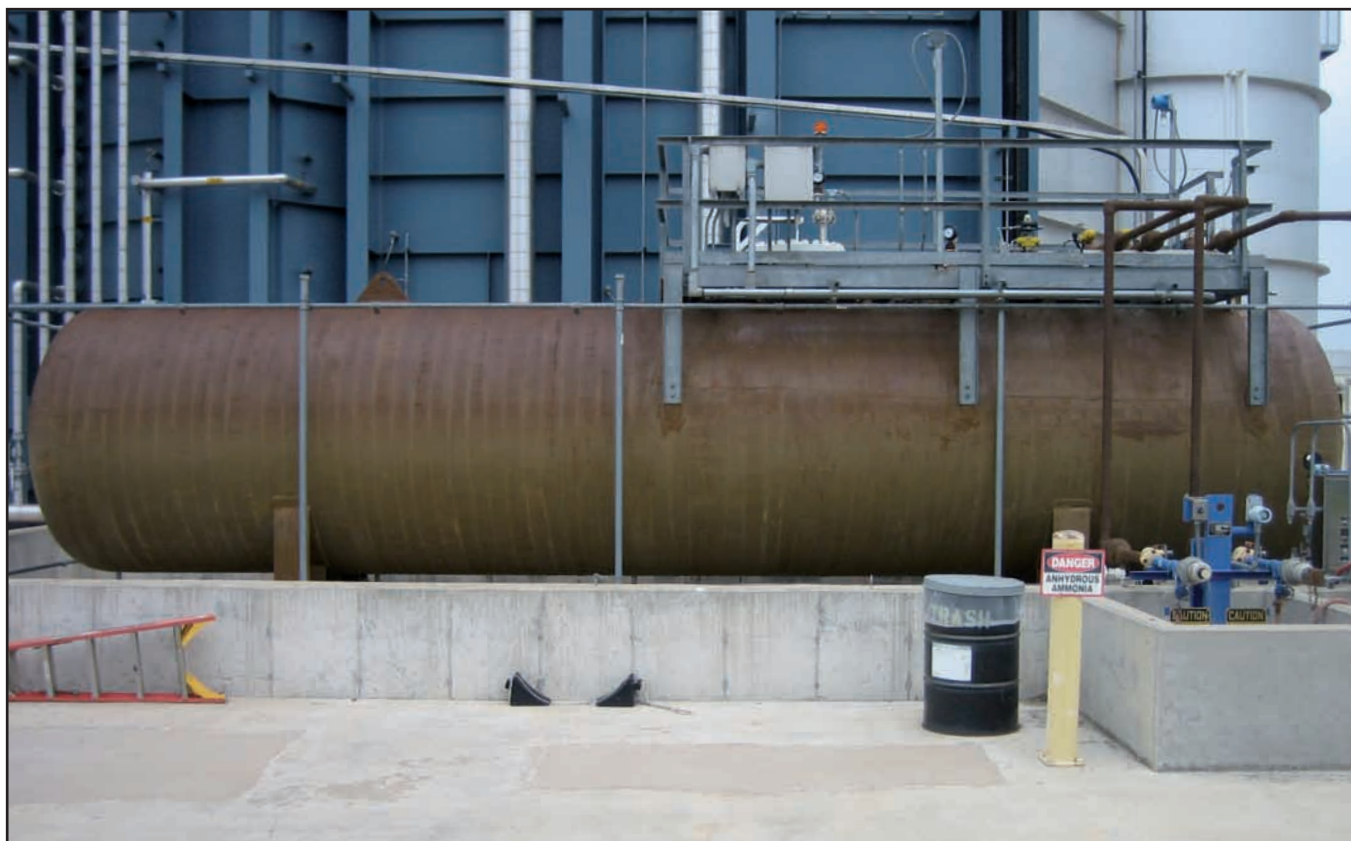
Country:	United States of America
Location:	Texas
Object	Ammonia tanks
Problem:	Corrosion prevention in aggressive environment
Product solution:	Denso Steelcoat 100 System

Corrosion protection for 2 large ammonia tanks (10 ft tall x 40 ft long) at their Bastrop facility had been a continual battle due to constant sweating. After many years of painting the tanks (every 3 to 5 years), the LCRA engineers selected the Denso Hi-Tack Tape coating for long-term corrosion protection.

with the results. The large steel tanks will now receive many more years of long-term corrosion prevention.

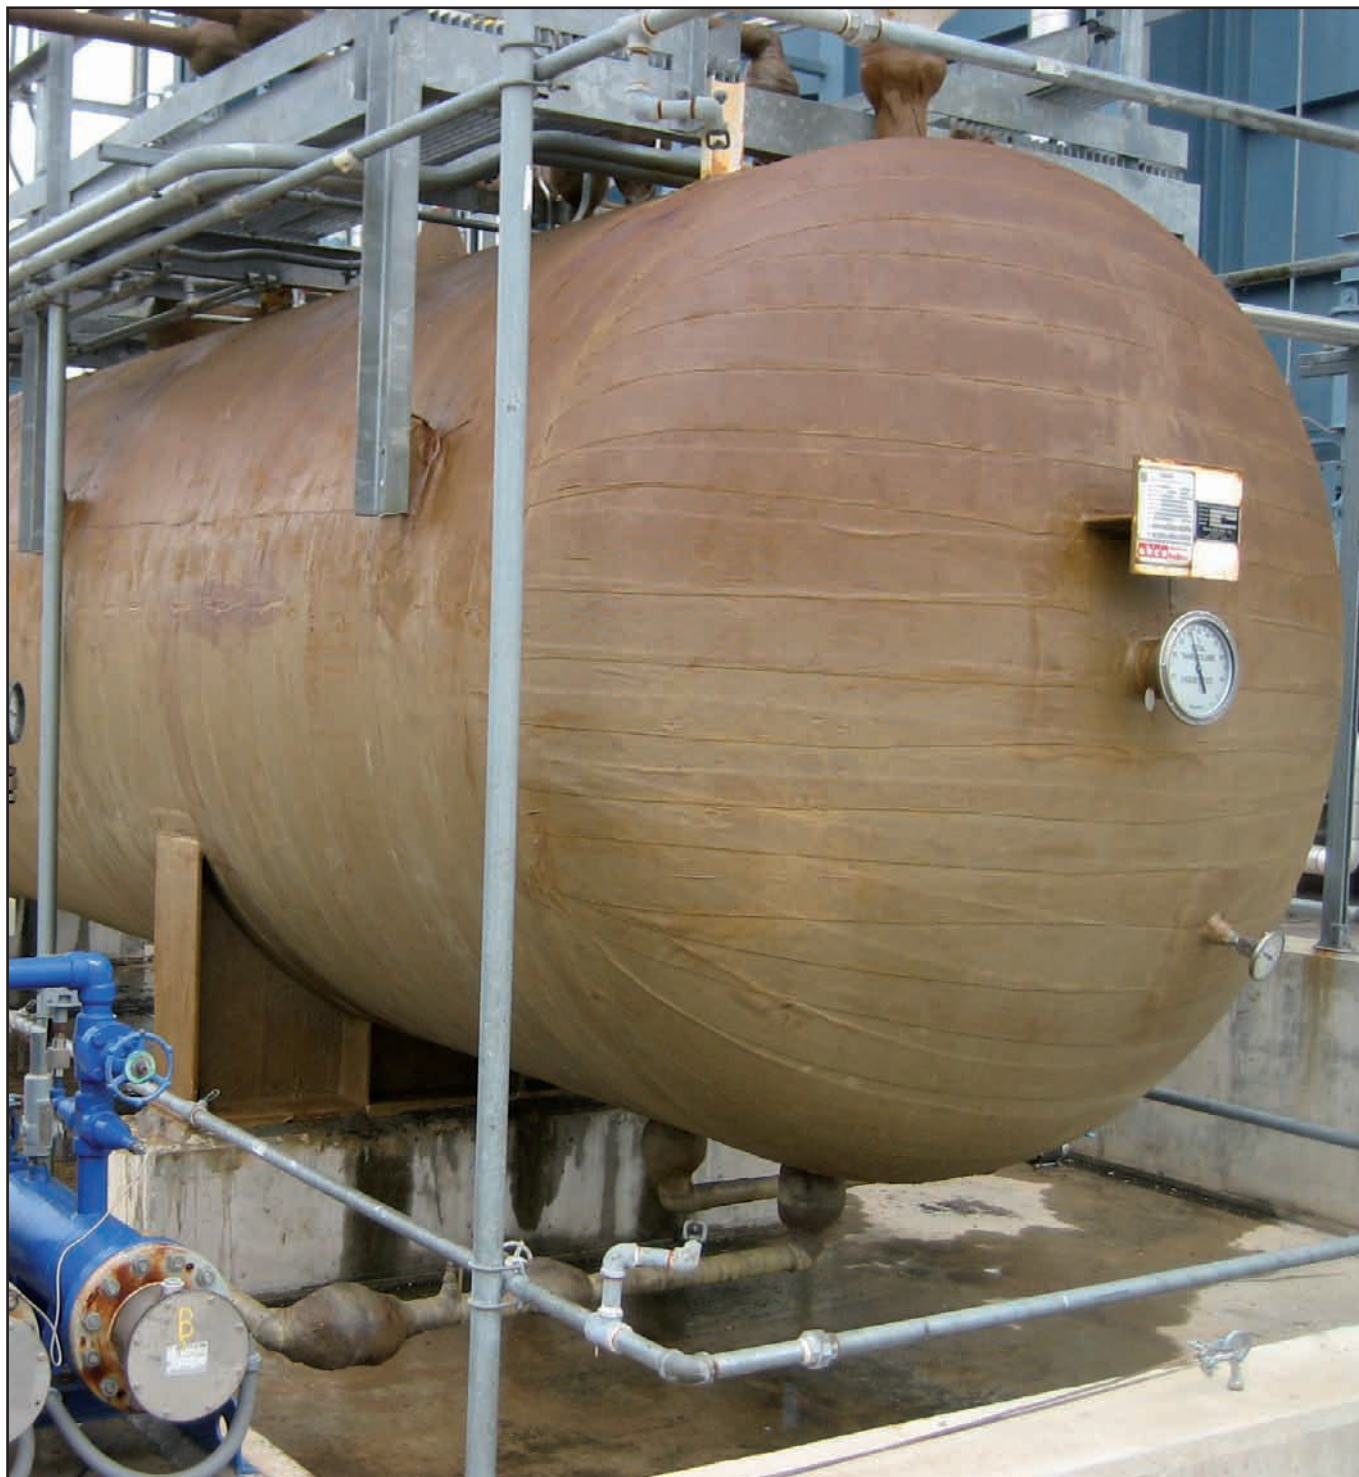
Photos: Denso Hi-Tack Tape and Primer applied to sweating ammonia tanks.

The scope of the work included hand tool cleaning the

surface, application of a thin layer of Denso Hi-Tack Primer and a double layer of Denso Hi-Tack Tape to the tanks and steel support columns. The total

surface area protected was approx. 3,100 square feet.
