1929 - 2009
80 Years of
Pipeline & Steelwork
Protection

Volume 29 - Number 1

LEADERS IN CORROSION PREVENTION & SEALING TECHNOLOGY

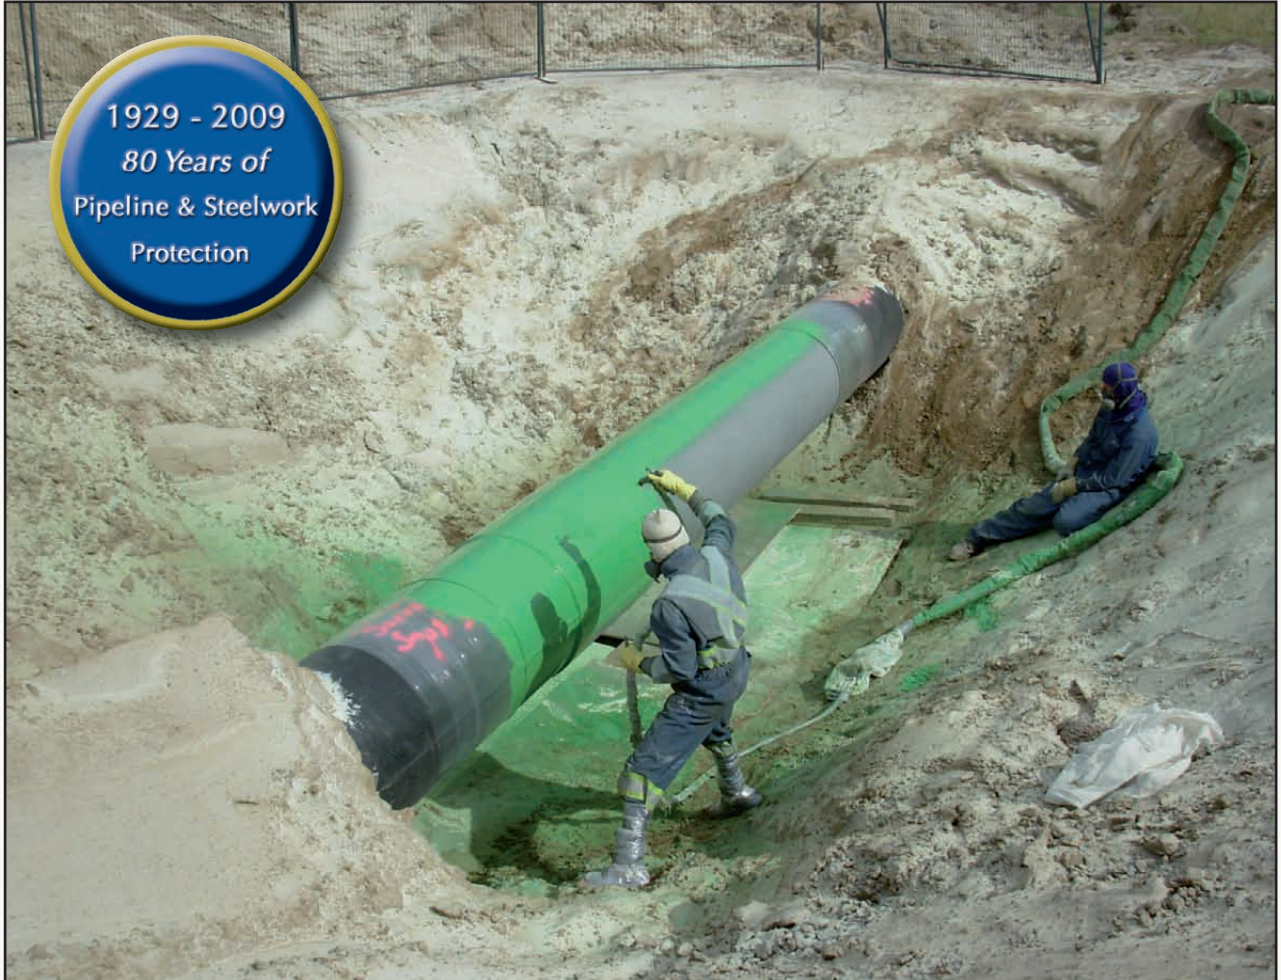
Denso Protal 7250 being applied to a crude oil pipeline in Canada - see story page 6-7.

Page 6 - A finished pipeline section.

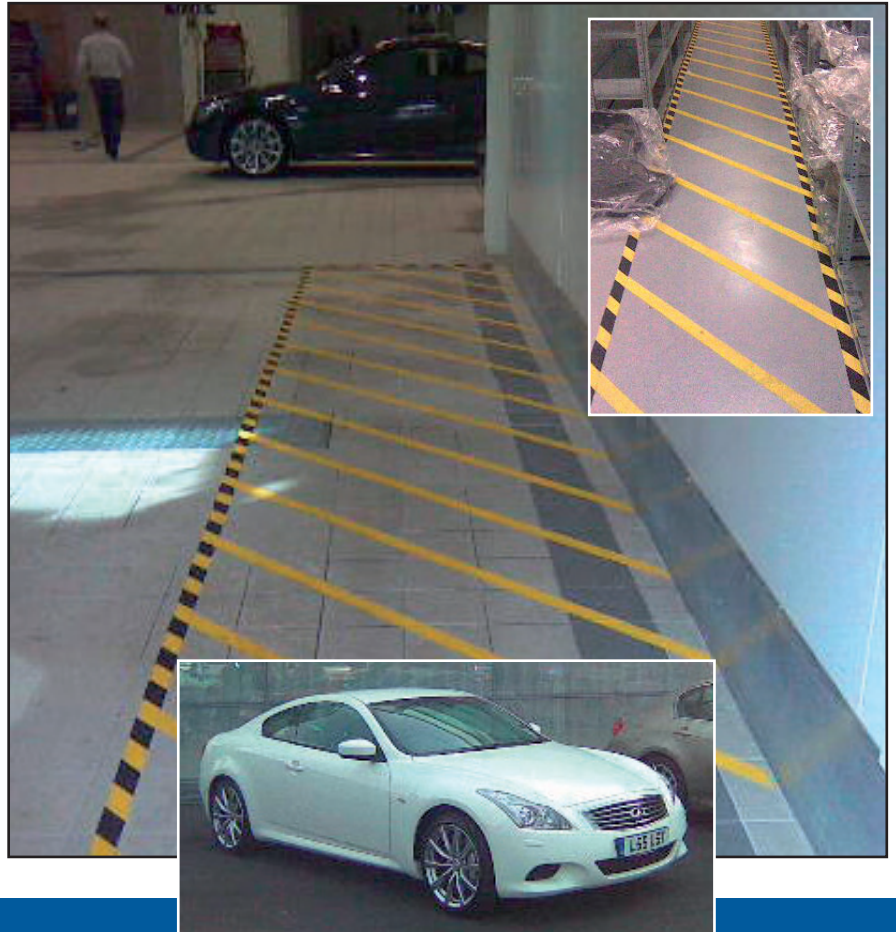
Below: Denso Anti-Slip Tape used in the service bay and emergency walkways (inset).

Denso Anti Slip Tape comprises a self-adhesive PVC Tape coated on one surface with a layer of acrylic adhesive. The upper surface is coated with a continuous layer of aluminium oxide particles. It is available in several colours and supplied in 18m roll form. The adhesive surface is protected by a plastic film interleaving which is discarded during application.

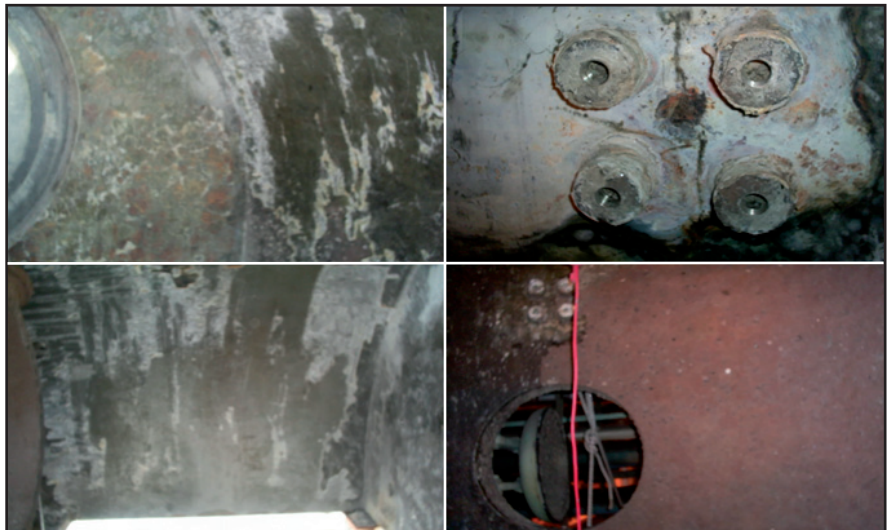
Top: The badly corroded condensers.

Below: The problem is solved using the Archco-Rigidon lining system.

The condensers were first grit blasted to remove the old FRP coating and then primed. A filler coat was used to fill the winding section and then Archco-Rigidon 402B lining was applied over the damaged areas.

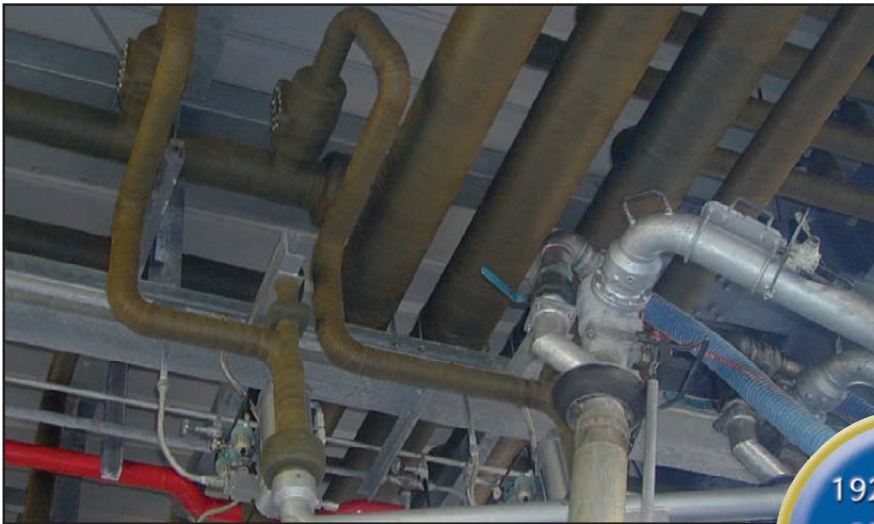
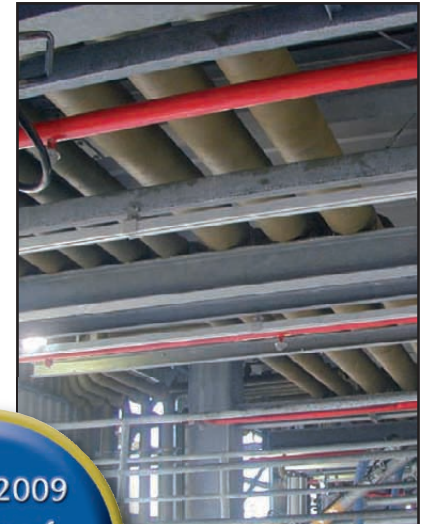
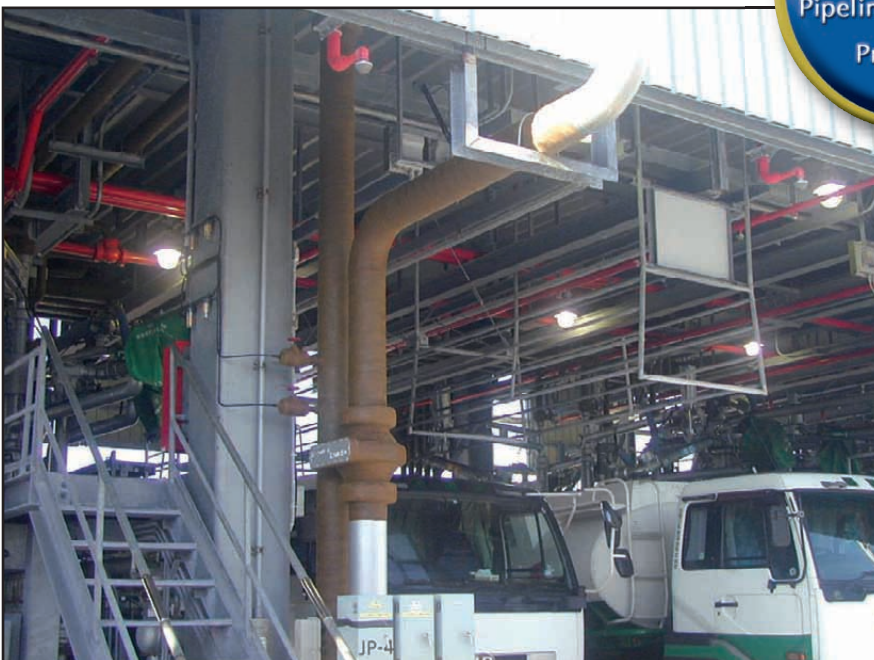
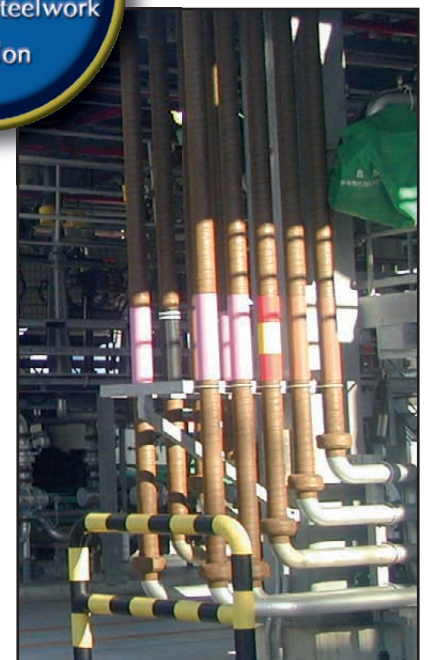
All joints and flanges on the pipework sections chosen for the Denso system, were filled with Densyl Mastic to give a smooth profile prior to wrapping with Densyl Tape. The conformity, flexibility and acceptably neat finish of the petrolatum tape system is perfectly demonstrated in the photographs below.

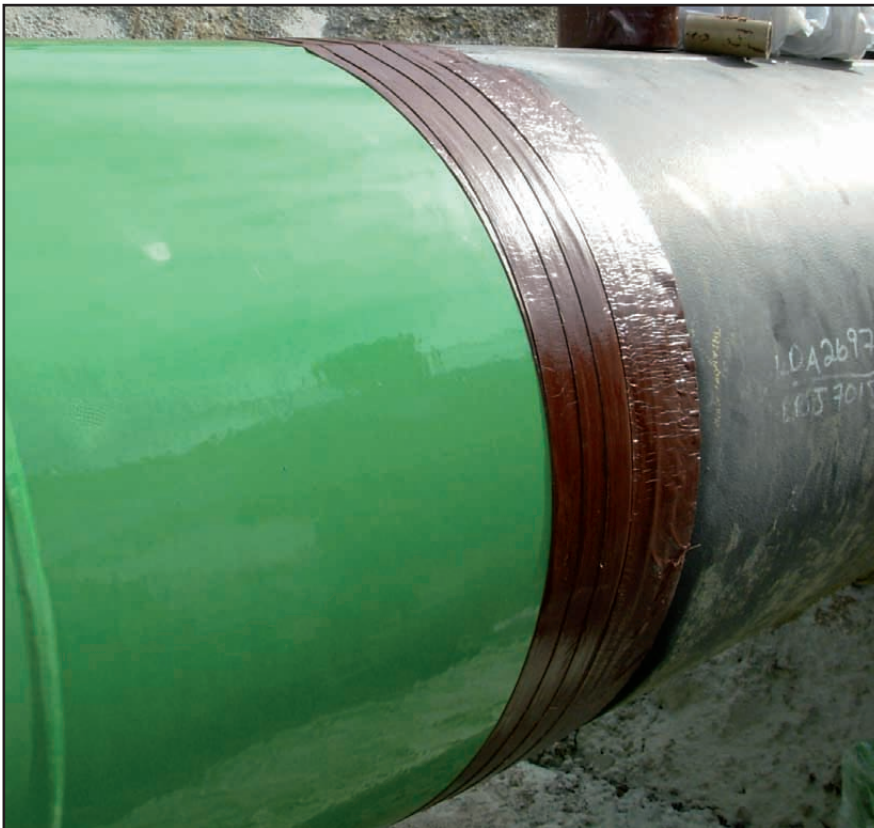
Left - The effective transition from the new Protal 7250 to the original three-layer polyethylene coating was achieved with a wrap of Denso Hotline Tape.

the length of pipeline that had been stripped of the original three-layer polyethylene coating. After a short period and after the 7250 epoxy had set, the final requirement of the surgical operation required the newly installed 7250 be tied into the existing three-layer polyethylene coating at either end of the repair. This last step was accomplished by using Denso

Hotline Tape to transition the two coatings and to ensure strong mechanical protection on the 42" diameter pipe transition coating, Denso Glass Outerwrap was utilized.

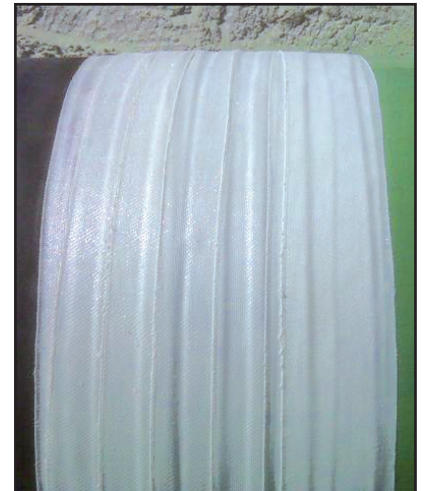
Above - A final outerwrap of Denso Glass Outerwrap completes the job.

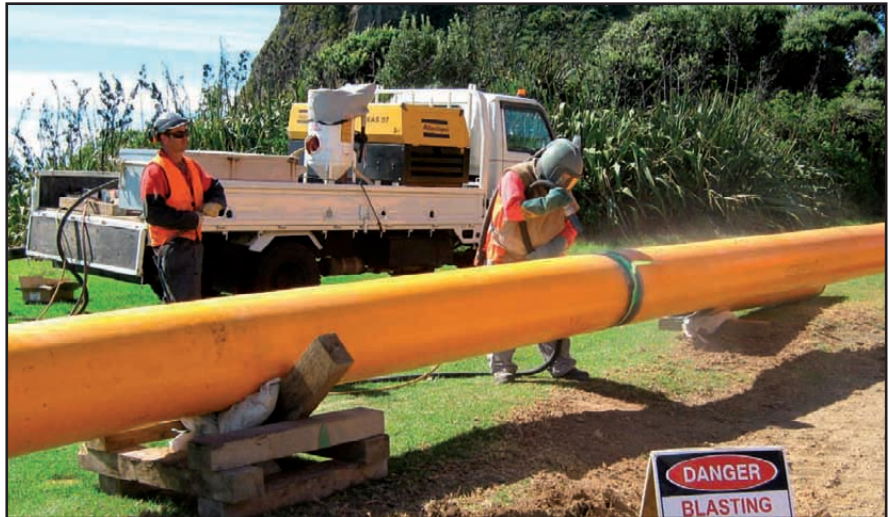
The pipeline joints are cleaned by grit blasting.

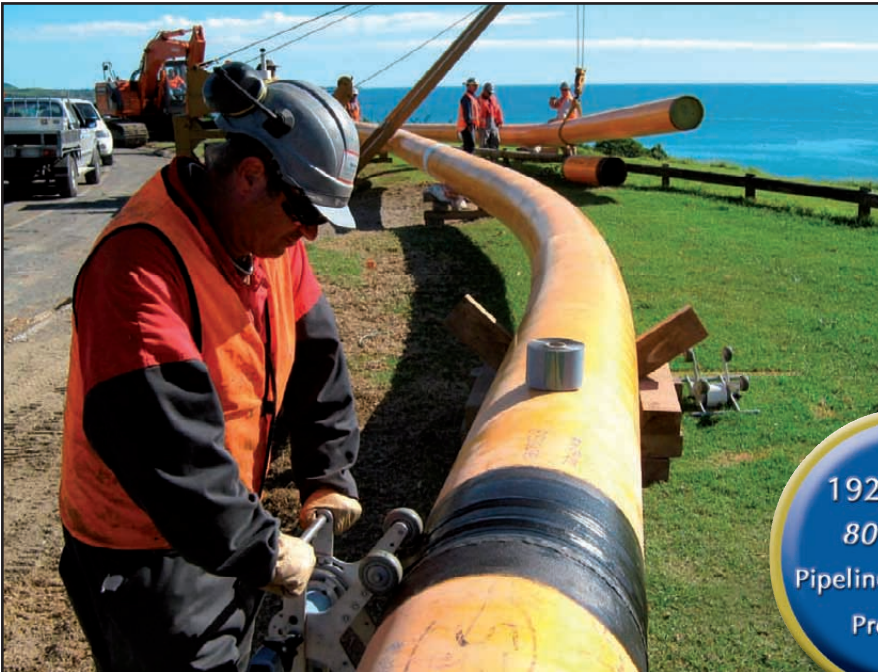
Below: After priming, the S43 Tape is applied to the joint using a Densoman wrapping machine.

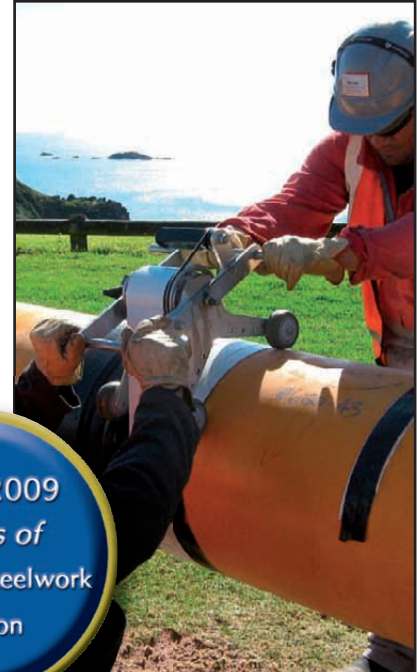
Below: The R23 Tape is applied over the S43 Tape, completing the joint protection system.

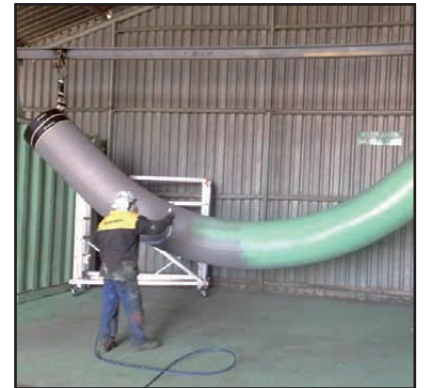
A pipeline bend being spray coated with Denso Protal 7200.

The project also required long radius induction heated bends for both pipelines, Bulldog Projects and RJ Southey coated the bends in their yards. The bends were blasted and the Protal 7200 spray applied, the Corroklad inner and outerwraps and Denso Stoneguard 1200 is then applied on site prior to installation.

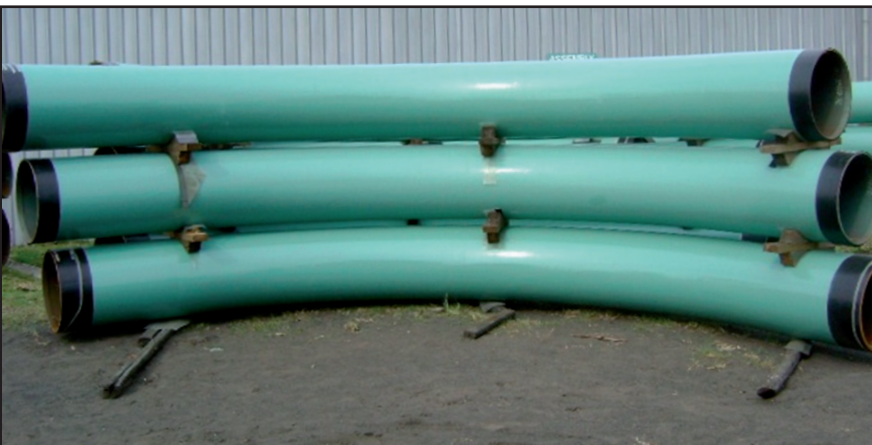
Stockpiled pipeline bends, coated with Protal 7200 and ready for installation.

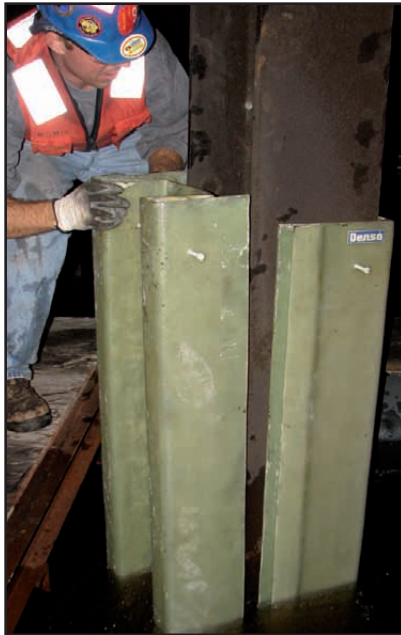
1. Installation of the two Fiber-Form half shells.

The Series 500 was used to protect the steel H-piles. The system includes a custom fabricated Fiber-Form Jacket and SeaShield 550 Epoxy Grout. The Fiber-Forms were fabricated in two half shells to the shape of the existing H-pile to allow for a 1" (25 mm) annulus space between the jacket and pile. The Fiber-Forms were installed and secured with self tapping screws and temporary nylon straps. The 1" (25 mm) annulus space was adjusted with plastic offset screws. The SeaShield 550 resin, hardener and aggregate were mixed and then poured through a pneumatic vibratory funnel into the top of the jacket.

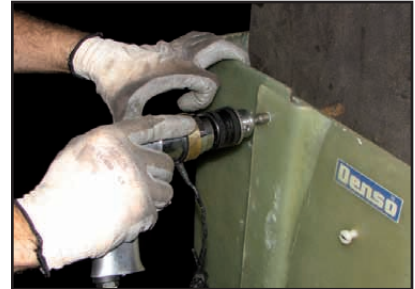
2. Installation of the screws through the tongue and groove closure.

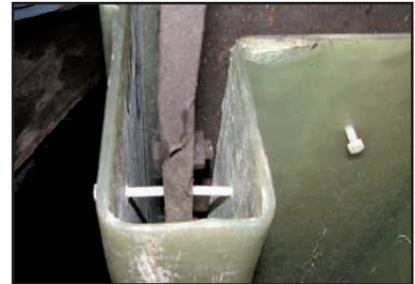
3. Annulus space adjusted with plastic screws between Fiber-Form and H-pile.

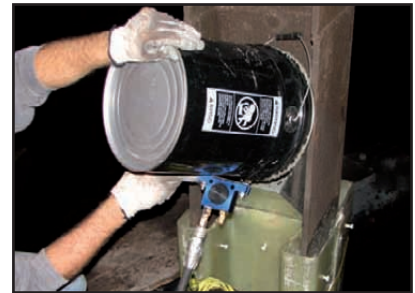
4. Pouring of mixed Seshield 550 Epoxy Grout through pneumatic vibratory funnel.

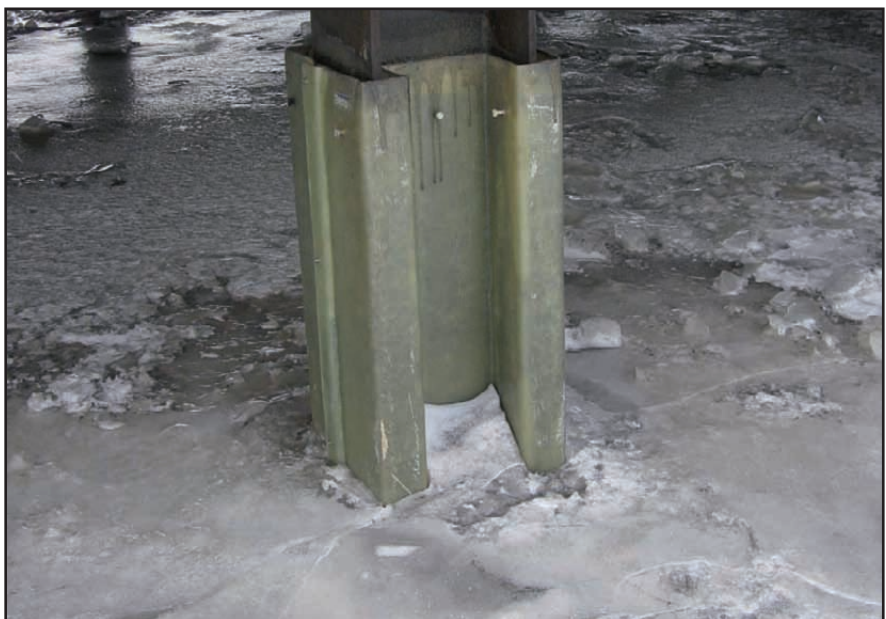
Series 500 during winter ice buildup.

The Series 500 and 2000FD Systems have been inspected after one year of severe winter ice buildup with no damage. The systems have provided a long-term solution for this aggressive environment.

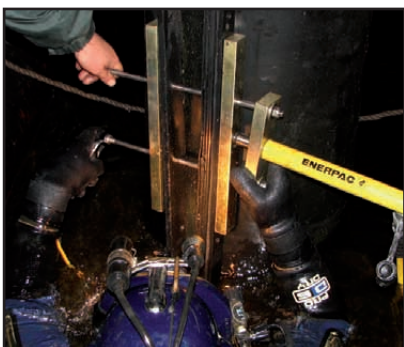
Installation of HDPE jacket and hydraulic tensioning system.

The Series 2000FD was used to protect the cylindrical piles. The system includes a Denso Marine Piling Tape and a custom engineered HDPE outercover. The Denso Marine Piling Tape was applied above and below water with a 55% overlap. The outercover was then installed and secured with 316 stainless steel bolts using Denso's proprietary tensioning bars and hydraulic equipment.

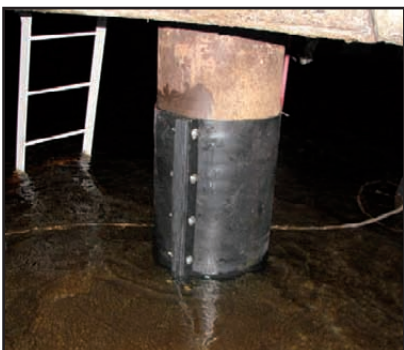
Completed installation of SeaShield 2000FD on 18" diameter pile.

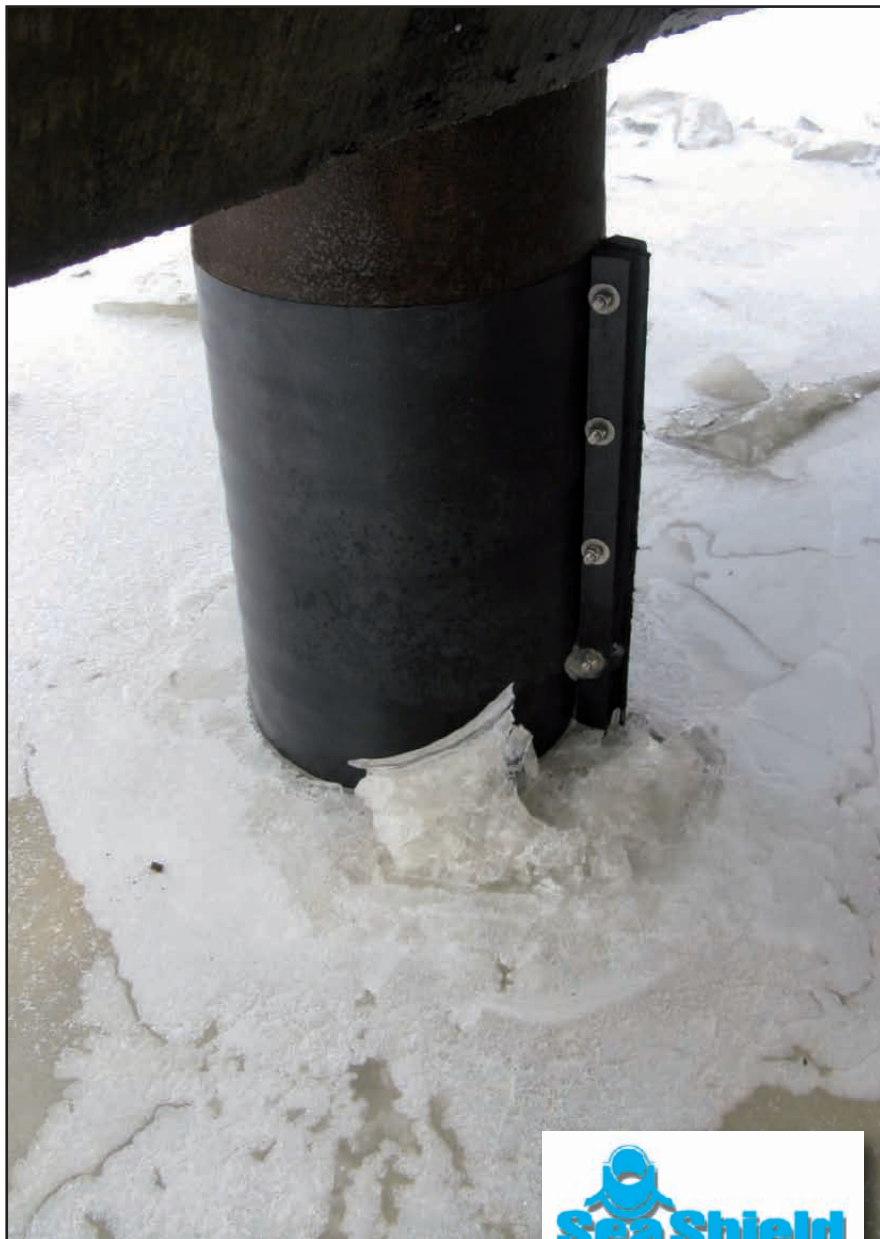
Series 2000FD during winter ice buildup.
