Volume 33 - Number 3

QUALITY & INNOVATION FROM 1883 INTO THE 21ST CENTURY

WINN & COALES INTERNATIONAL LTD

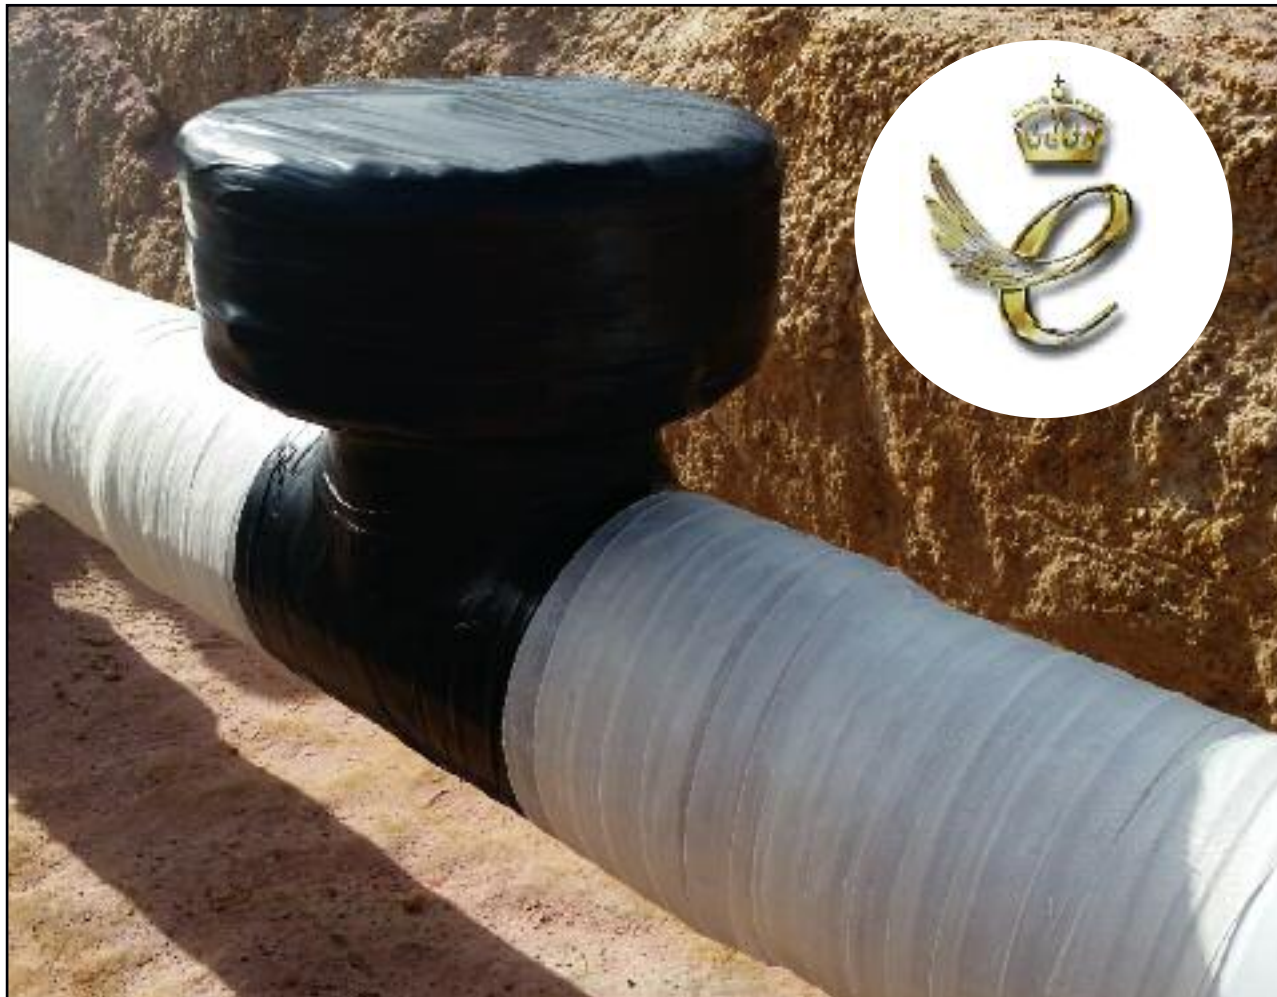
Denso systems used to tie-in to existing pipeline coatings on the Parmelia Pipeline, Australia
- See story page 11.

Parmelia Pipeline, Eneabba – 278km North of Perth, Australia managed by APA Group was supplied with Denso S43/R23 tape system, which was used to tie-in with the existing pipeline coating.

This range of products was decided to be the best option for this project, as APA wanted to ensure that the chosen protective coating system would withstand the natural backfill being used. The hot tap section of the pipeline also needed to be protected in a tape system that could be removed at a later date for on-going inspections. Glass outerwrap was used to provide additional impact protection over the petrolatum tape system.

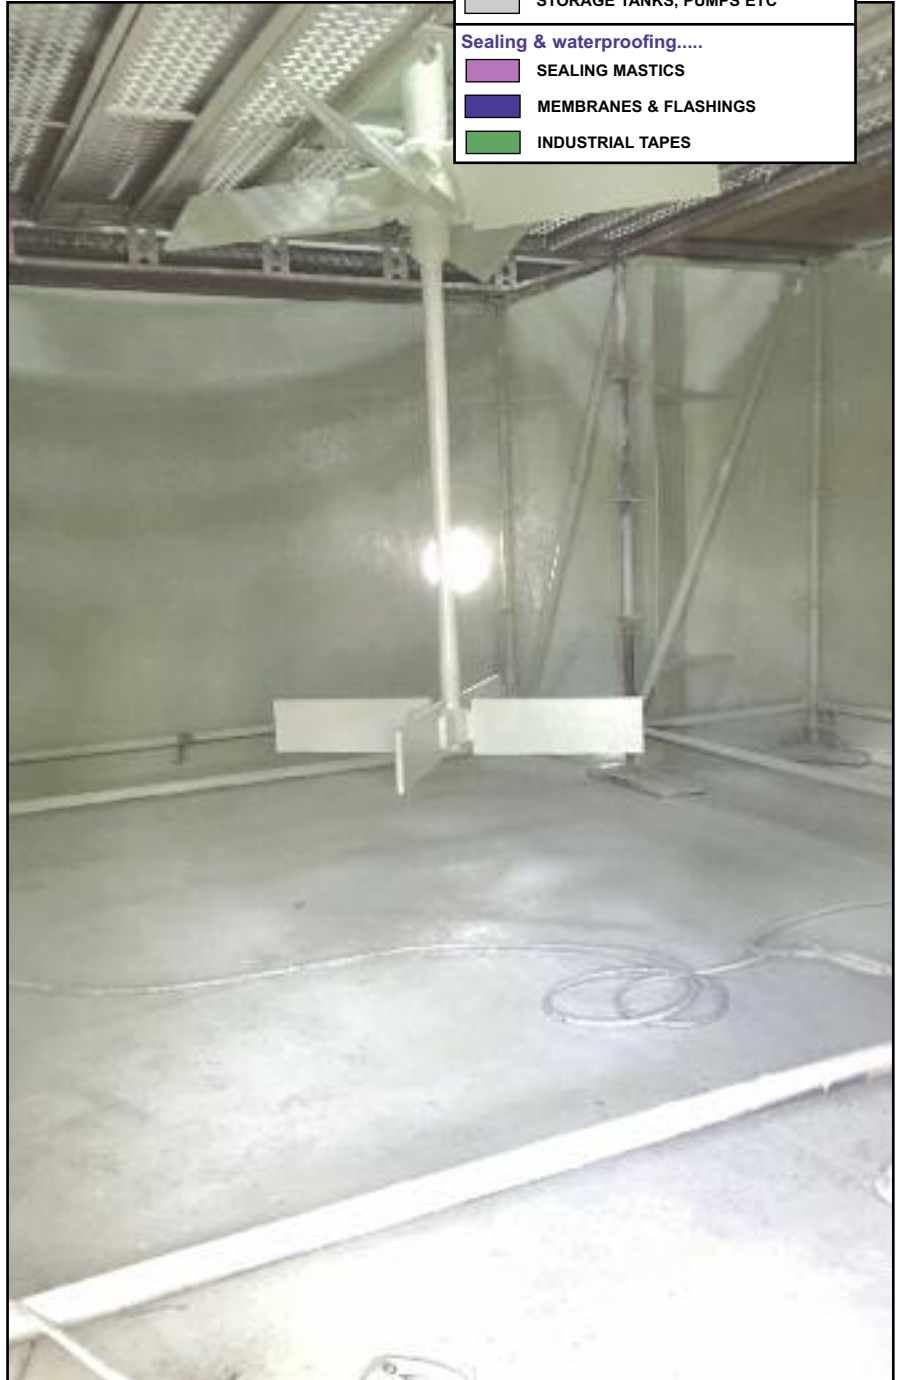
The Cristal mixer tank lined with Archco-Rigidon 403D by Hertel (UK).

Following blast cleaning at Hertel's premises of the internal surfaces of the tank to the Sa2½ near white metal standard, the first coat of Archco-Rigidon 403D was applied to approximately 1000 microns. A final 250 microns coat of Archco-Rigidon Blue Wax Topcoat was then applied.

Final thickness readings were taken and full holiday detection was carried out to ensure the work was in line with the specification requirements.

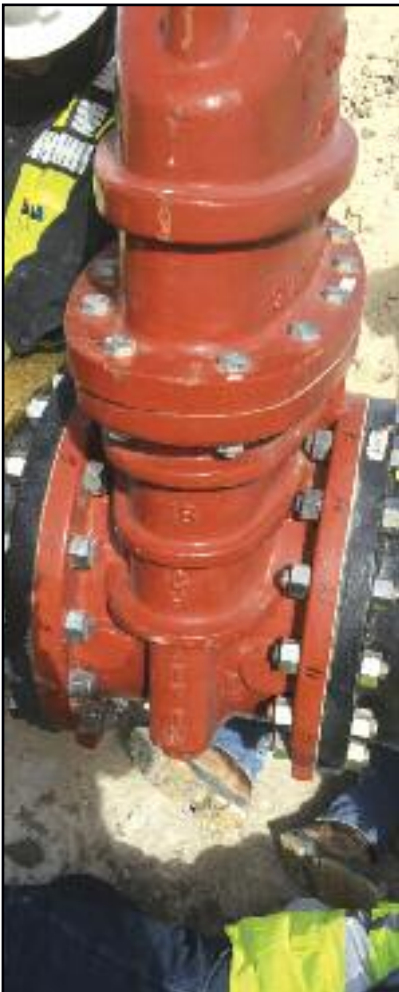
The surface was prepared in accordance to SSPC SP-2/SSPC SP-3 prior to application of the Denso Paste.

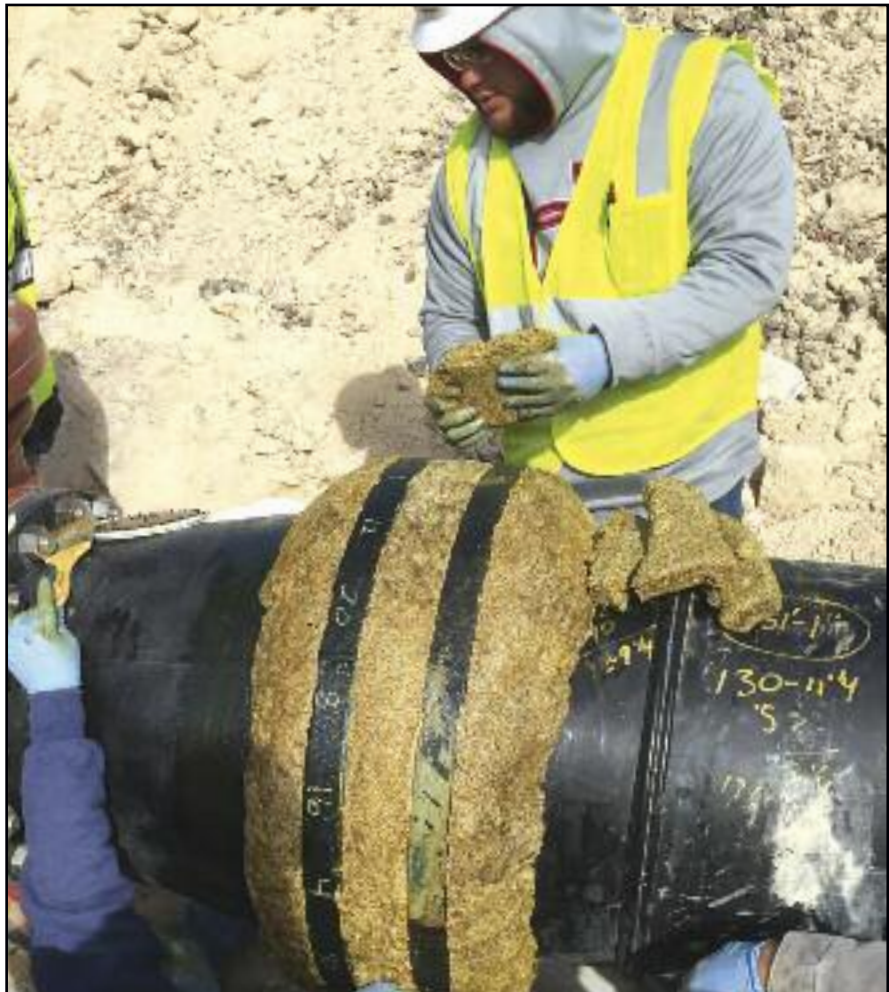
Application of the Denso Profiling Mastic creating a smooth profile for the Densyl Tape.

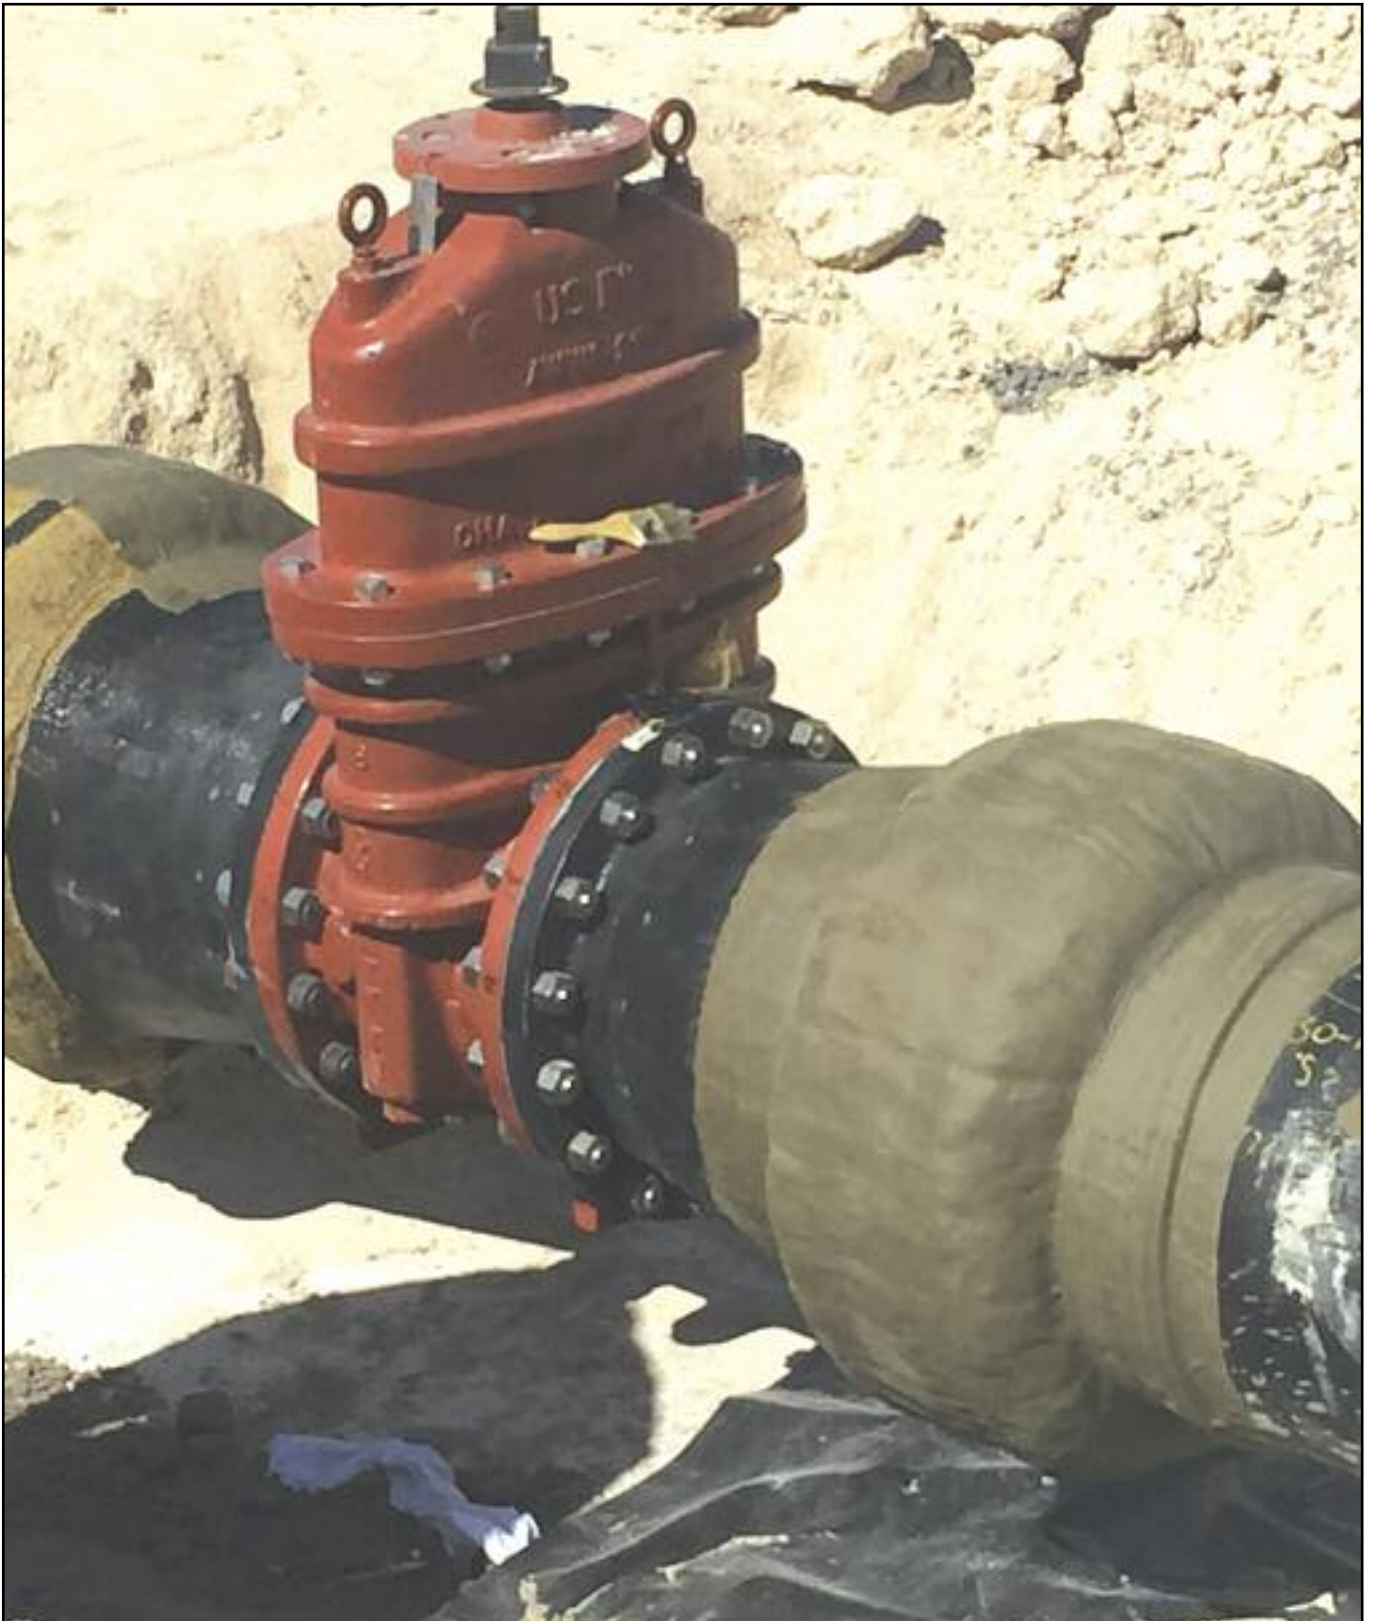
Application of the Densyl Tape which was cut into strips over the Profiling Mastic on the flanges.

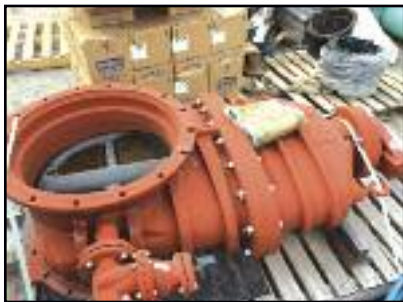
A new valve ready for installation.

With a project as grand as this and with a price tag of over \$790 million dollars, corrosion prevention was one of many major concerns for this new infrastructure. The designers of the development enlisted Denso to provide the Denso Petrolatum System to protect the buried ductile pipe and all of the fittings both direct buried as well as within chambers. This project, which remains in progress, requires the replacement of kilometers of water distribution piping and installation of new valves and fittings with sizes in the 600mm range.

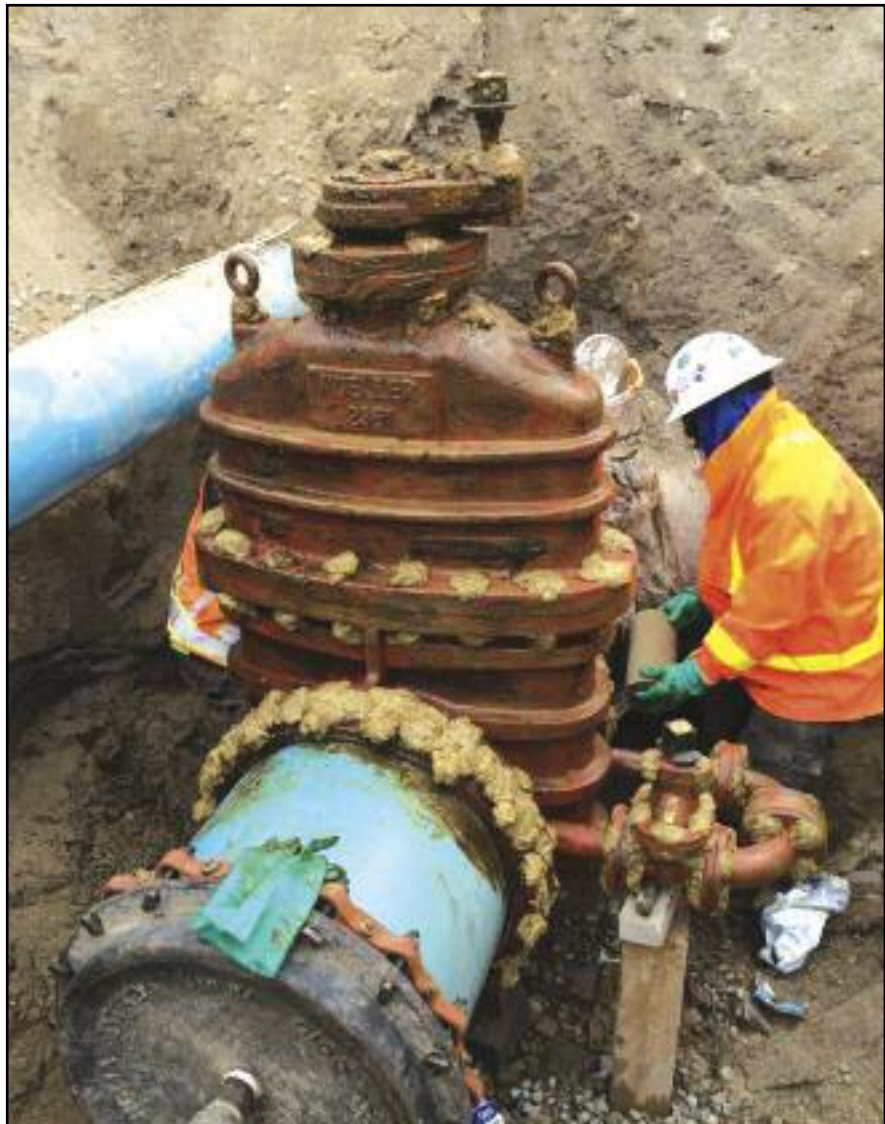
Below: Voids and awkward angles on the valve are first filled with Denso Profiling Mastic.

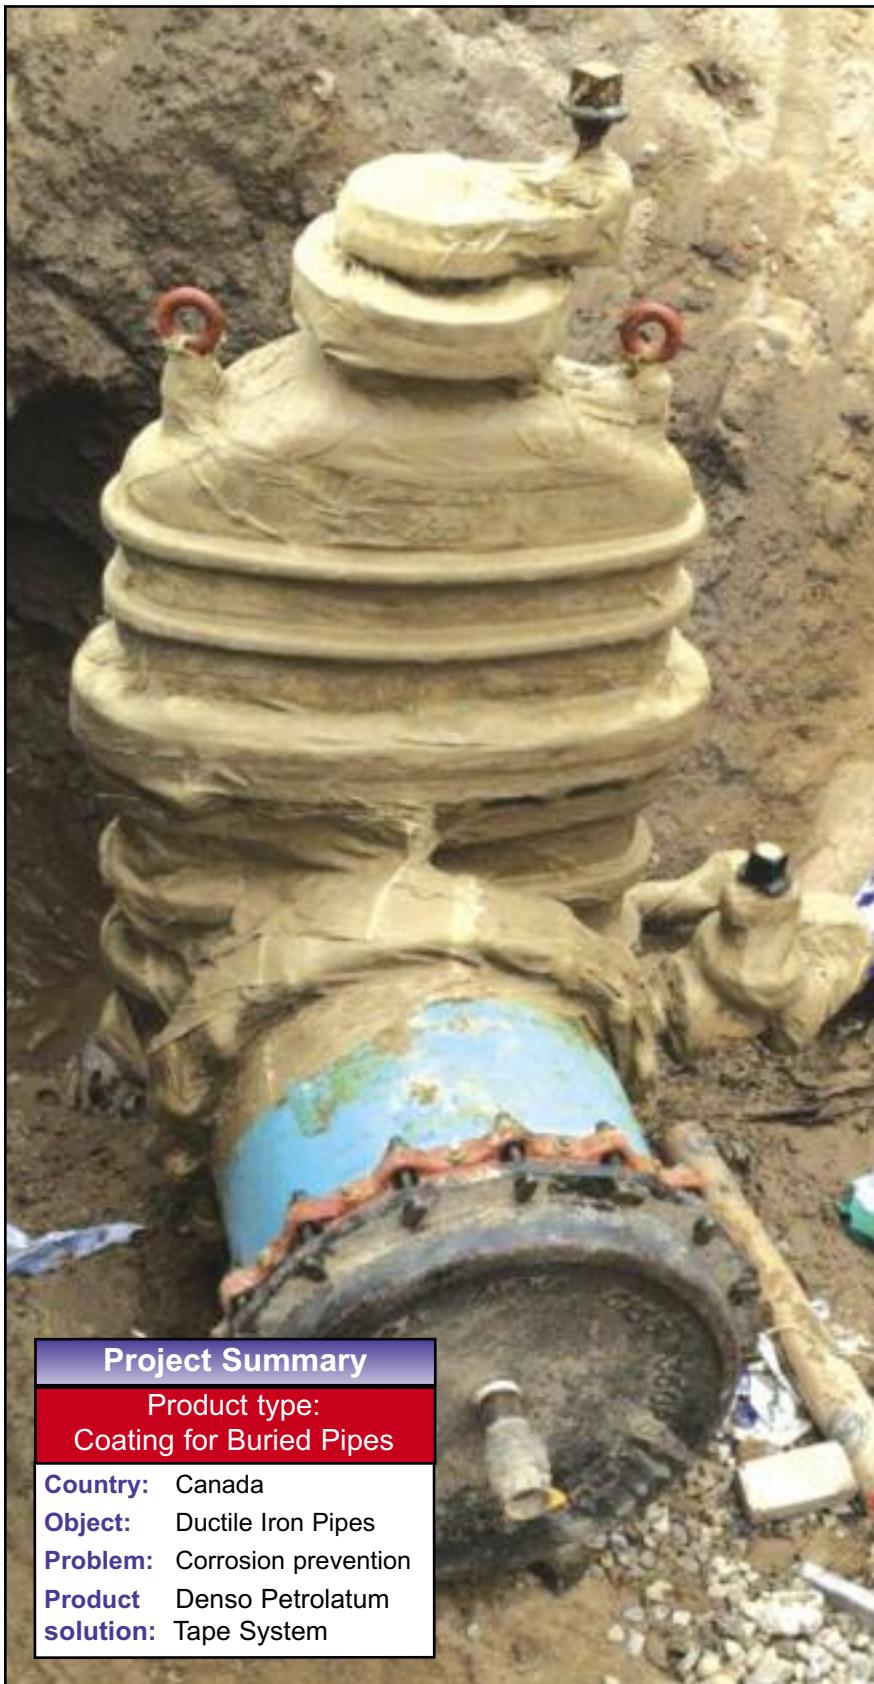
Left: The valve is wrapped with Denso Petrolatum Tape to complete the protection

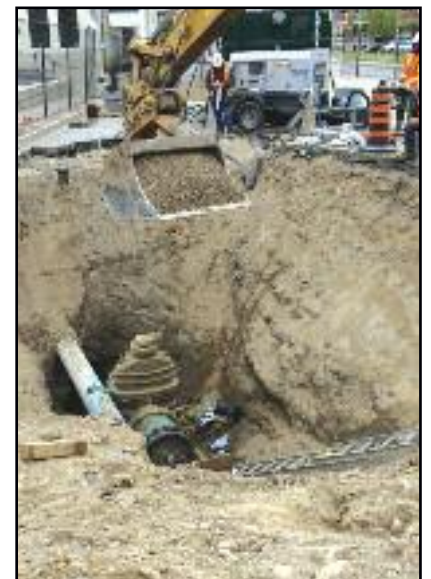
Below: After the Denso system is completed the valve is buried.

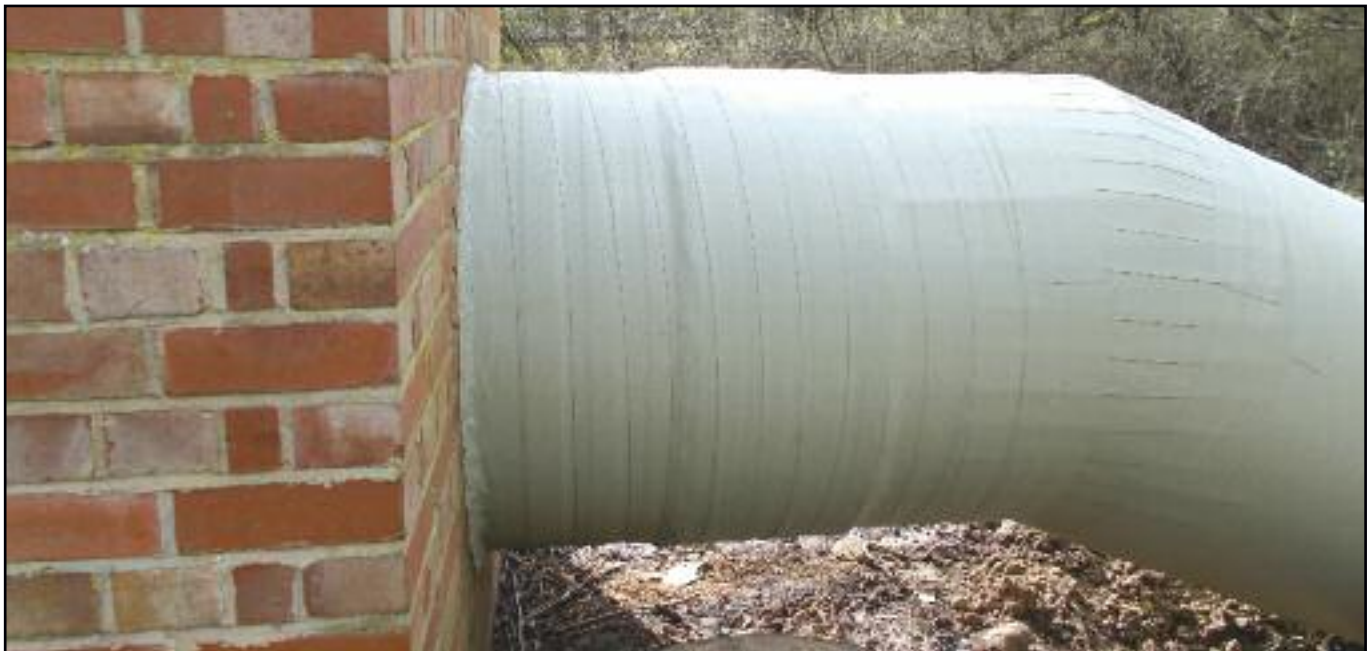
Below: Close up of the completed 2016 Denso Steelcoat System with sage green Topcoat finish.

The Denso Steelcoat 100/400 System consists of Denso Hi-Tack Primer followed by Denso Profiling Mastic to fill voids and smooth profiles etc. This is followed by a wrap of Denso Hi-Tack Tape overwrapped with Denso Ultraseal Tape and then finally coated with Denso Acrylic Topcoat.

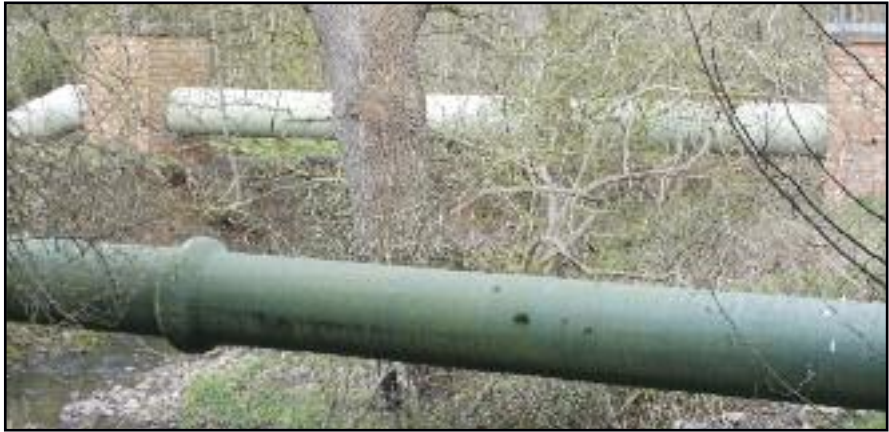
Below: The original 2005 Denso Steelcoat protected pipebridge in the foreground with the new application underway to the pipebridge in the background.

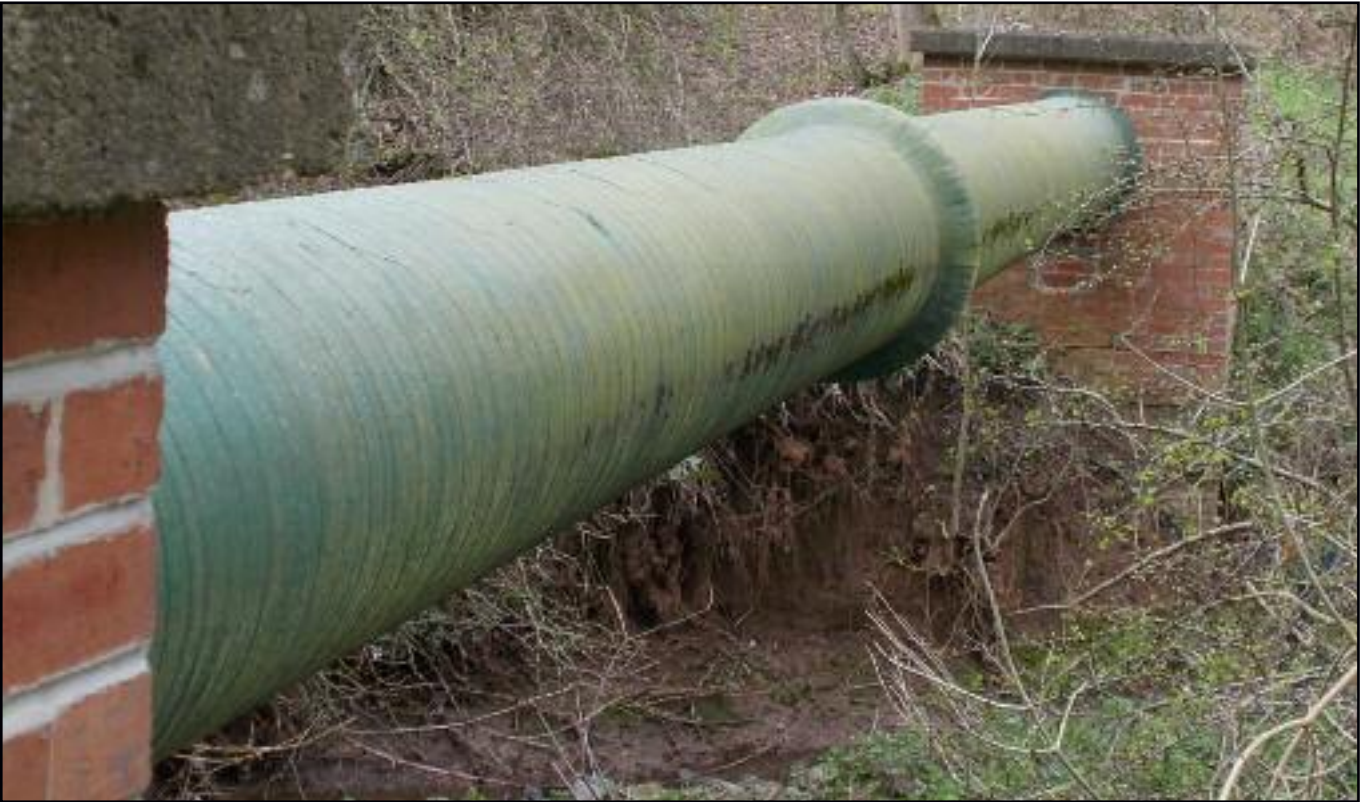
Above: The original 2005 applied Steelcoat 400/100 System. The photo was taken in 2016 showing a little moss and dirt accumulation as to be expected.

The company reports that apart from some dirt and moss on the pipe, as expected the 2005 applied system is still functioning extremely well and will continue to protect the structure for many years to come.

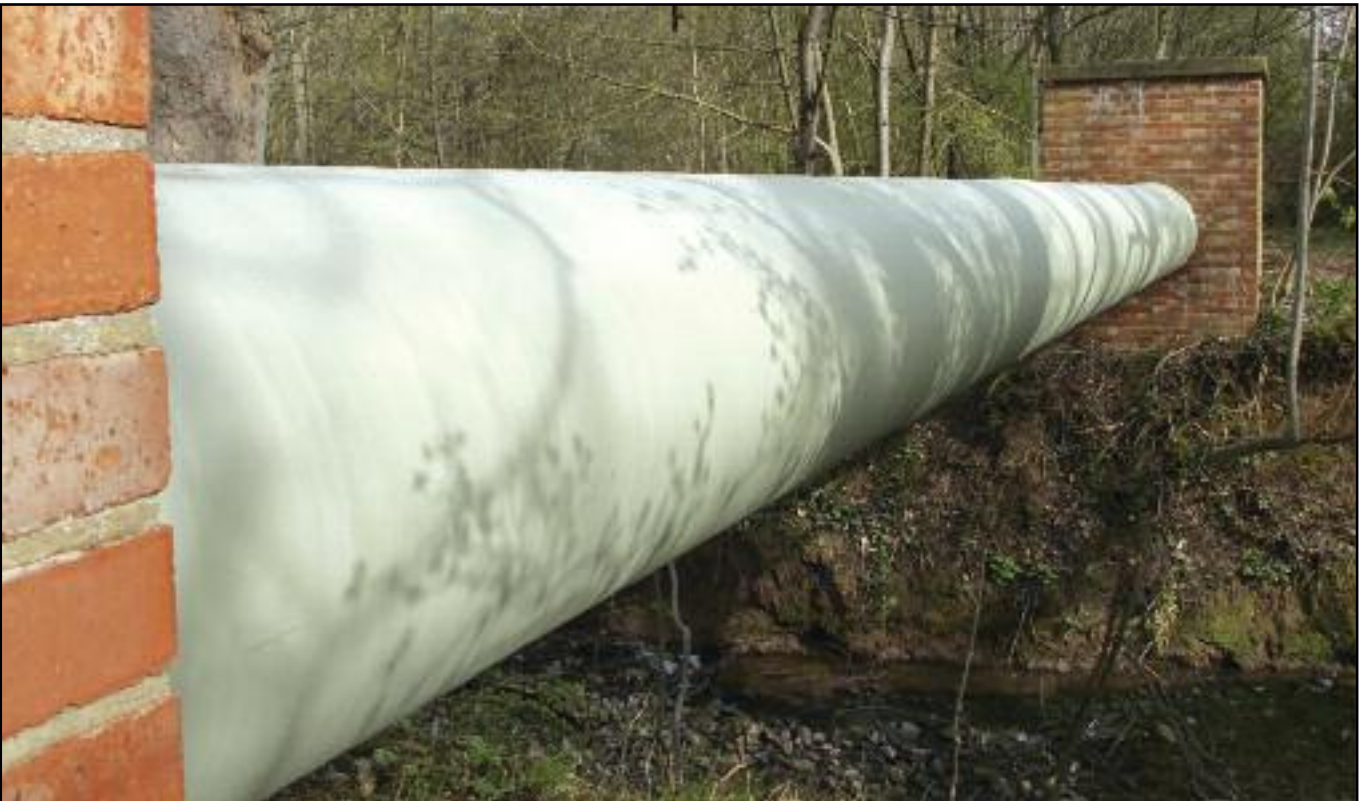
Below: The completed 2016 Steelcoat 400/100 System in sage green finish.

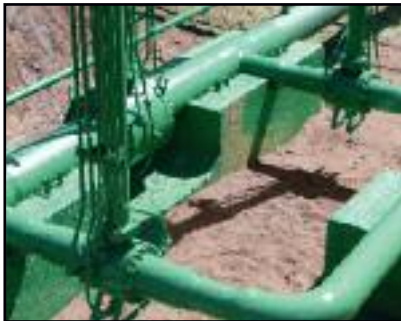
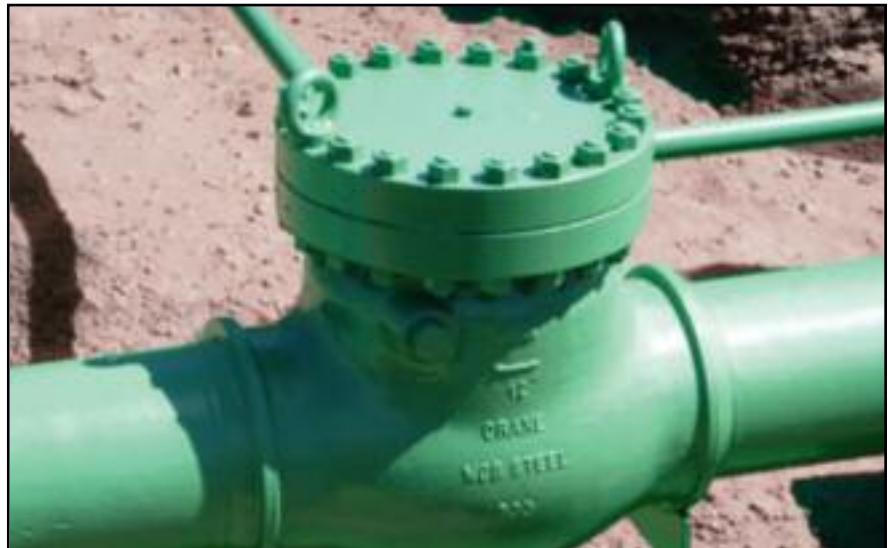
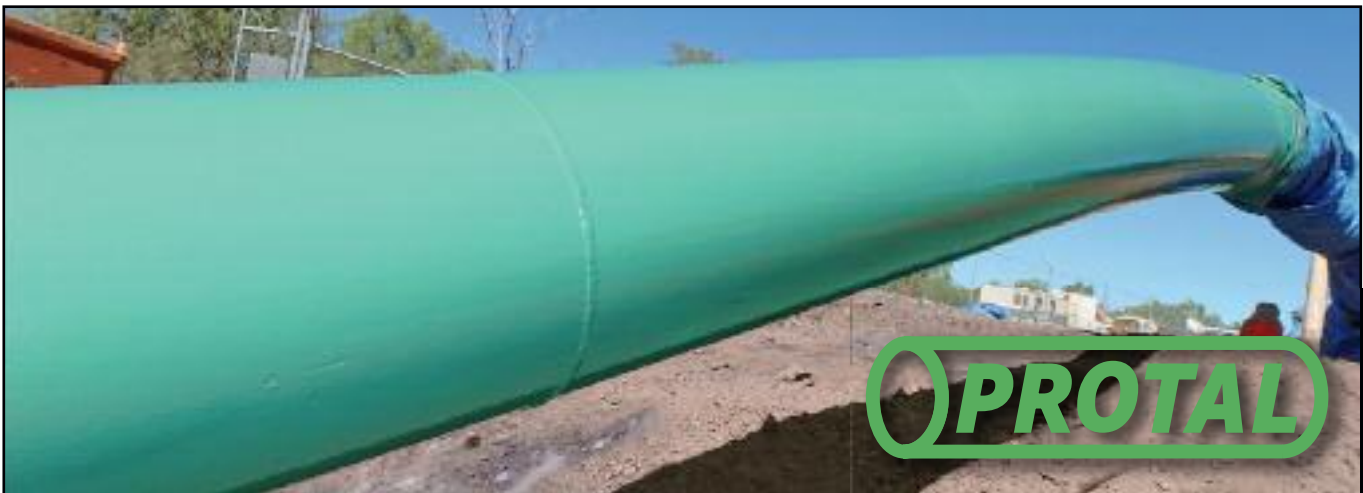
Pictures: All steel parts of the valve stations were protected with Protal 7200.

Protal 7200 was the system of choice for APA Group and McConnell Dowell and proved to be an economical, high quality application where it was applied through Plural Spray application on pipe work and cut in with brushes on the valves and flanges.

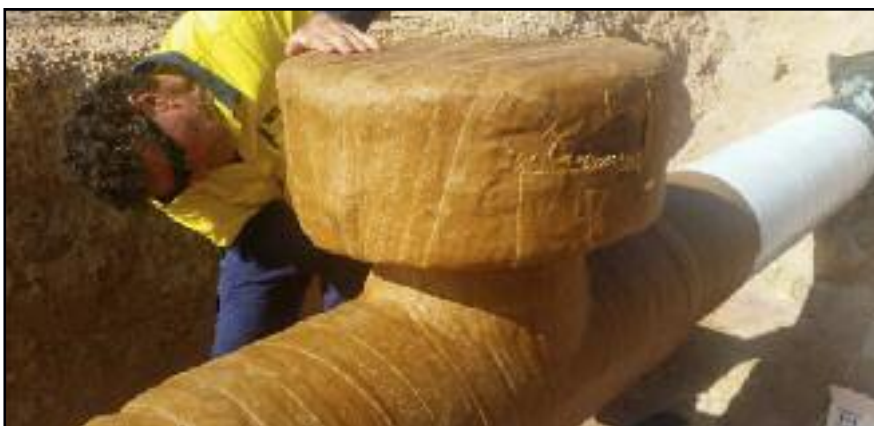
Application of the Denso Petrolatum Tape System.

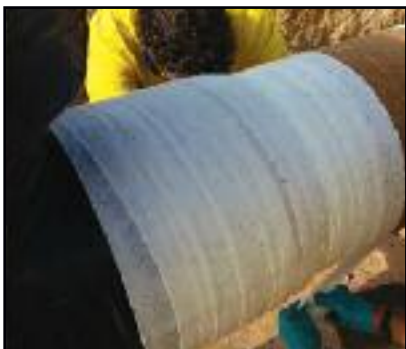
Application of the Glass Outerwrap System.

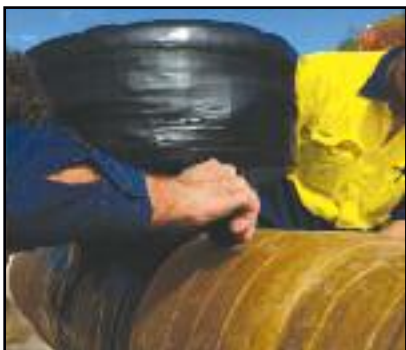
Application of the SA PVC Tape.

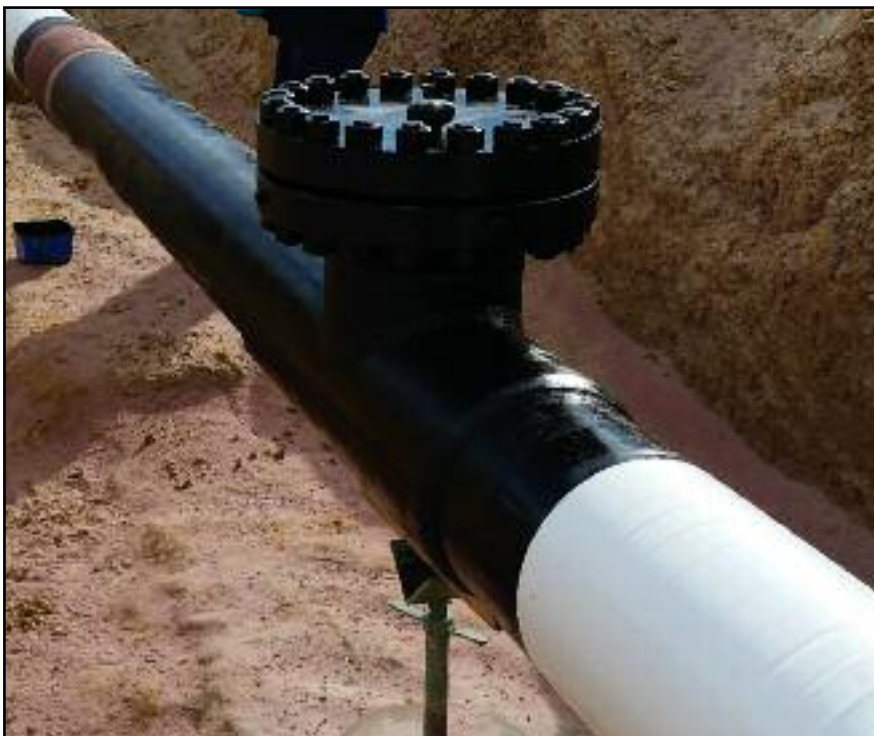
Protection of a joint and tie-in to existing coating underway.

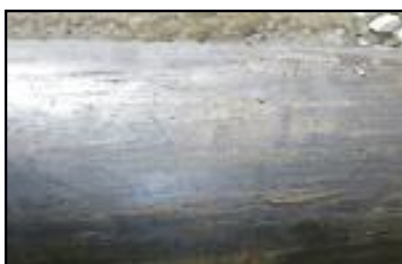
The pipe still in perfect condition - immediately after the removal of the original Denso system and still showing a layer of petrolatum compound.

The entire coating system was removed and the pipe surface was cleaned. No corrosion whatsoever was evident after 28 years since its installation in 1988. The inspections reflected an excellent coating system

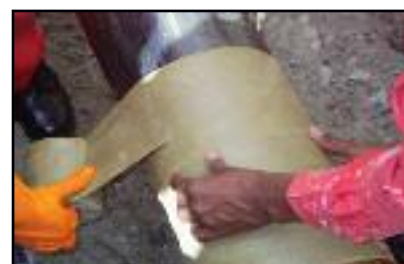
After cleaning, the pipe was re-coated with the Denso Petrolatum Tape System using a 55% overlap of the tape.

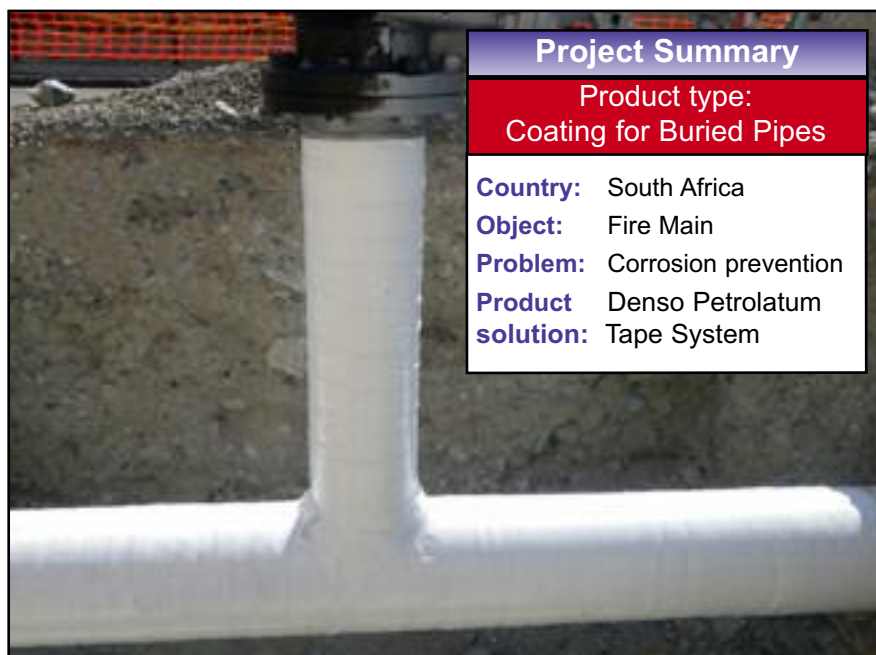
The new tie in, also wrapped in the same Denso Petrolatum Tape System used in 1988.

A 6" tie-in was then subsequently done for a fire water system installation at the Main Store using the original system supplied back in 1988!

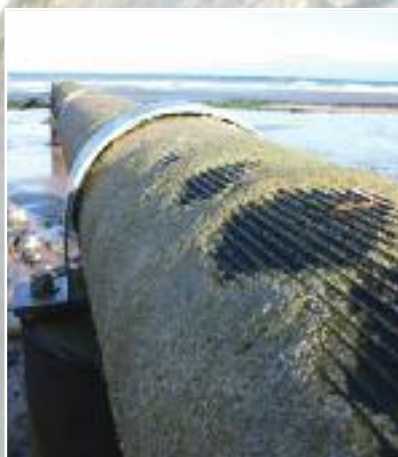
Above: Damage to the cement mortar on the Jurby outfall pipe.

In July of this year an inspection by Pipeline Protection (NE) revealed that the fibre cement had been eroded in most areas and particularly in the intertidal zone. It was here that the SeaShield 100 jackets were then applied. Their structure consists of HD polyethylene sheeting, and they

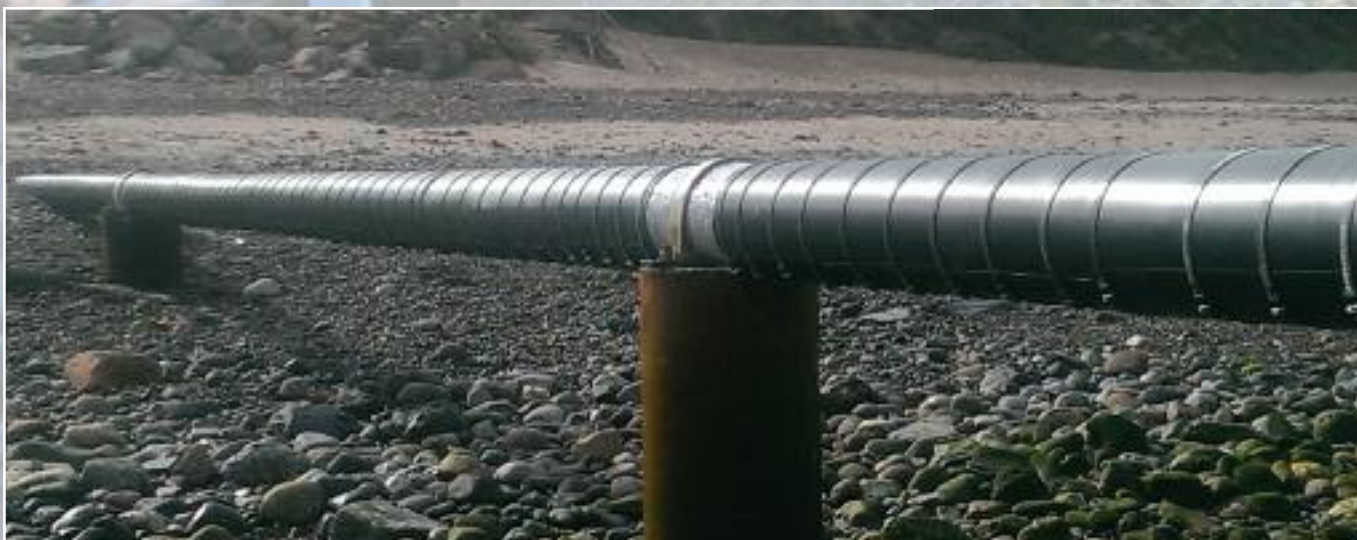
Below: The Jurby outfall pipe now protected with SeaShield 100 Jackets

The jackets are normally used as part of Winn & Coales SeaShield 100 system which was specifically developed for anti-corrosion protection in splash and intertidal zones, including for exposed pipes. In this main use the system consists of Denso Paste S105, Marine Piling Tape, SeaShield jackets and Smartbands for fixing. This seals the substrate against oxygen and water, preventing corrosion.

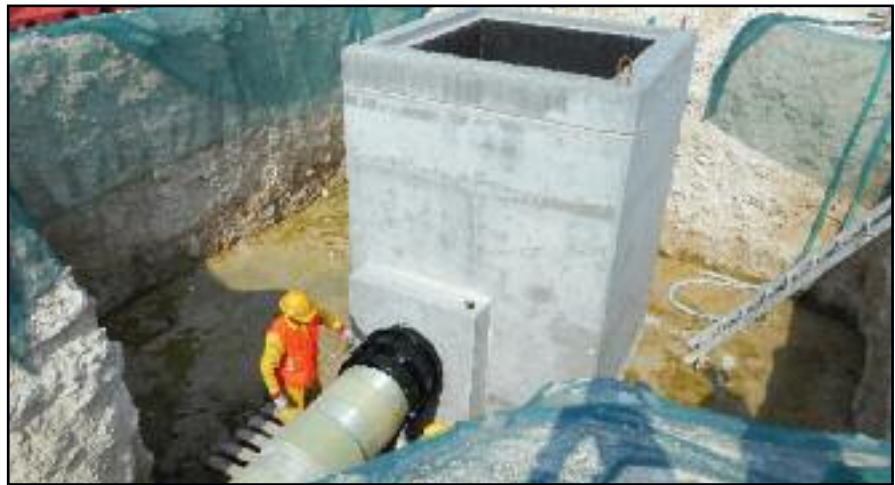
Above: After cleaning, the coupling is primed with Premcote Primer.

The system comprises Premcote Primer applied to the coupling surface, Premier Joint Moulding Putty used to fill voids and smooth profiles ready for overwrapping with Premcote 1500 Tape.

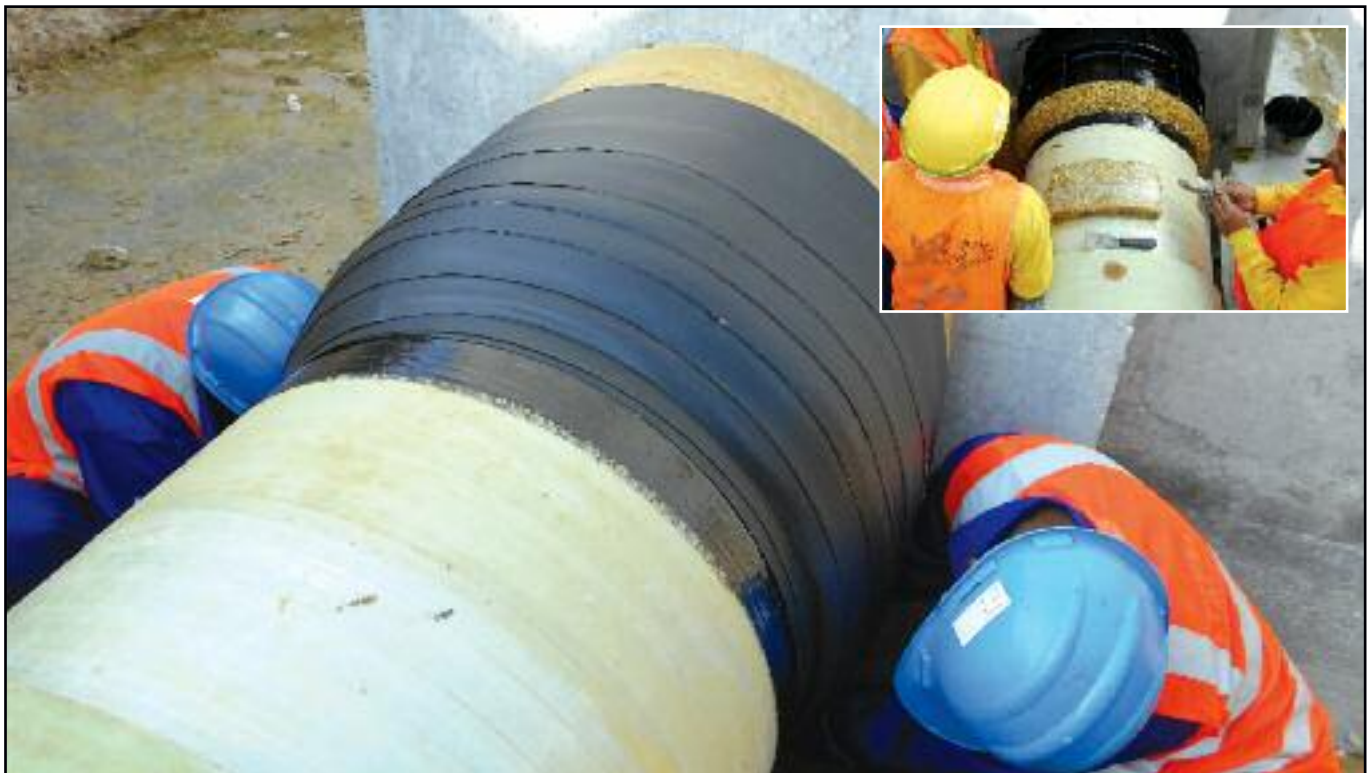
A circumferential wrap of Premcote 1500 Tape completes the protection. Inset shows Premier Joint Moulding putty used to smooth profiles.

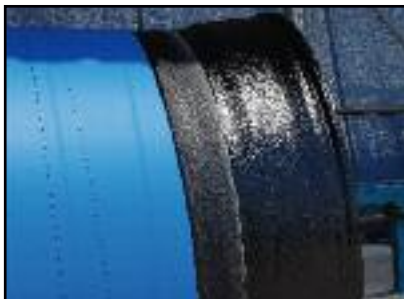
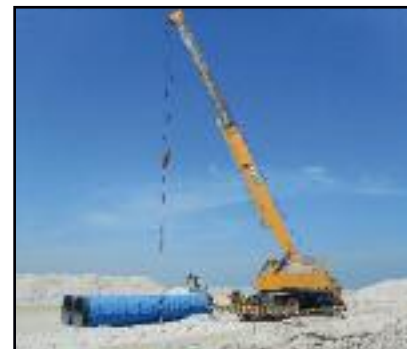
Below: Close-up of finished application of the Premcote Tape System.

Above and Below: The Premier Premcote System protected pipelengths are laid out prior to installation on-site.

After cleaning, a coating of Premcote Primer is applied followed (when dry) by an overwrap of Premcote 1500 Tape, completing the protection.

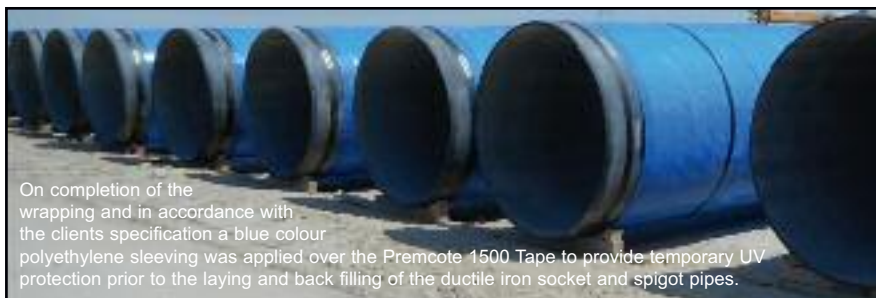
On completion of the wrapping and in accordance with the clients specification a blue colour polyethylene sleeving was applied over the Premcote 1500 Tape to provide temporary UV protection prior to the laying and back filling of the ductile iron socket and spigot pipes.

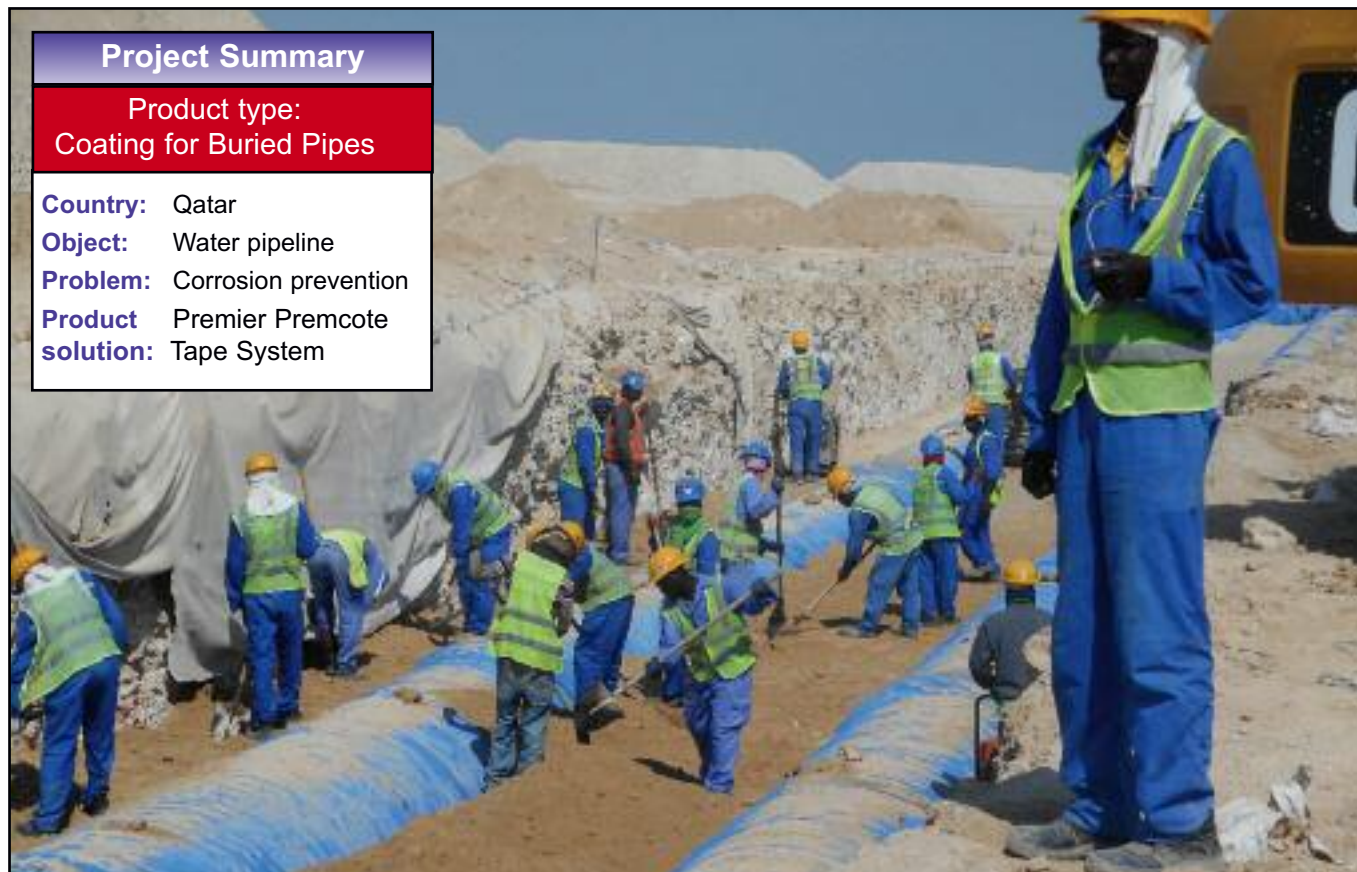
Below: The Premier protected water transmission pipeline is finally buried.
