Subject: Final Report Entitled "Evaluation of VISCOTAQ[®] Pipeline Wrap Performance Related to Crude Oil Exposure"; EERC Fund 20014

EVALUATION OF VISCOTAQ[®] PIPELINE WRAP PERFORMANCE RELATED TO CRUDE OIL EXPOSURE

Final Report

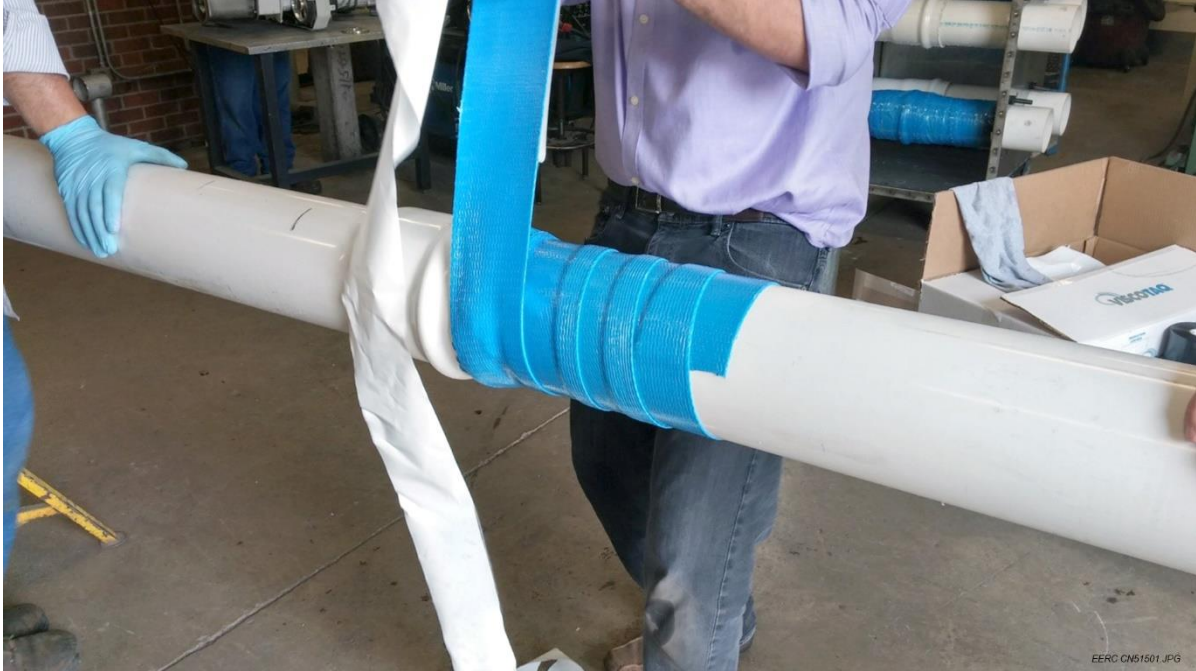
Figure 1. VISCOTAQ wrap being applied by Chuck Holt on June 2, 2015.

Before inserting the pipes into the test apparatus, Chuck Holt, a representative from Pro-Kote Engineering and Supply, arrived at the EERC in early June to wrap four of the six pipes with the VISCOTAQ bell and spigot sealing system (Figure 1). Three of these were single-wrapped and one was double-wrapped. Once wrapped, the pipes were inserted in the box with the ends extending beyond the walls of the test apparatus, and each was fitted with a pressure gauge and valves for venting and sampling. Once the pipes were inserted, the box was reinforced and tested for leaks by filling it with water. The pipes were also flushed with water and tested for leaks. After the leak checks were completed, the pipes were flushed several times with tap water followed by distilled water and tested for total organic carbon (TOC) until levels were at background levels (<1 mg/L). They were then filled with distilled water. The water pressure in Pipes 1, 2, 4, and 5 was maintained at 45 to 47 psi, while there was no internal pressure in Pipes 3 and 6 (Figure 2). Each pipe contained approximately 21 liters of water. Below are descriptions of the six test pipes:

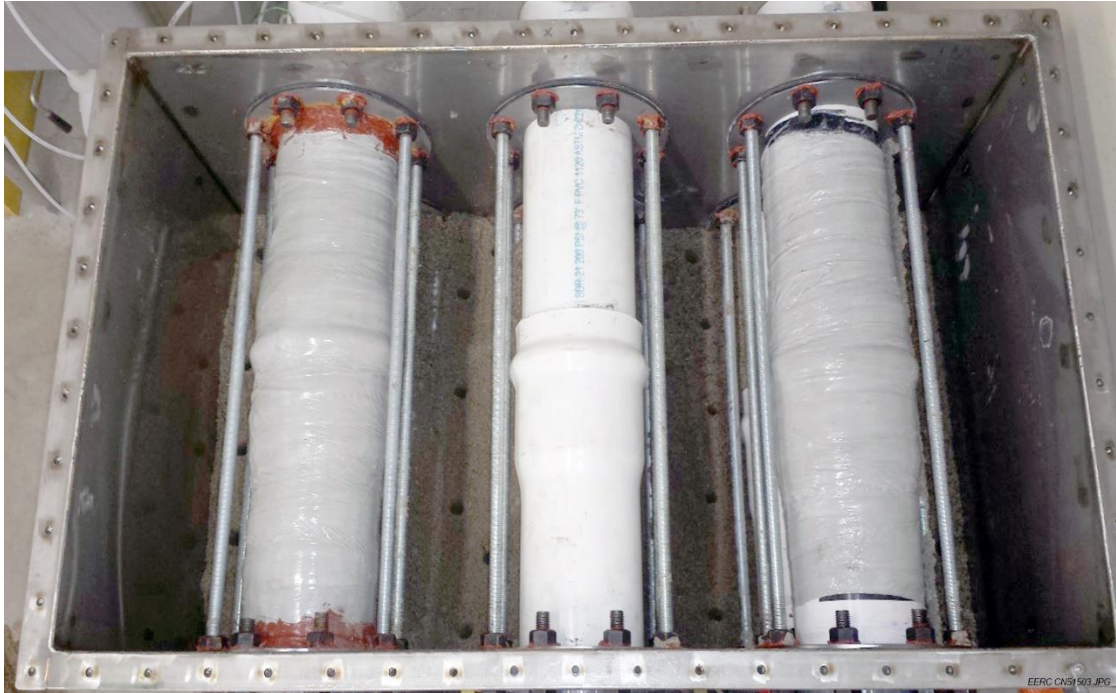
Figure 3. Top view of box after the first layer of sand was added.

On June 11, 2015, the box was filled with a mixture of damp sand and Bakken crude oil. The sand and oil were added in layers by filling the box approximately one-third full with sand (Figure 3) and then pouring 20 gallons (four 5-gallon pails) of crude slowly over the sand, which was readily absorbed. This was followed by another layer of sand and 20 gallons of oil and then a final layer of sand and 15 gallons of oil (Figures 4 and 5). This resulted in a completely saturated sand-oil mixture (Figure 6). The test box was covered with a stainless steel plate lined with a Viton[®] gasket and bolted along the edges. A pressure release valve was installed in the center of the top cover, with a pipe vent to an exhaust fan.

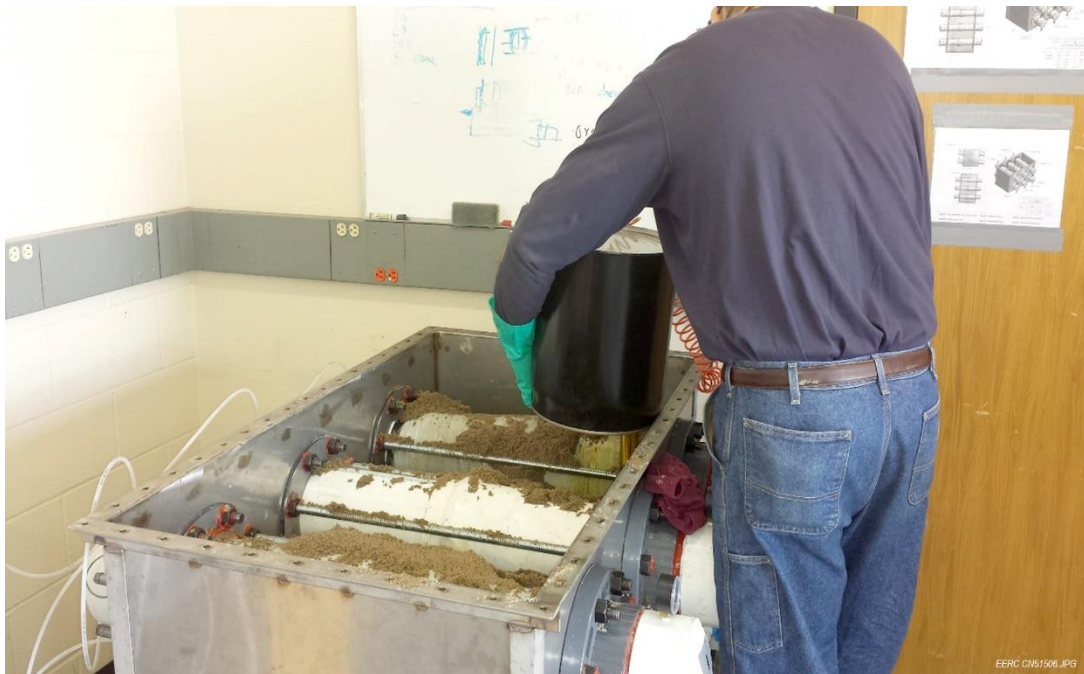
Figure 4. Second 20 gallons of crude oil being added.

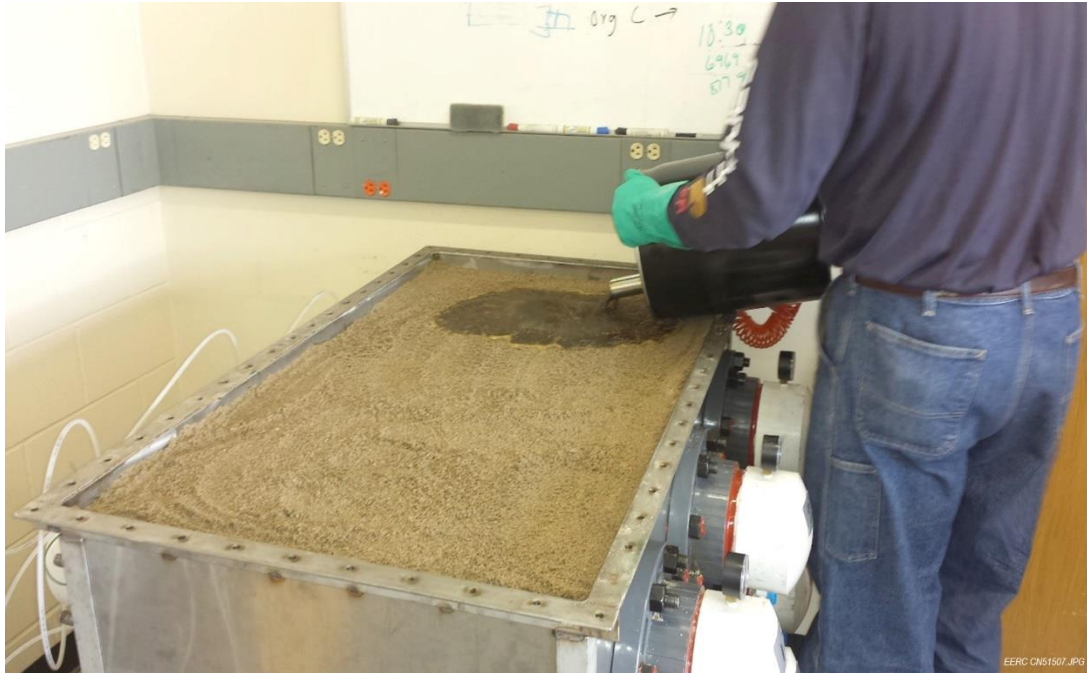
Figure 5. Final addition of crude oil.

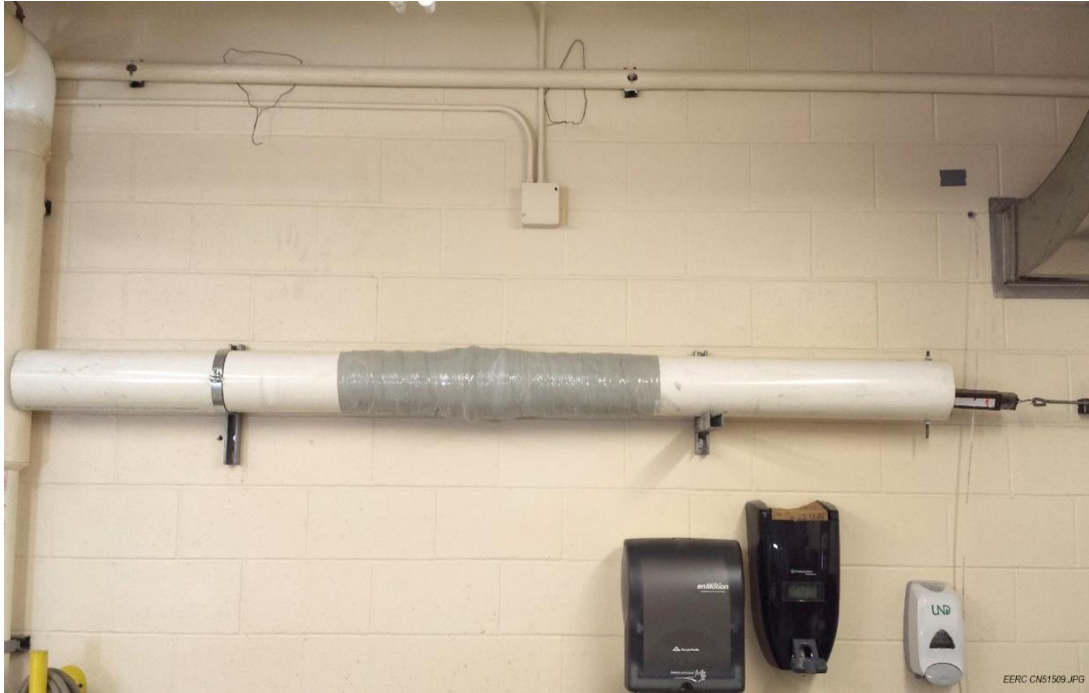
Figure 7. Wall-mounted pipe used for tension testing.

One additional test was performed to evaluate the cohesiveness of the VISCOTAQ sealing system when used on rural water supply pipes that may be subject to expansive and compressive stress conditions as a result of seasonal temperature fluctuations in the subsurface. A jointed section of PVC pipe was wrapped with the VISCOTAQ sealing system, and an initial tension of 30 psi was applied to one end of the pipe, while the other end was fixed to a stable bracket (Figure 7). A spring gauge was used to monitor the tension on the pipe, and the gauge was checked regularly for the duration of the project. The tension remained at 30 psi, and no visible changes to the pipe or the VISCOTAQ pipe wrap were detected.

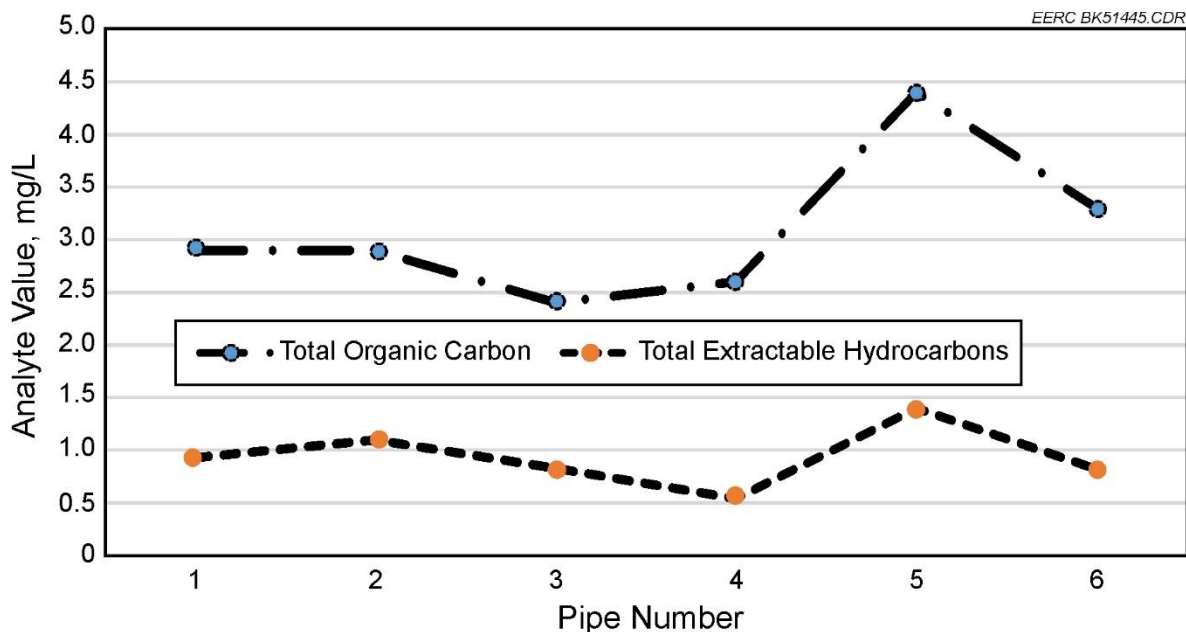
Figure 9. Comparison of TOC and TEH results for Week 4 samples.

Although the GC screening that was done in Week 2 showed that the organic carbon levels seen in the TOC analysis were likely due to one or more of the pipe assembly materials, a second set of tests were done on samples collected in Week 4 to confirm this. The Week 4 samples were analyzed using EPA Method 8015B for total petroleum hydrocarbon (TPH)–DRO and total extractable hydrocarbons (TEH). These are also referred to as semivolatile petroleum hydrocarbons. The TPH–DRO results for all pipe samples were <0.3 mg/L. The TEH results ranged from 0.54 to 1.4 mg/L. However, after reviewing the chromatograms, it was confirmed that the peaks were caused by the pipe assembly materials and not a crude oil leak, and the results followed the same trend as the TOC results (Figure 9).
