FX-70[®] INERT CORROSION-FREE SYSTEMS

Structural Restoration and New Construction

PILES-PIERS-MARINE STRUCTURES

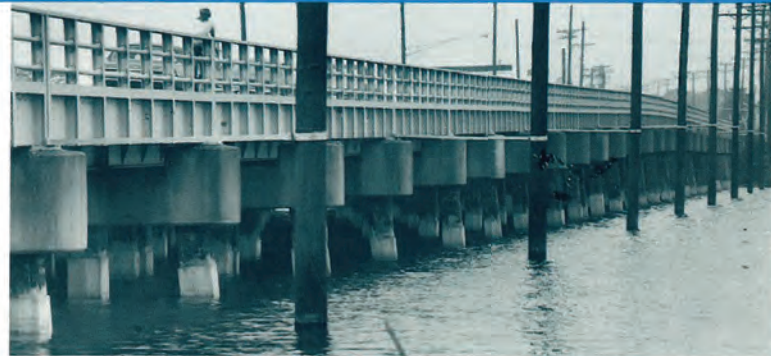
CONCRETE

Reconstructed with FX-70[®]

corrosion

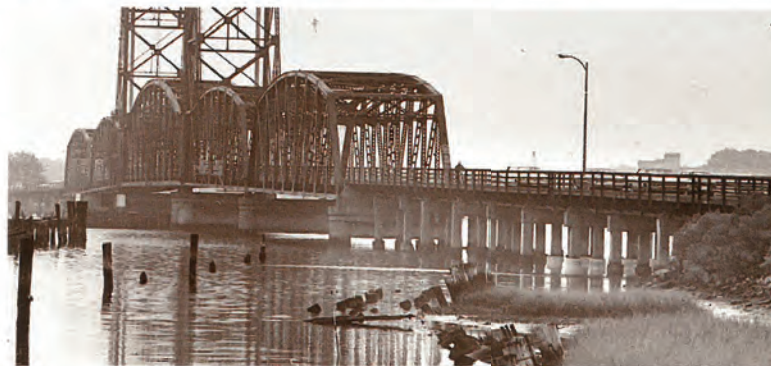
STEEL

Protected with FX-70[®]

missing sections

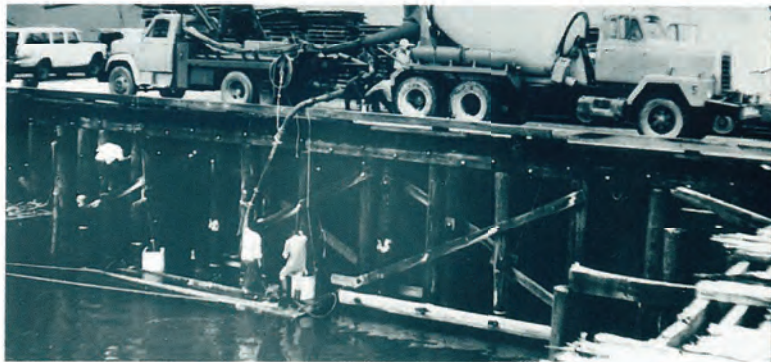
WOOD

Reconstructed with FX-70[®]

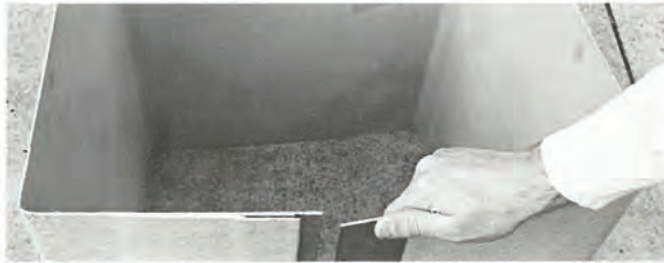
The Full length of this square FX-70[®] interlocking jacket is easily opened by one man for positioning around a pile. This saves field time and is a great advantage where the jacket must be handled by divers.

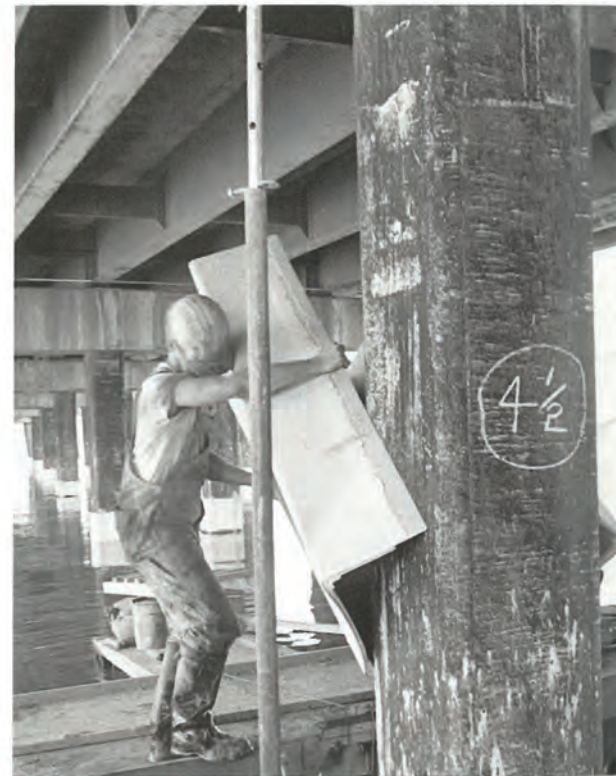
Curing room is an important step in the closely controlled manufacturing process.

FX-70[®] Interlocking Jackets are manufactured at the Fox Manufacturing plant in Baltimore, Maryland. Dimensions, chemical composition, and overall quality are closely controlled to assure long dependable service in field applications all over the world.

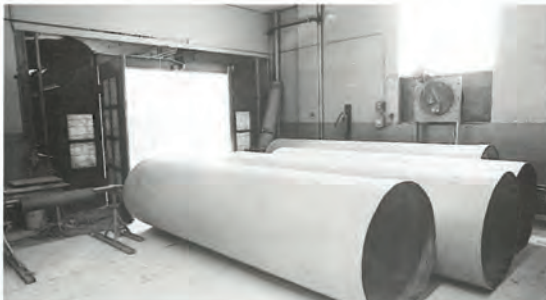
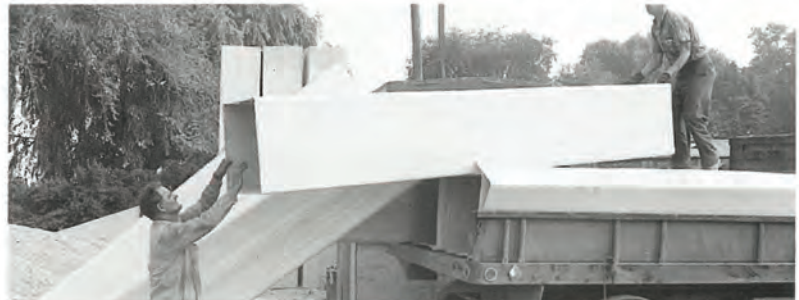
Light weight of only 1 pound per square foot of 1/8" thick surface make handling of FX-70[®] jacket both safe and fast.

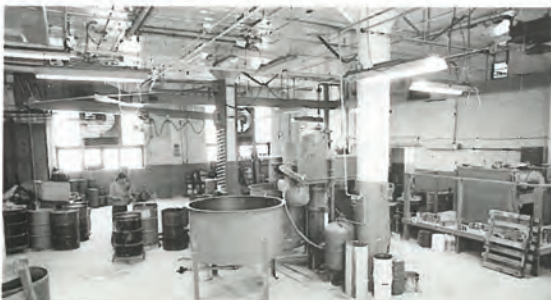
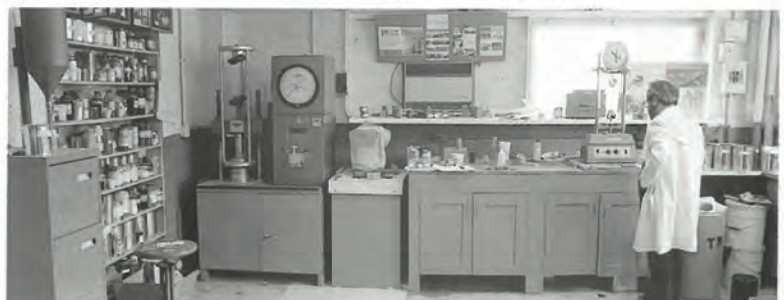
The quality control laboratory is located next to the manufacturing area.

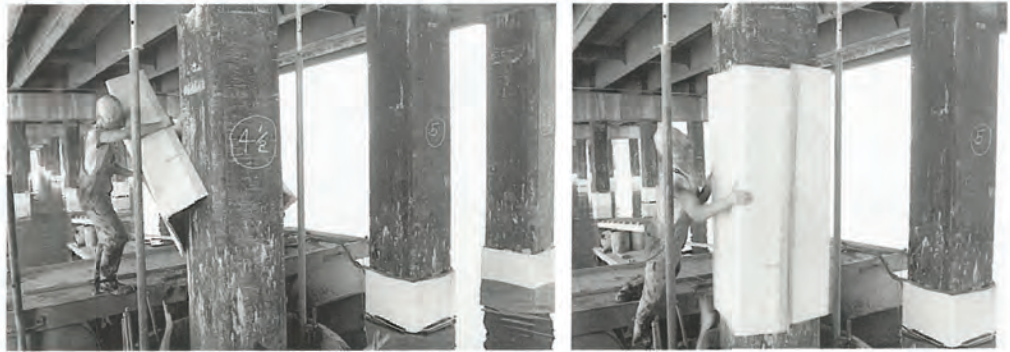
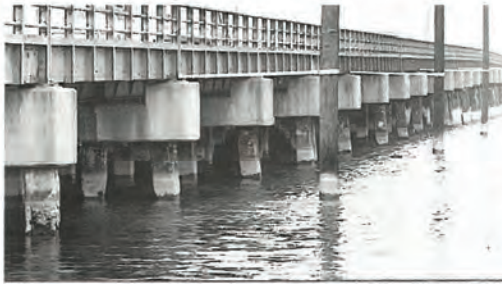
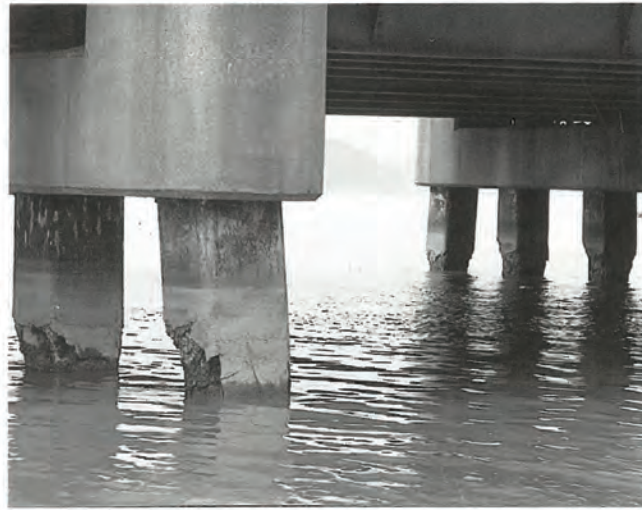
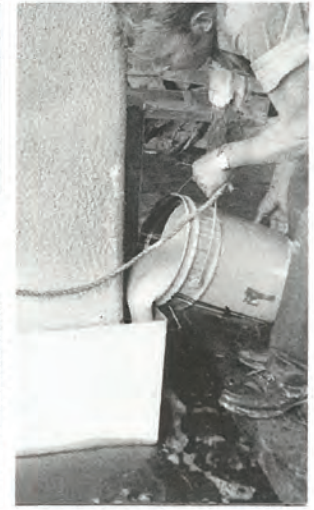
CONCRETE PILE REPAIRS — MARYLAND

Severe deterioration of concrete at the waterline exposed the reinforcing steel to brackish tidal waters. Reconstruction of 2000 lineal feet of 23" square pile was accomplished with FX-70® Inert Corrosion-Free System.

1. Deteriorated concrete was removed by chipping.
2. Rectangular FX-70® jackets from 3 to 9 feet long were positioned around the piles down to the mudline.
3. FX-70-6 Hydro-Ester mortar was poured to seal the bottom perimeter.
4. Portland cement grout with FX-32® Catalytic Agent was used for the middle area.
5. Top was finished off with a seal of FX-70-6 Hydro-Ester mortar.

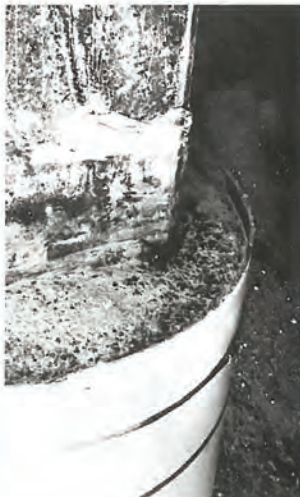
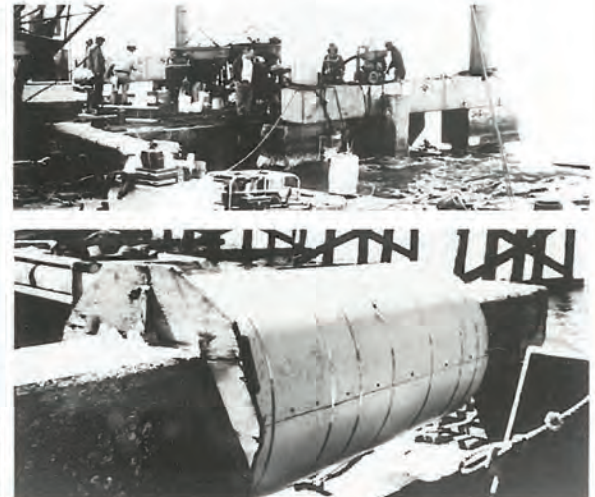
REPAIR OF STREET BRIDGE — LONG ISLAND

18" square prestressed concrete piles with a 9" center void were used to cross this salt water bay. Several piles were damaged during construction, probably as a result of hitting boulders during driving. Cracks in the concrete exposed the prestressed wires to corrosion. A full scale test of corrective measures was made with the FX-70® system.

seal the interlock.

2. Bottom was below mudline and was sealed with FX-70-6 Hydro-Ester mortar.
3. Cementitious grout made with FX-32® Catalytic Agent was pumped in through a bottom entry displacing all water.
4. Tests were successful and other damaged piles were repaired with this system.

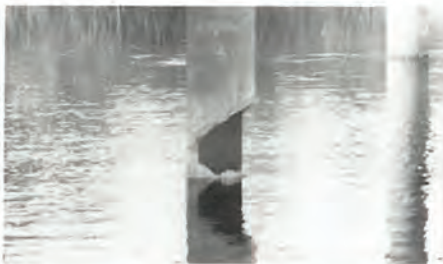
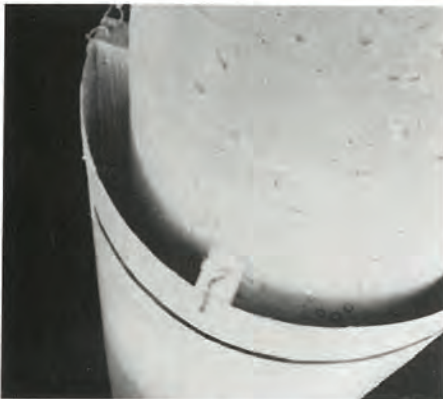
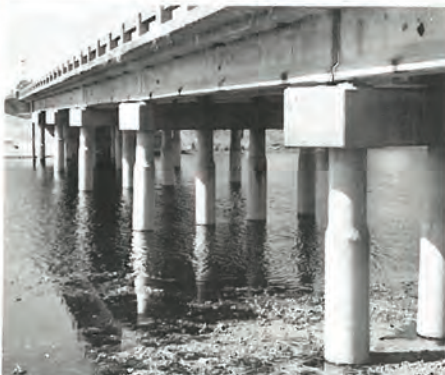
HIGHWAY BRIDGE — FLORIDA

Concrete protecting steel H-piles on this state highway bridge had deteriorated at the waterline exposing the steel to corrosion. Permanent and economical repairs were carried out by state highway personnel.

1. Deteriorated concrete was removed with a hydro laser.
2. 24" FX-70® jackets were cut to exact lengths, and the interlocking joint was filled with FX-763 Hydro-Ester Trowel Grade.
3. The jackets were placed in position around the pile, and FX-70-6 Hydro-Ester grout was poured through the water to make a tight seal at the bottom.
4. The next day the water was pumped out and an annular void was filled with concrete to within 3" of the top.
5. Top was sealed with a final layer of FX-70-6 Hydro-Ester mortar troweled to a neat beveled finish.

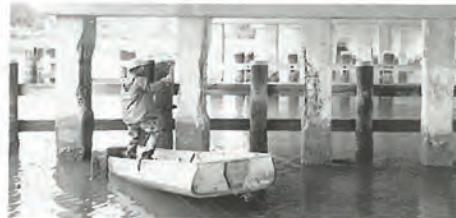
Rehabilitation of the pile bents on a bridge in Norfolk utilizes the FX-70® Inert Corrosion-Free System.

1. Piles show severe deterioration.
2. After cleaning with accomplished high pressure water blasting, FX-70® protective jackets are placed around each pile.
3. FX-70-6 Hydro-Ester and FX-701 Filler are mixed mechanically to mortar consistency.
4. Mortar is poured into annular void displacing water and forming high chemical bond both to jacket and pile.

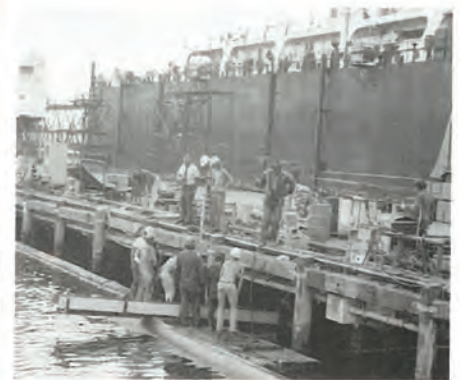
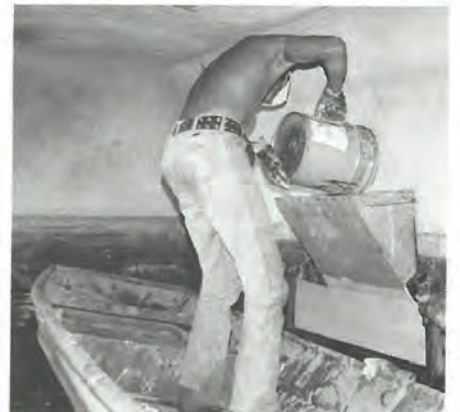
REPAIRS TO NAVY PIER — TEXAS

1. Water is used to clean pile surface. (note deterioration)
2. Welder attaches steel plates to span corroded section.
3. FX-70® interlocking jackets of 20" diameter are easily positioned in tight working space. Void is filled with concrete.

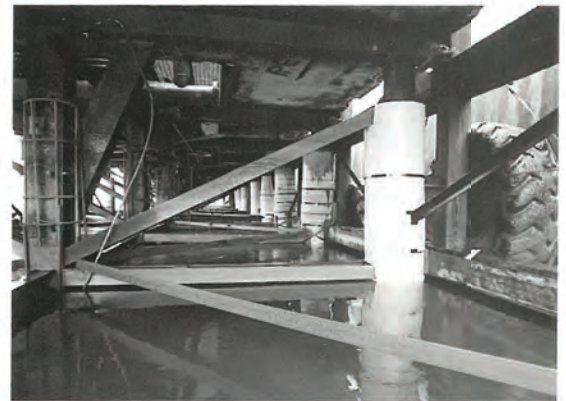
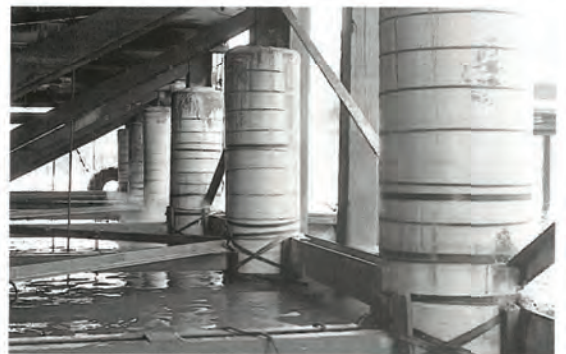
GRAIN PIER — LOUISIANA

Flowing water of the Mississippi River reduced the steel cross-section of these H-piles on the grain handling pier. Various repairs have been tried over the years. The current repairs are with the FX-70® system.

1. FX-70® interlocking jacket is positioned and tightly fixed to resist the river current.
2. Seal is made with FX-70-6 Hydro-Ester mortar.
3. Void in middle area was filled with cementitious grout made with FX-32® Catalytic Agent.
4. Work is completed with top layer of FX-70-6 Hydro-Ester mortar.

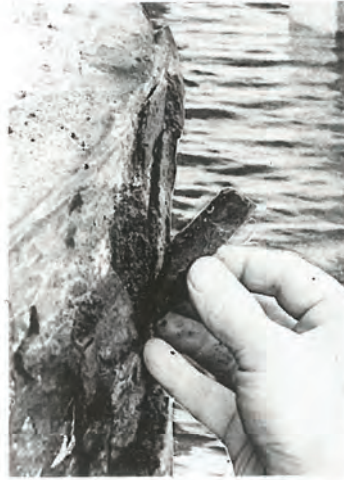
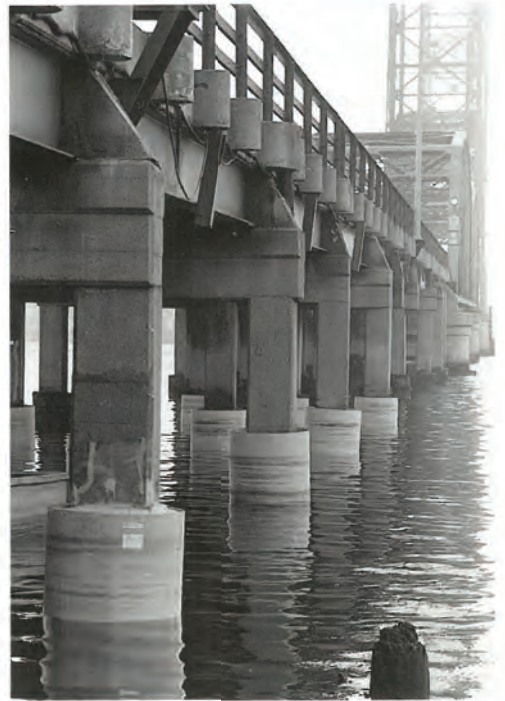
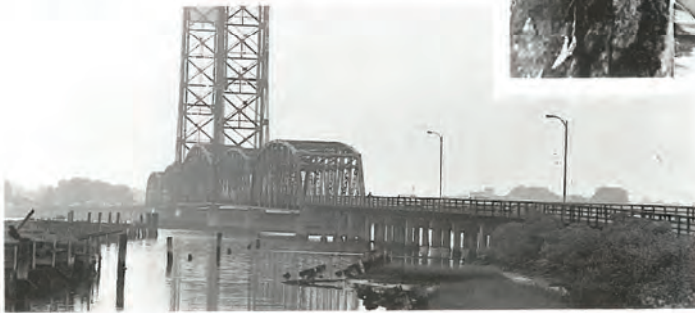
Corrosion, cracking, and separation of the steel jacket from the concrete pile at the waterline required a practical and effective maintenance procedure.

1. Steel shell is badly deteriorated.
2. After removing loose scale and barnacles, FX-70® interlocking jackets were slipped around each pile base.
3. FX-70-6 Hydro-Ester mortar was poured into the annular void and finished at the top providing an encapsulation of all exposed surface area. (Near pile is completed.)

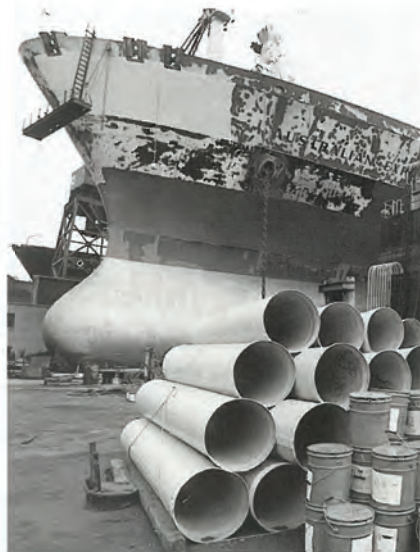
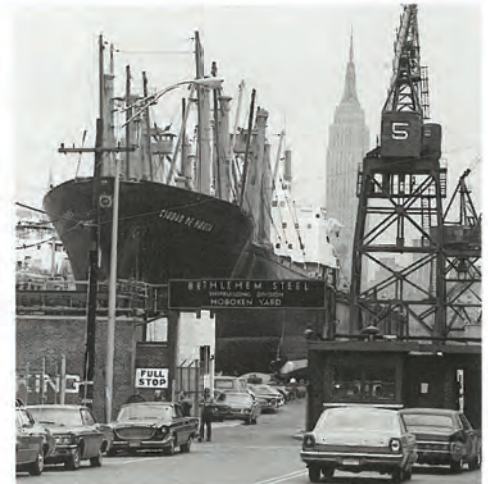
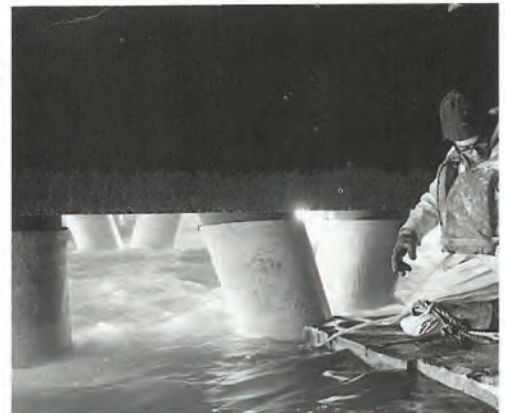
Steel pipe piles supporting heavy shipyard repair facilities were deteriorating in the polluted waters of the Hudson River. Repairs were made without interrupting work of the shipyard.

1. Divers worked in the low clearance area and positioned FX-70® jackets.
2. FX-70-6 Hydro-Ester and FX-701 Filler were mixed to grout consistency and pumped into the annular void space displacing the water.

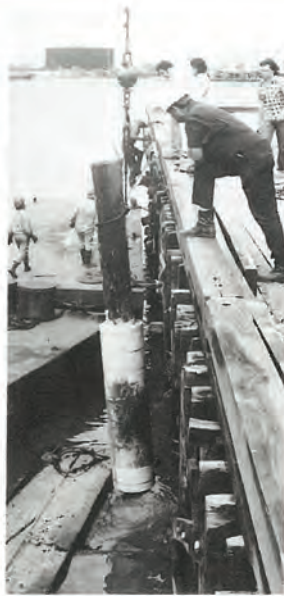
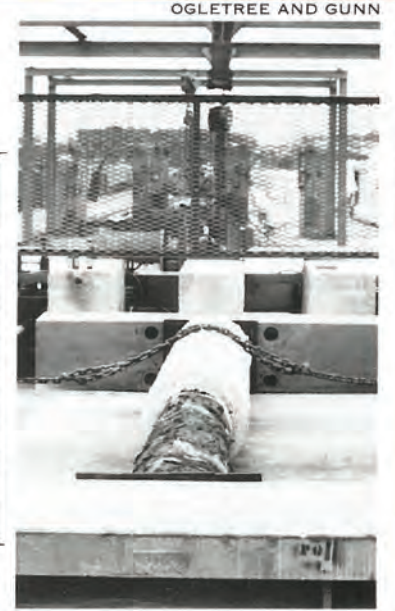
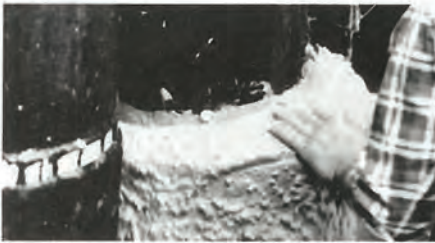
Sections were totally missing at the water line from many of the wood piles supporting this municipal pier. Reconstruction with FX-70® was preceded with a full scale test:

1. Rotted wood was removed from piles.
2. Wire reinforcing cage was attached to top and bottom sections, spanning the missing area.
3. FX-70® jacket was prepared with an FX-70-2 seal along the bottom and positioned around the pile.
4. FX-70-6 Hydro-Ester Mortar was poured through the salt water to permanently seal the bottom.
5. Cementitious grout made with FX-32® Catalytic Agent was pumped into the jacket displacing the water and filling the entire center section.
6. Top was sealed with FX-70-6 Hydro-Ester mortar.
7. Full sections of the reconstructed pile were removed and tested in a 100-ton hydraulic press.
8. Result: reconstructed section of the pile was stronger than the original.

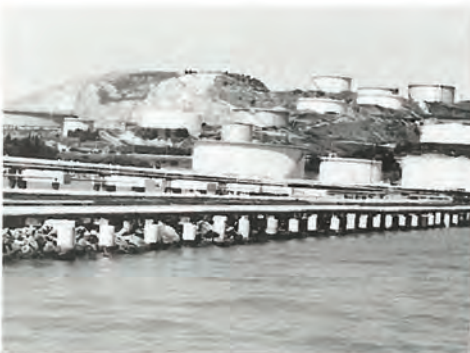
Wood piles showed varying degrees of deterioration at the waterline on this petroleum pier.

1. FX-70® jackets were installed as permanent 36" diameter forms from the mudline to the cap.
2. Void space was filled with high strength concrete.

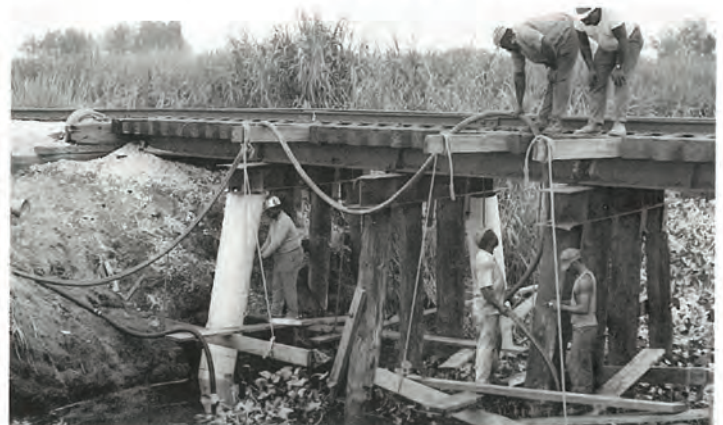
Wood piles on this railroad bridge were rotting away at the waterline in this shallow waterway. Repairs were made from above the waterline.

around the pile, well into the mudline.

2. Annular space of 2 to 3 inches is created.
3. Cementitious grout made with FX-228 High-Early Non-Metallic Compound displaced the water in the annular void.

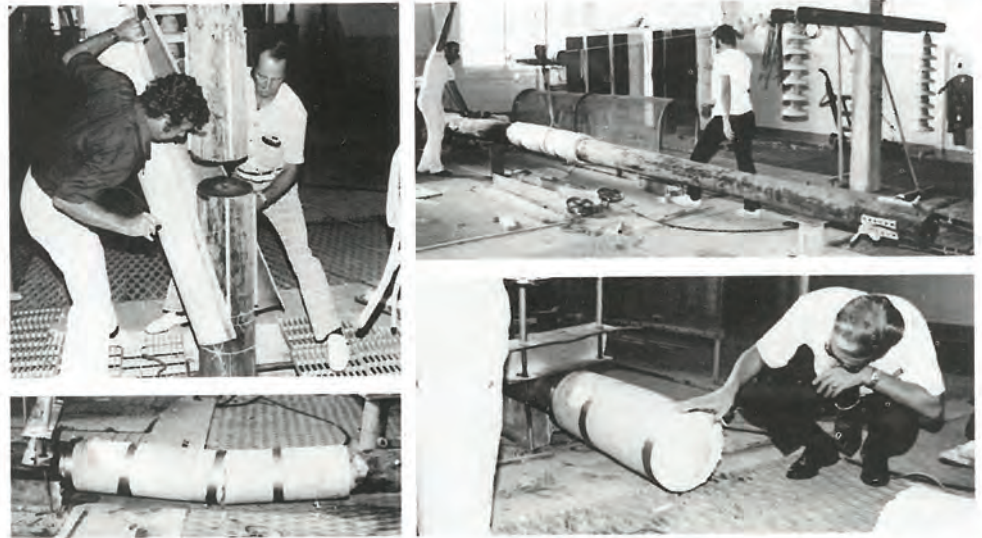
UTILITY POLES — FLORIDA

1. A 6" gap was selected for reconstruction.
2. A 5-foot long FX-70® jacket was slipped around the splice area.
3. FX-70-6 Hydro-Ester and FX-70-1 Filler were mixed to grout consistency and poured into the void.
4. Pole was positioned horizontally for testing.
5. Failure occurred at 26,266 ft.-lbs, or a fiber stress of 2005 psi.

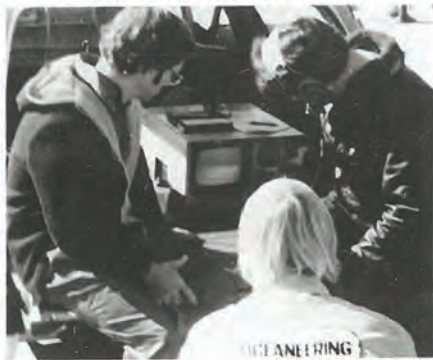
NAVY MAINTENANCE — VIRGINIA

Mothballing in a propeller shaft without putting this Navy ship in dry-dock was accomplished with FX-763 Hydro-Ester Trowel Grade and FX-70-10 Fiber Reinforcing.

1. Divers apply FX-763 to clean propeller shaft.
2. 6" wide FX-70-10 fiber reinforcing is wrapped around the coated shaft.
3. TV camera monitors the work through murky water.

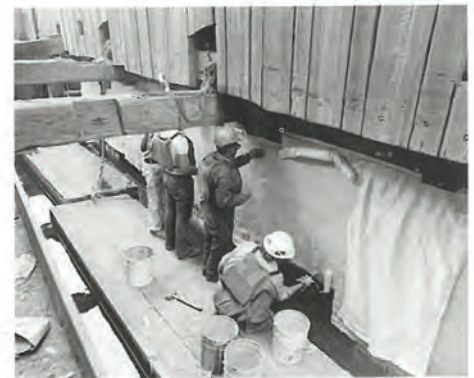
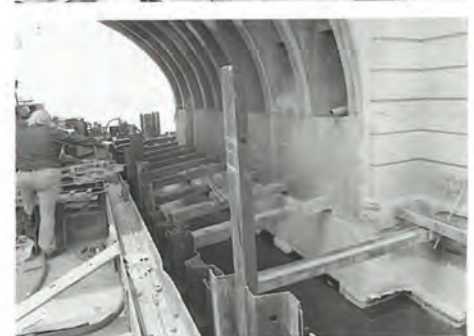
HIGHWAY BRIDGE — BALTIMORE

Repair methods were studied and a detailed specification was prepared outlining the following procedure:

1. Cofferdams were constructed.
2. Deteriorated concrete was removed.
3. Shotcrete containing FX-32® catalytic agent was applied to rebuild the missing sections.
4. FX-70-9 Hydro-Ester Coating LV was applied by roller.
5. FX-70-10 Reinforcing was unrolled and embedded in the coating.
6. Another layer of FX-70-9 was applied to produce a finished surface.

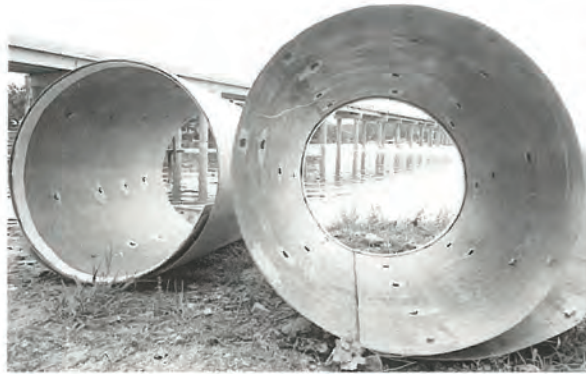
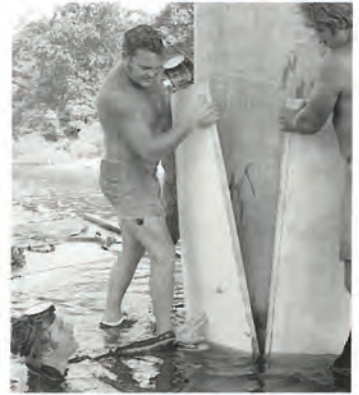
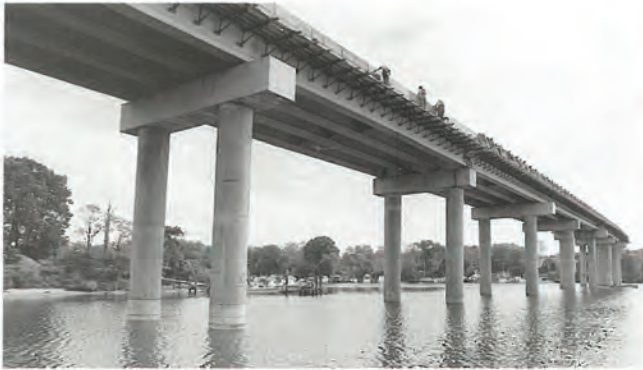
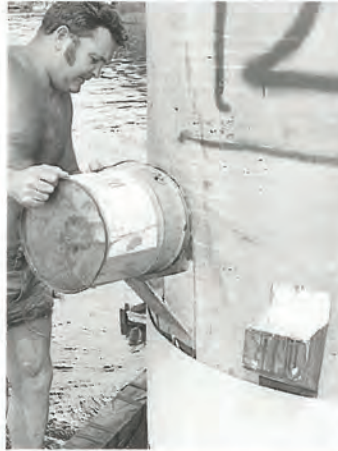
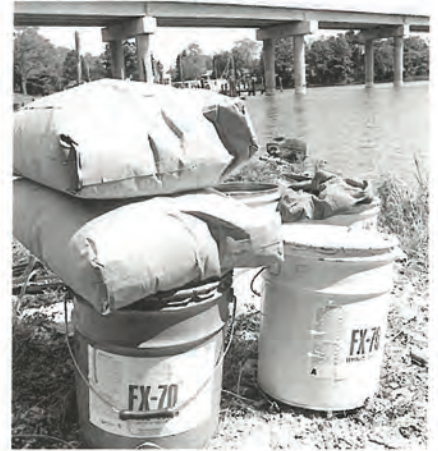
54" CONCRETE PILES — MARYLAND

Prestressed hollow piles 54" in diameter on this new bridge were protected at the tidal zone with the FX-70® Inert Corrosion-Free System. As superstructure was being completed, the protective FX-70® jackets were installed by workers on floats.

1. FX-70-1 seal was installed along the bottom perimeter of the 5-foot long jacket.
2. FX-763 Trowel Grade was buttered on the interlocking joint.
3. The jacket was banded in place.
4. FX-70-6 Hydro-Ester mortar was poured into the 1/2" annular space to provide a firm continuous bond over the entire protected area.

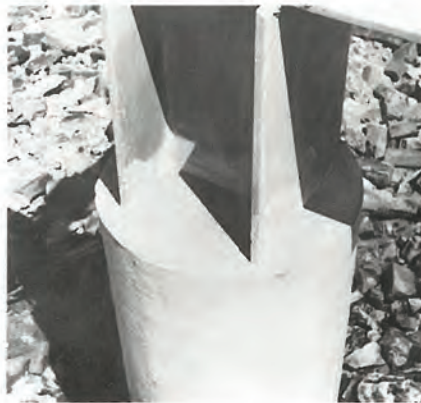
New oil receiving pier was designed with steel H-piles for support and FX-70® jackets for protection against corrosion.

1. Interlock of the jacket was buttered with FX-763 Hydro-Ester Trowel Grade.
2. FX-70® jackets were installed from mudline to within 24" of the cap.
3. Portland cement concrete was used to solidly fill the void area.

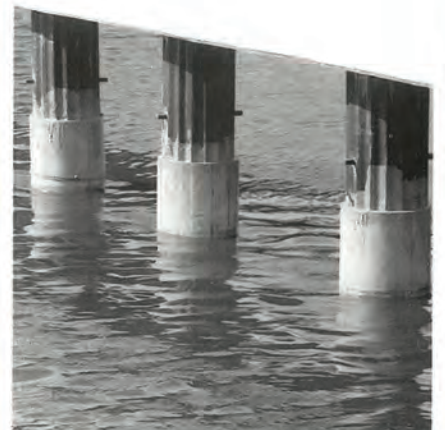
FLUTED STEEL PILES

Fluted steel piles on this new state highway bridge are protected with FX-70® Inert Corrosion-Free System.

1. FX-70® jackets are positioned from the mudline to one foot above mean high tide.
2. FX-70-6 Hydro-Ester mortar was poured through the brackish water to fill the annular void.

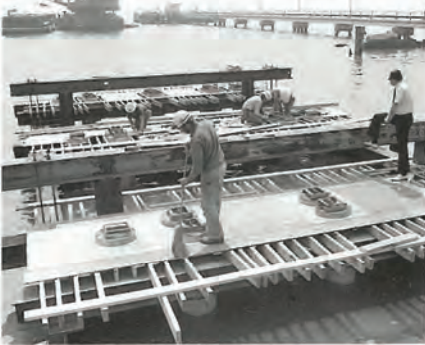
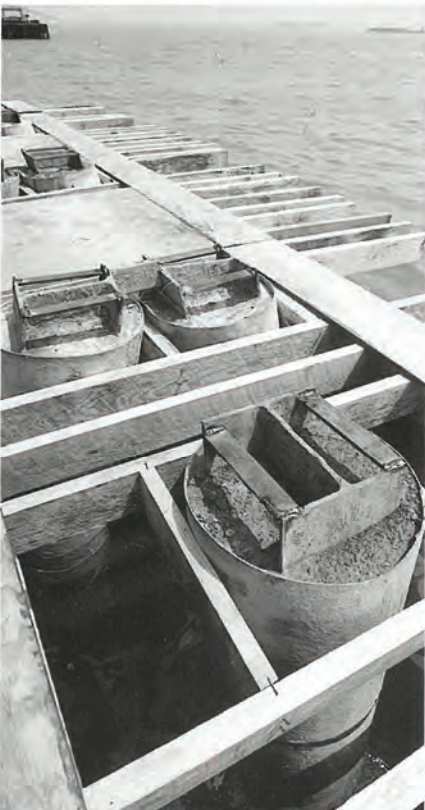
INDUSTRIAL PIER — MARYLAND

1. Steel H-piles were driven and cut-off to specified elevation.
2. FX-70® Hydro-Ester jackets were slipped around the piles and fixed into position.
3. Portland cement concrete with FX-32® Catalytic Agent was used to fill the void space.
4. Deck forms were constructed so that FX-70® jackets and H-piles would protrude into the underside of the cast-in-place deck.

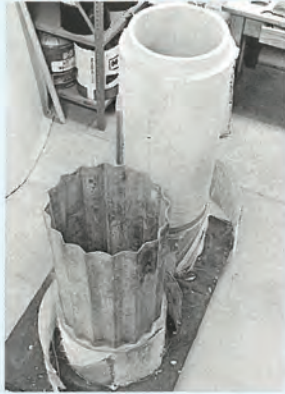
Both steel and concrete specimens were tested.

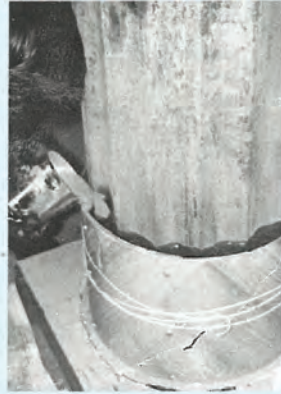
FX-70-6 Hydro-Ester mortar is poured through salt water solution.

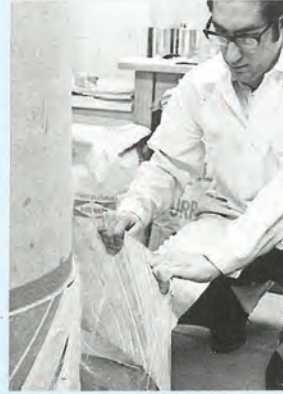
High bond is apparent as many fibers remain embedded in FX-70-6 Hydro-Ester mortar.

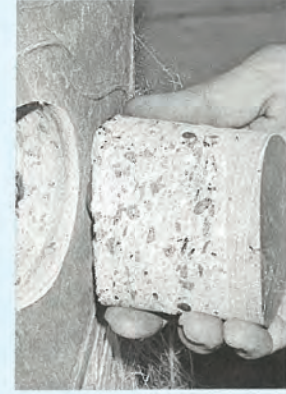
Core shows monolithic bond to concrete.
