Project Data

Location	Midwestern Region, USA
Completion	October 2025
Project Type	Pipeline Structural Repairs
Products Used	Protal™ 2800CF Tape, Protal™ 7300, Protal™ 3210 Filler, Denso Polywrap

Project Details

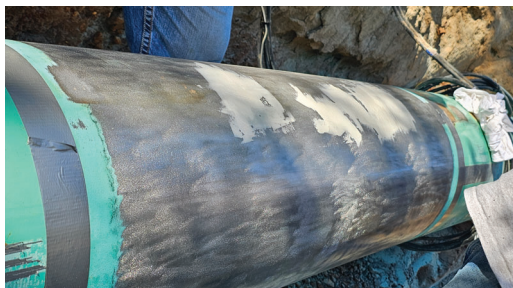
Protal 3210 Load Transfer Filler was applied.

The surface was prepared by mechanical cleaning to remove any residual corrosion products and achieve the optimal surface profile. Once prepared, the Protal™ 3210 Filler and Protal™ 7300, used as an epoxy primer, were applied accordingly, followed by successive spiral wraps of the Protal™ 2800CF composite material. Each layer was firmly tensioned to eliminate trapped air and ensure intimate contact between layers. Denso Polywrap film was finally applied and perforated, compressing the moisture-cured urethane material down against the substrate. The repair process was completed in approximately 30 minutes, demonstrating the efficiency and ease of application of the Protal™ 2800CF system. Throughout the composite wrap install process, all Denso material batch numbers were documented for traceability and quality assurance purposes.

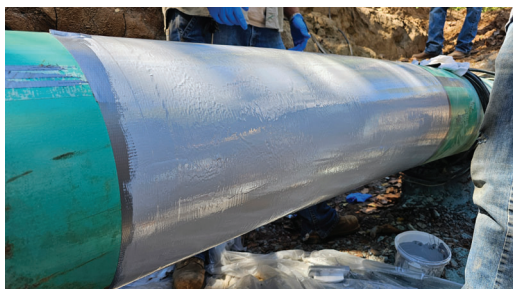
Protal 7300 Epoxy applied next as an adhesive primer for the carbon fiber system.

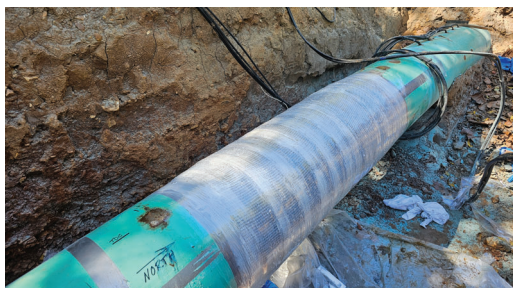
Completed section of the Protal 2800CF pipeline repair system in place.

This project highlights the effectiveness of the Denso Protal™ 2800CF System in addressing wall loss due external corrosion defects quickly and reliably. The resulting composite reinforcement provides long-term protection against corrosion and mechanical stresses, restoring the pipeline's integrity and extending its operational life with minimal downtime.
