Structural silo foundation repair utilizing Denso 190DP Epoxy Grout.

<b>Location</b>	Rensselaer, IN
<b>Completion</b>	2025
<b>Project Type</b>	Concrete Foundation Repair
<b>Products Used</b>	Denso 190DP Epoxy Grout
<b>Contractor</b>	Green Future Structural Innovations

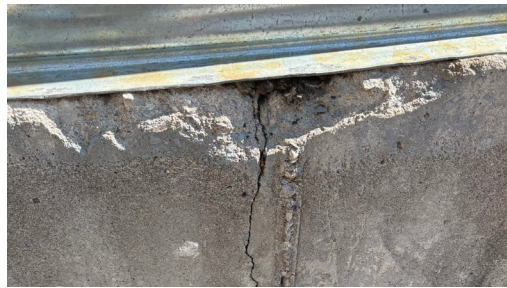
Deteriorating concrete foundation causing major structural issues at a silo facility.

A facility required significant repairs to a deteriorated silo foundation supporting fertilizer and grain storage operations, with approximately 50 feet of the existing concrete needing removal and replacement due to long-term exposure to moisture, chemicals, and environmental stress. To restore structural integrity while minimizing downtime, the repair team from Green Future Structural Innovations, experts in silo restoration, selected Denso 190DP Epoxy Grout as a high-performance alternative to traditional concrete.

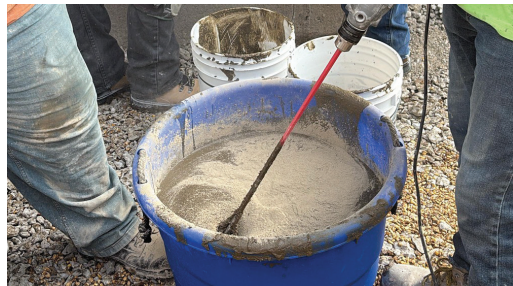
Denso 190DP Epoxy Grout is a high strength, low exotherm deep pour grout.

The repair process began with saw-cutting and square-cutting the damaged concrete to remove all unsound material and create clean, well-defined edges. Once the substrate was properly prepared and reformed, the Denso 190DP Epoxy Grout was mixed and poured up to approximately 18" deep in one lift, where it bonded seamlessly to the existing concrete and conformed to the required repair geometry. Unlike conventional concrete, which can require seven or more days to cure, the epoxy grout cured and set within hours, allowing the project to move forward quickly. This rapid strength development enabled the application of an epoxy topcoat within the same day, providing additional surface protection and extending the service life of the repair.
