CASE STUDY

FLEET PROTECTION

Hydraulic and Electronic Component Protection

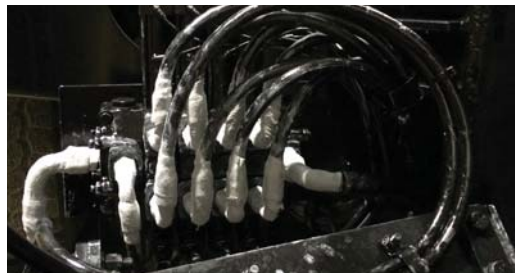
Hydraulic hose fittings protected with Denso ColorTape against harsh weather conditions and water infiltration.

To guard against these issues, many municipalities and private companies such as Carillion, Miller and BDI have now started using Denso ColorTape on fittings when replacing a hose as well as having it installed from new on all at risk fittings. This is done at the facilities of truck builders like Viking-Cives, Alliston Truck Equipment, Tenco, Gin-Cor and Northern Powertrain.

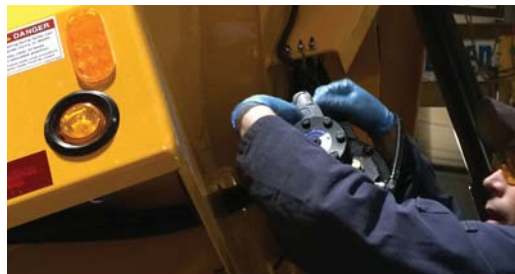
Denso ColorTape is easily applied by hand and requires no primer.

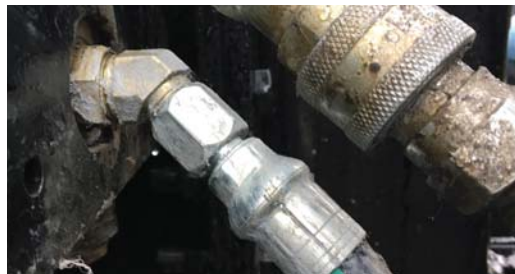
Denso ColorTape removed after 1 year (left fitting) vs one fitting (right fitting) that was not wrapped.

In Ontario, Canada is faced with harsh winters and the necessity of aggressively salting the roads. With millions of pounds of salt and brine solution being sprayed over the course of a long winter season, the trucks that are tasked with the job pay a serious toll in the form of corrosion and electrical failure due to moisture infiltration. Corrosion of fittings results in hose failure and loss of control of hydraulic equipment, spilling of hydraulic fluids and danger to vehicles sharing the road as well as a substantial towing cost and vehicle downtime. Additionally, when attempting to change a hose if the fitting is seized, a huge amount of time and effort is required to uncouple the fitting as well as the possible necessity to change couplings and attached hoses because they cannot be separated. Finally, quick connections cannot be utilized if they are seized and electronic components such as sensors often have to be replaced prematurely due to failure related to corrosion or water infiltration.
