SeaShield Marine Systems

Series 90

Timber pile protection system that includes petrolatum tape and a protective outercover

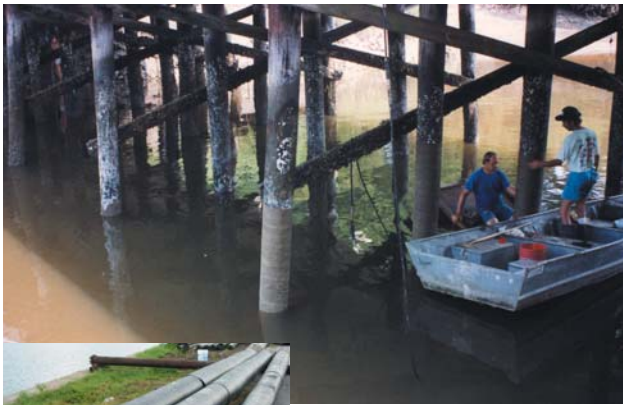
SeaShield Series 90 consists of Denso Marine Piling Tape preventing marine borer destruction and an outcover for mechanical protection of tape.

The Series 90 System utilizes the proven Denso Marine Piling Tape for eliminating oxygen from reaching the pile and is highly conformable to all shapes and irregularities of the pile. The outcover is used for mechanical protection of the tape. No seals are required on the outcover, thus eliminating the need for a tight seal of the jacket.
