## CASE STUDY

## HARBOR WEST CONDOMINIUMS

**Pile Rehabilitation**

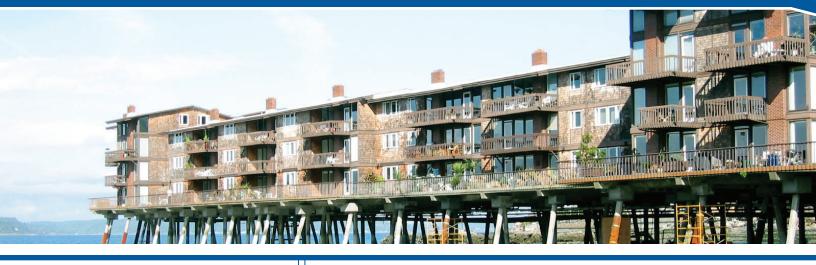
Preparing surface with high-pressure water blasting.

Completed SeaShield™ 500 System.

SeaShield  $^{\scriptscriptstyle\rm TM}$  550 Epoxy Grout being pumped into the Fiber-Form jacket.

The Harbor West Condominiums were built in 1965 along the aggressive coast of Puget Sound in Seattle, WA. The structure is supported by 140 each 14" octagonal concrete pilings and had been performing well until they were damaged from an earthquake in 2002. The SeaShield Series 500 System was selected as the sole-source system for complete encapsulation of all the piles.

The project included the complete encapsulation of all 140 piles. Firstly, 100 of the piles were protected with the Series 500 System, that included a 153/4" dia. SeaShield Fiber-Form jacket that yielded a minimum 1/2" annulus at the 8 corners of the existing octagonal piles. The jackets were constructed of 3/16" thick woven and roving fiberglass and gel coated. The annulus was then pumped and filled with the SeaShield 550 Epoxy Grout. The epoxy grout kits consisted of 1 gallon of 2-part epoxy and a 44 lb. bag of grout yielding 0.4 cu. ft.

Next, 40 of the 140 piles were encapsulated with %" thick 16" dia. steel split sleeves, welded and then filled with the 550 Epoxy grout. Finally, these 40 piles were encapsulated with 17 %" dia. Fiber-Form jackets that included ½" stand-offs and were again filled with the 550 Epoxy Grout.
