### Project Data

Location	Tampa, FL
Completion	2011
Project Type	Dock Pile Rehabilitation
Products Used	SeaShield™ Series 2000HD System
Contractor or Applied By	Misener Marine

### Project Details

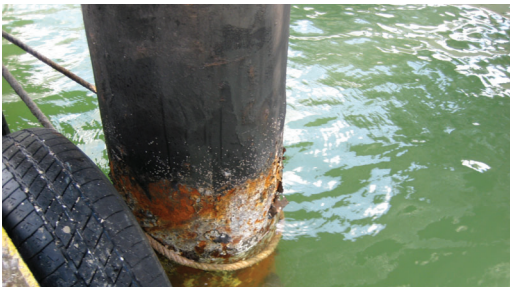
Severe corrosion of pile prior to cleaning.
