WINN & COALES INTERNATIONAL LTD

Denso Digest

Volume 31 - Number 3

LEADERS IN CORROSION PREVENTION & SEALING TECHNOLOGY

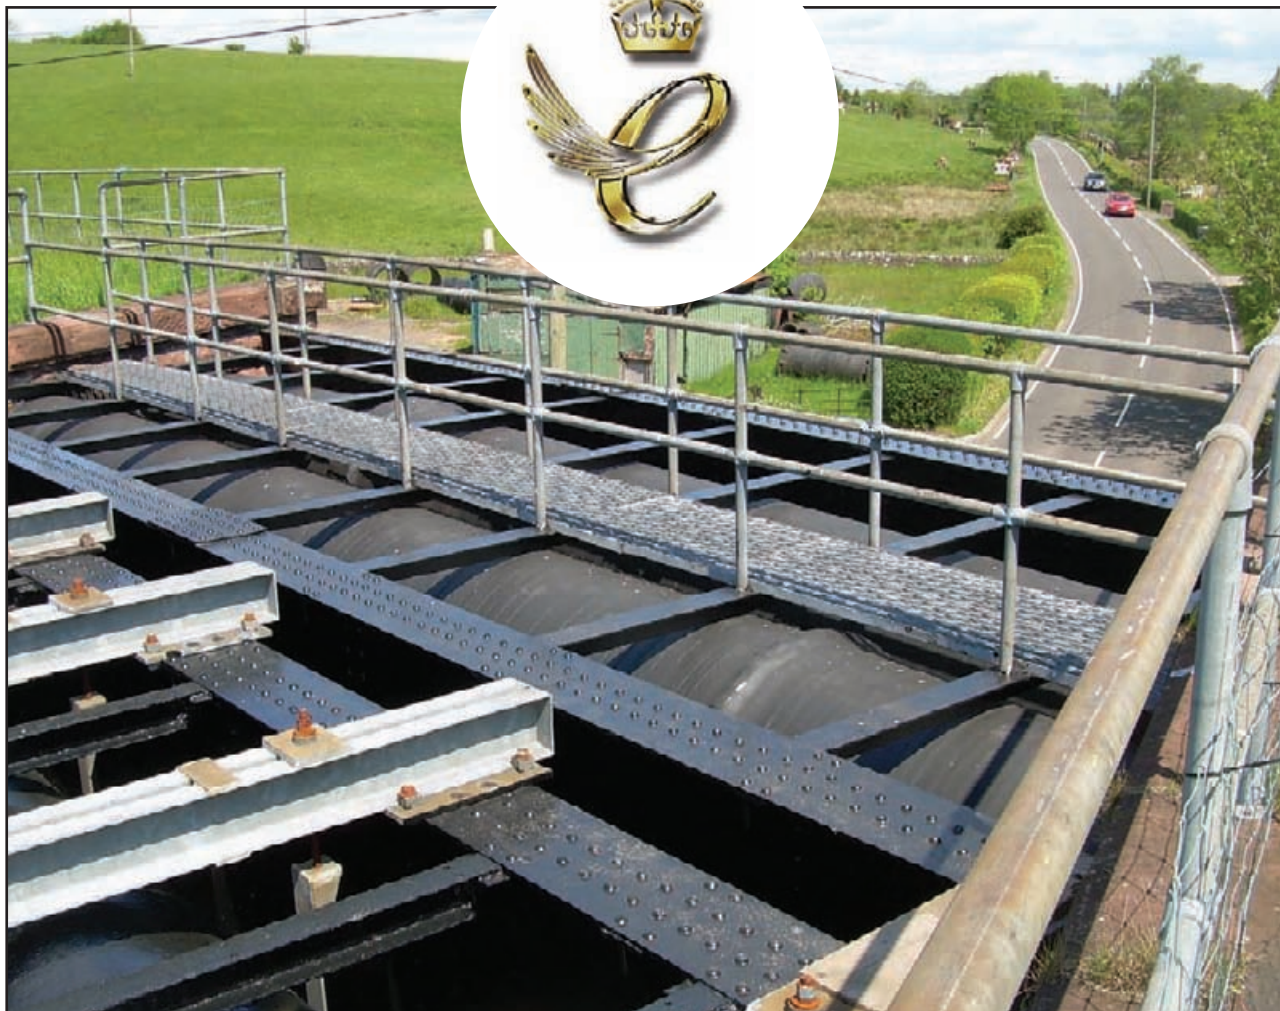
Aqueduct protected with the Denso Steelcoat 400 System, Loch Katrine Scotland - see page 11,

The Denso Steelcoat 400 System was chosen to give long-life protection to the 48" diameter pipes used at three structures which were virtually reconstructed along the aqueduct system. These carry two twin pipeline sections conveying 450 million litres of water per day to 1.3 million people.

Subcontractor Interserve carried out the Denso Steelcoat application comprising a coat of Denso Hi-Tack Primer followed by Denso Hi-Tack Tape overwrapped with Denso Ultraseal Tape. The system was completed with a coat of Denso Acrylic Topcoat.

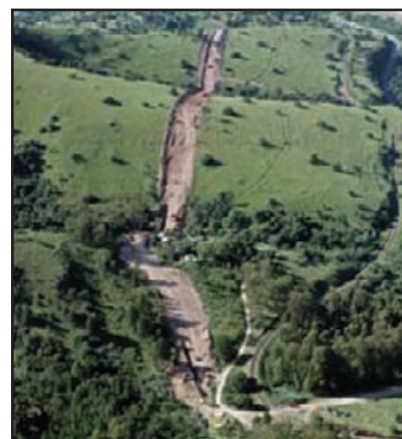
Arial view of the Western Aqueduct Project.

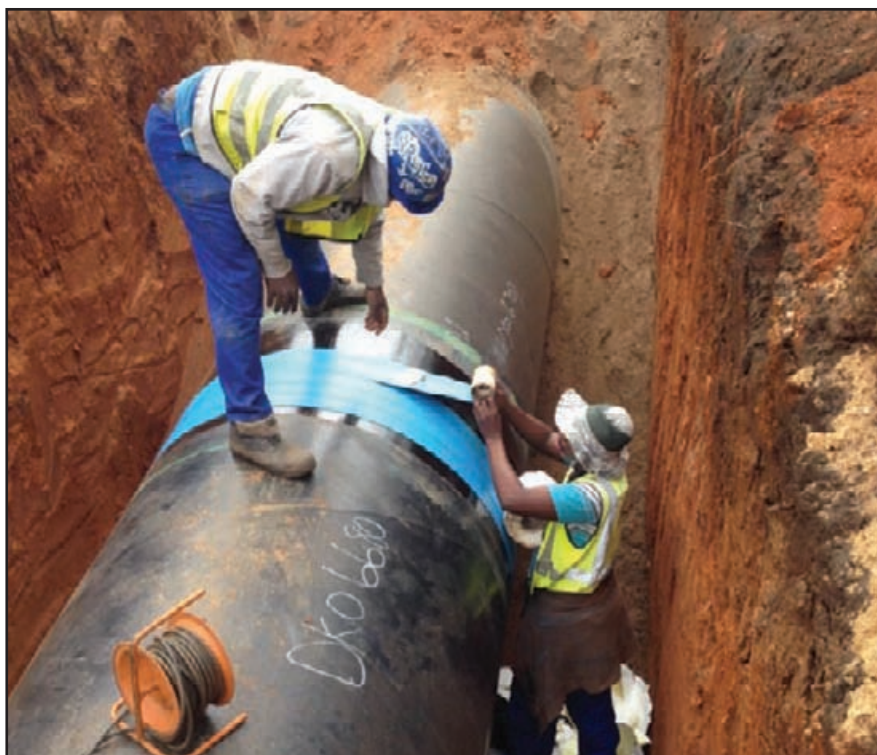
After application of Denso Primer D the joints are overwrapped with Denso Ultraflex 1250 Tape.

The Denso Weldbead and Ultraflex 1250 Tape is being used to protect the external welded joint. A mechanical clean to ST2 is required before the application of Denso Primer D, Denso Weldbead Tape and the Denso Ultraflex 1250 Tape.

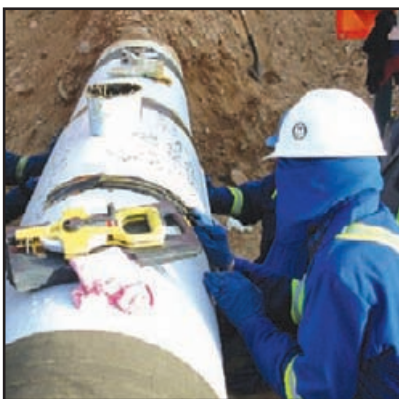
Fig 2. The Denso coatings are applied.

Denso Protal 7125 and the Denso Interface Coating System are widely used in pipeline maintenance because these products can essentially be applied to cold pipe, down to minus 20 Celsius for the 7125 and potentially colder for the Interface Coating System which is comprised of Denso Paste, Denso LT Tape, (possibly Denso Profiling Mastic) and Denso Glass Outerwrap.

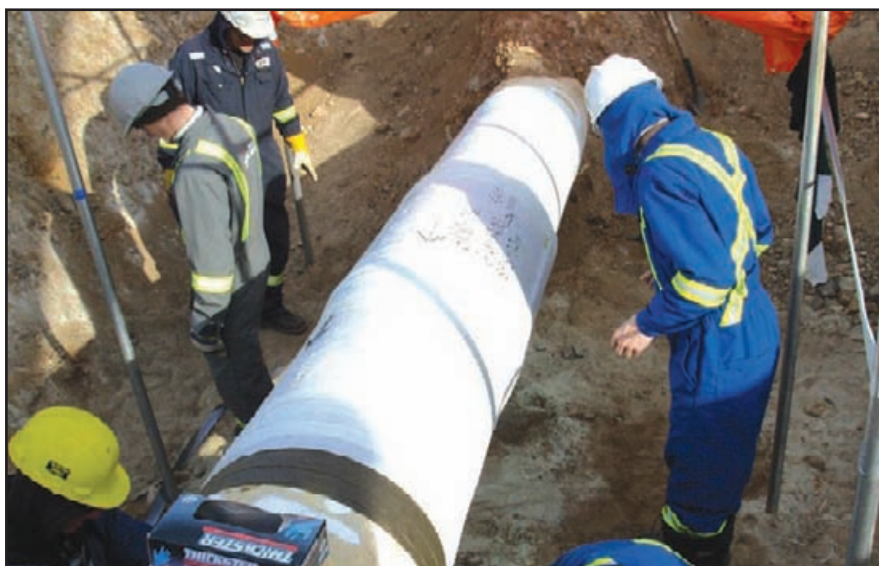
Fig 3. The repaired section is complete.

Coating ties the newly applied 7125 back into the existing line coating which in this case is PE (see figure 3).

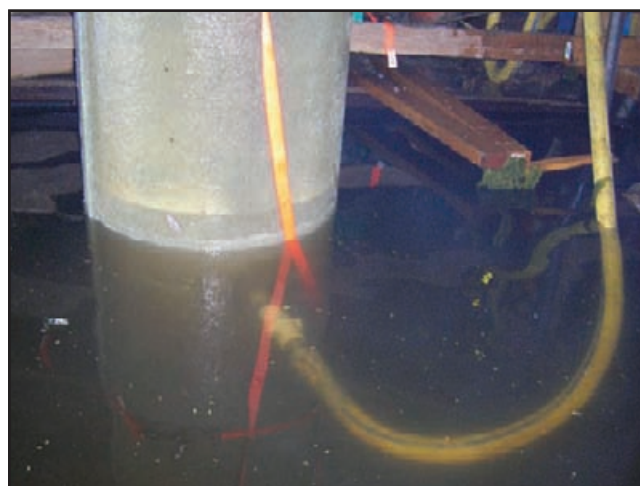
The SeaShield 550 Grout is pumped into the SeaShield 500 forms.

The SeaShield Series 500 forms were taken by boat and barge out onto the river and affixed to specifically identified damaged piles. One of the piles was almost too badly crushed to affix the rebar cage and jacket around, but it was finally secured and pumped full of SeaShield 550 Epoxy Grout.

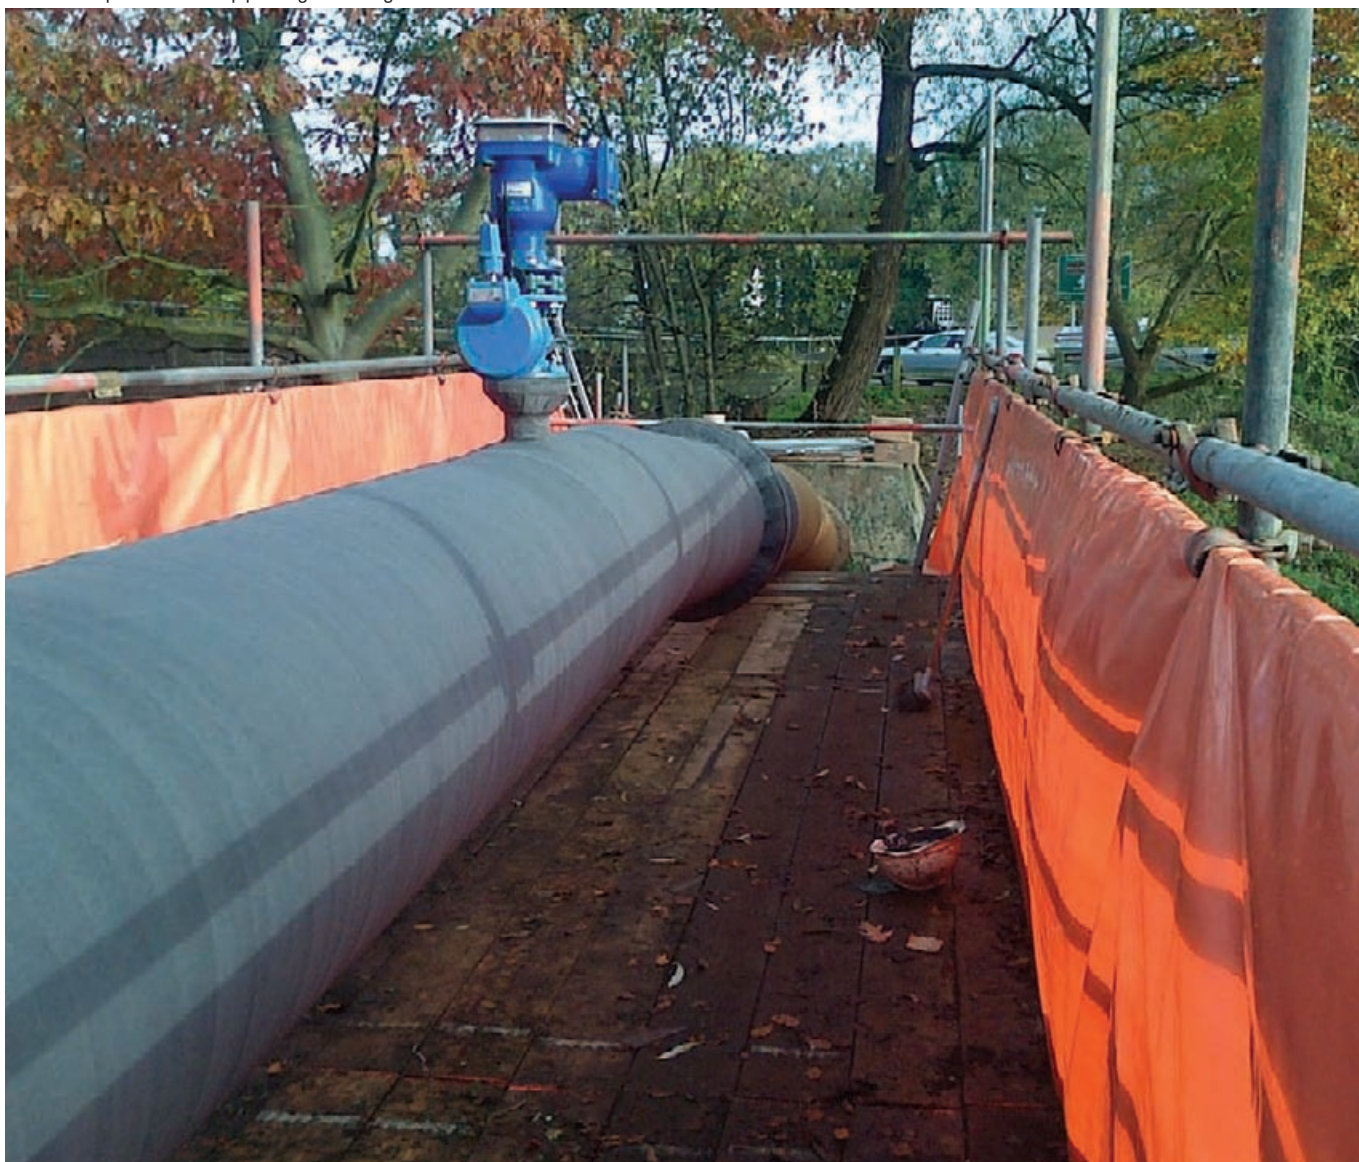
The Denso protected 30m pipebridge crossing the River Stour.

wire brushes and emery cloth, the 30 metre water pipe was protected with a combination of Denso Steelcoat 100 and 400 tape wrap systems. The structural steework supporting the pipebridge was protected with

the Steelcoat 700 System comprising two coats of Denso ST Epoxy followed by a coat of Denso Weathershield.

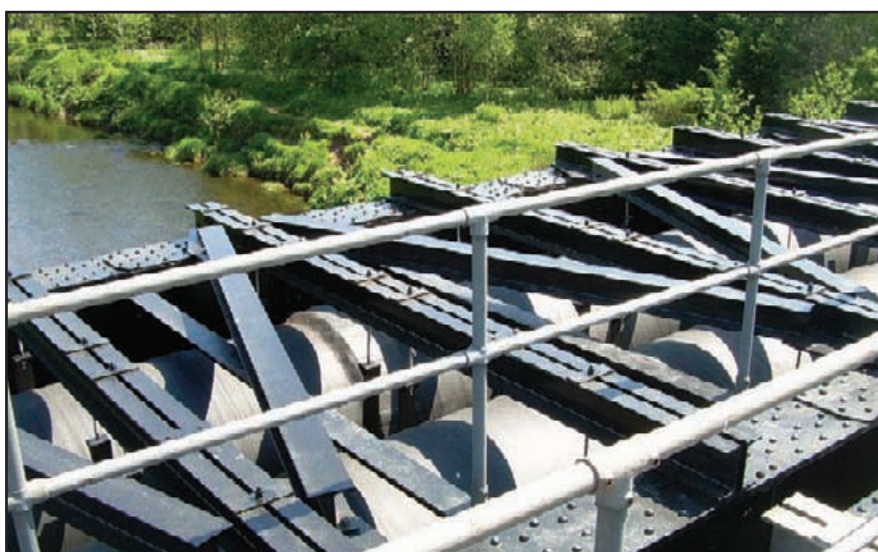
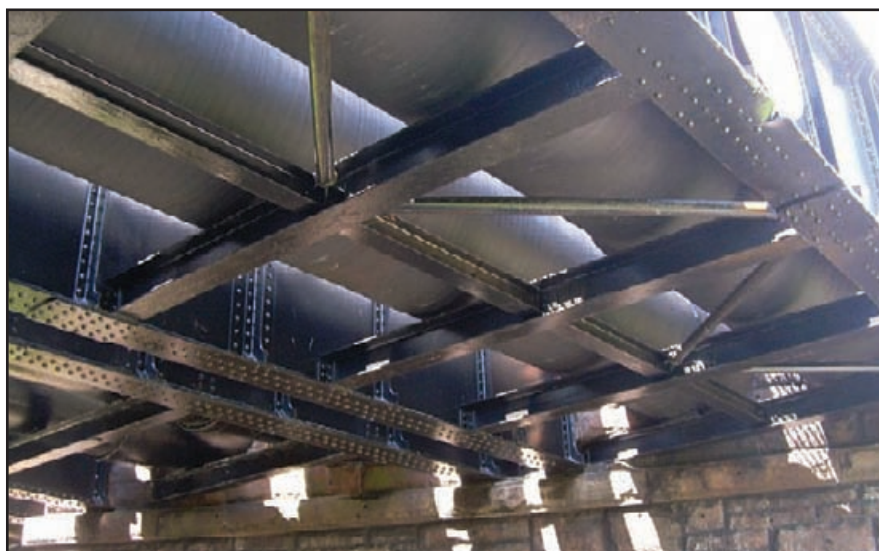
Photos:
Above and underneath view of one of the aqueducts.

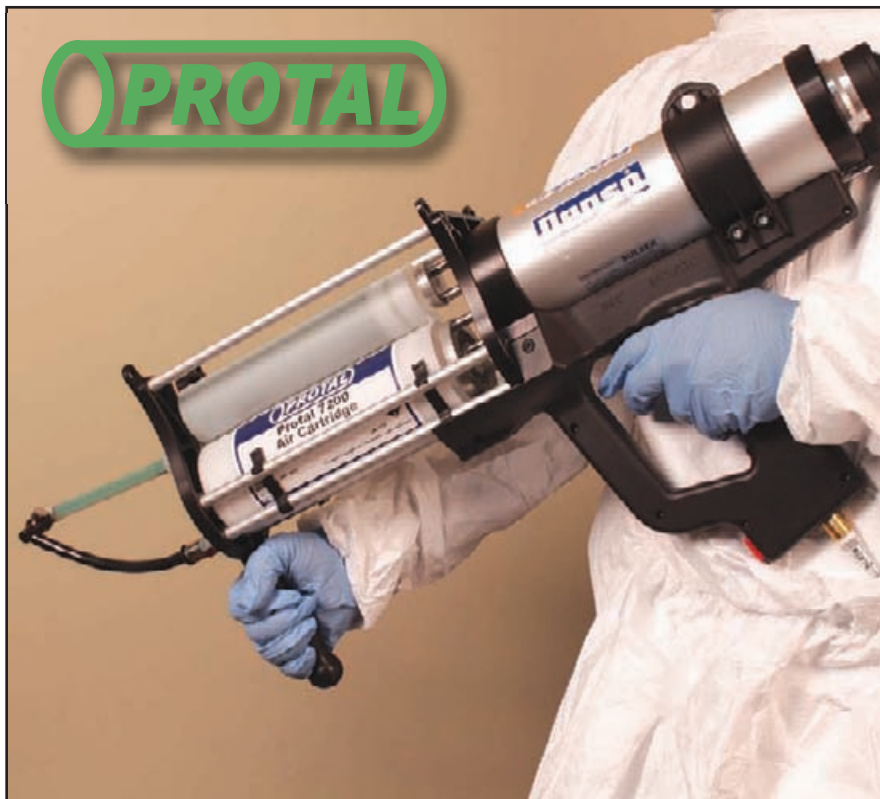
Above: The Protal 7200 Air Cartridge Gun.

The Protal Air Cartridge Gun was designed for use with fast and easy setup, minimal material waste and equipment maintenance. Functionality is much improved by controlling airflow and fluid pressure right at the fingertips to give more precise control. Additionally, the spray gun includes a swivel handle and optional shoulder strap to provide comfort for all day spraying if required.

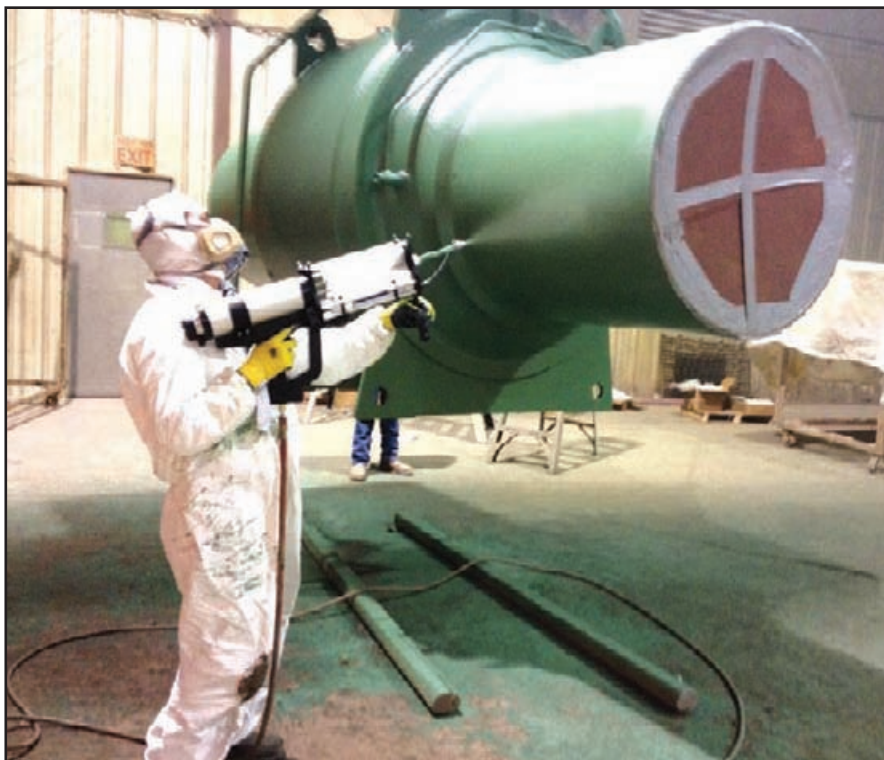
Left: Spray application of a 36" Ball Valve

First, the substrate to be coated was blasted to a near-white finish, SSPC-SP 10/NACE No. 2, while achieving a 2.5-5.0 mil anchor profile. The Protal 7200 Air Cartridge (1000ml) is heated in a 1000 watt microwave to approximately 120°F - 135°F (49°C - 57°C). Next the air mixing tip is tightened securely to the top of the air cartridge. The cartridge is then installed into the gun while connecting the quick-lock air coupling to the air mixing tip. The cartridge is purged slightly before proceeding with the spray application. Each cartridge is spray applied in approximately 1 minute and will cover approximately 15 sq. ft at 25-30 mils.

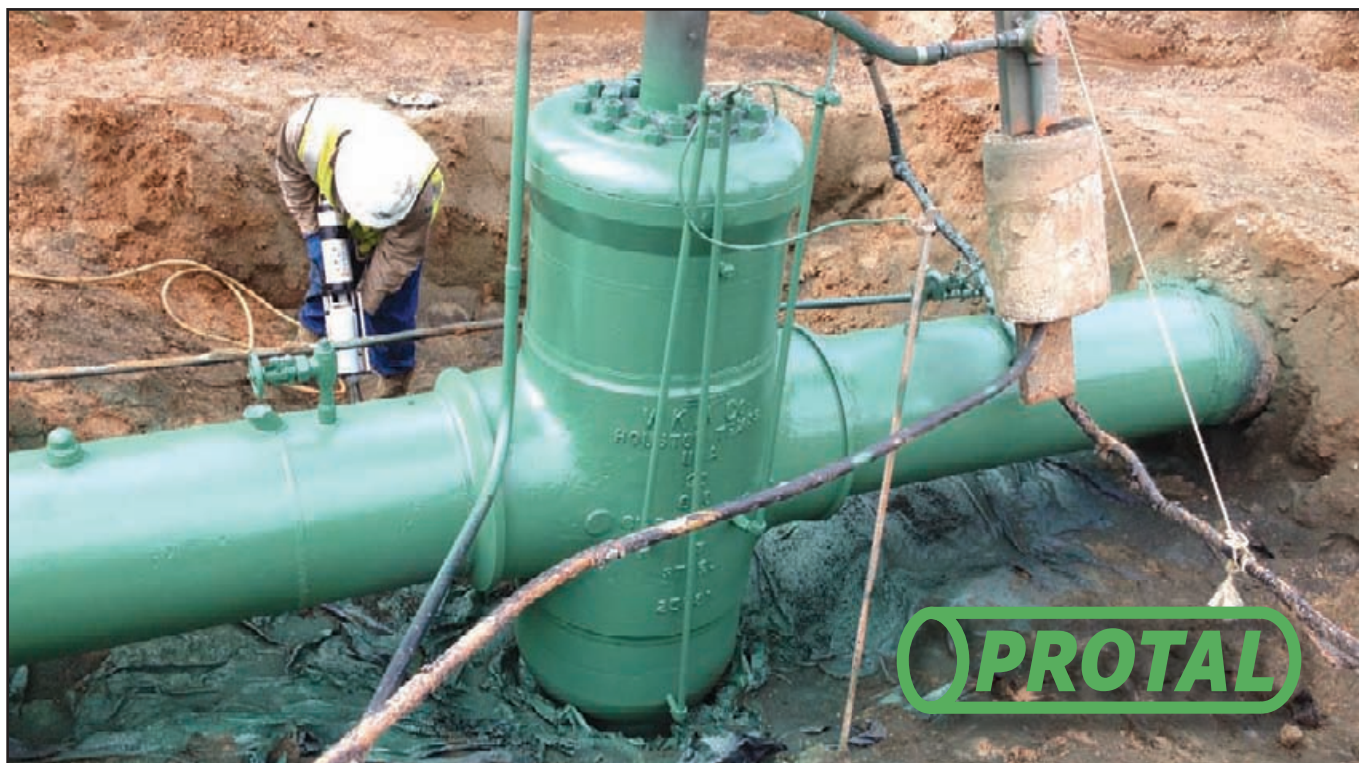
Above: Spray application of a 20" in service gate valve.

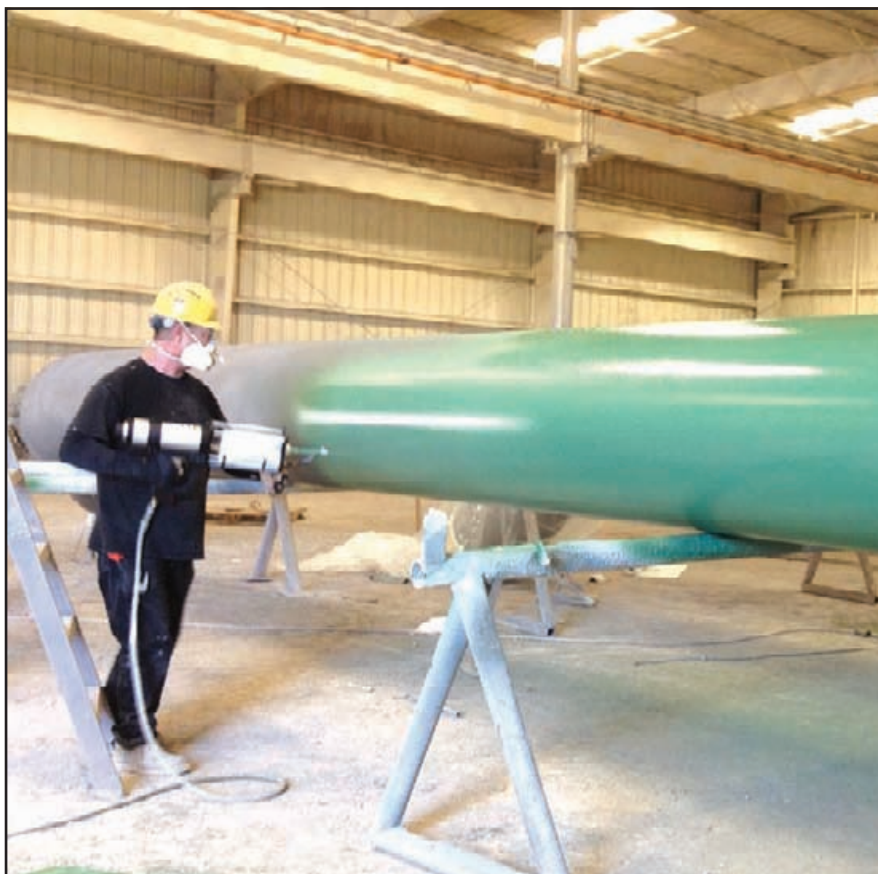
Right: Spray application of pipe.

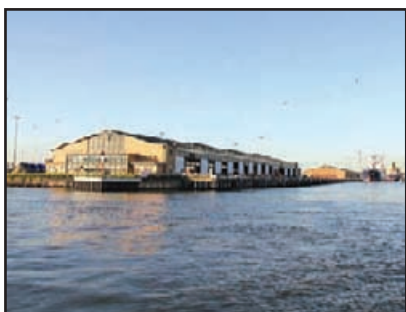
The Appleton Dock, Port of Melbourne.

The Appleton Dock Pile Rehabilitation Project at the Port of Melbourne was successfully tendered for by Denso (Australia) Pty Ltd and Professional Diving Services on reputation, project proposal and product selection.

The Denso SeaShield 400 & 70 Systems were the products of choice and specified by GHD for the rehabilitation of 1,200 timber piles ranging from 600mm diameter to 400mm in diameter. Protected pile lengths varied from 1.5 meters to 8 meters. The SeaShield materials used on this project comprised of 2,500 lineal meters of Denso fibre form jackets, 3,000sqm of Denso

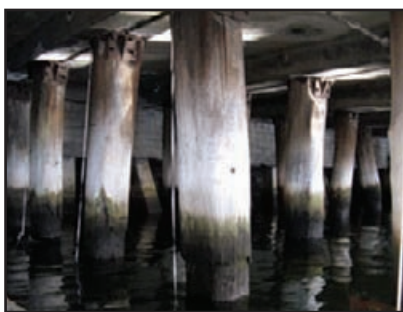
View of the timber piles beneath the dock.

The SeaShield 400 System uses Fibre Form Jackets which are filled with Denso 510 Grout.

C-Grid® 450, 27,000 bags of Denso 510 u/w grout (30 x 20ft shipping containers), 5,500 rolls of Denso Marine Piling Tape and 7,000 lineal meters of Denso Glass Outerwrap FX.

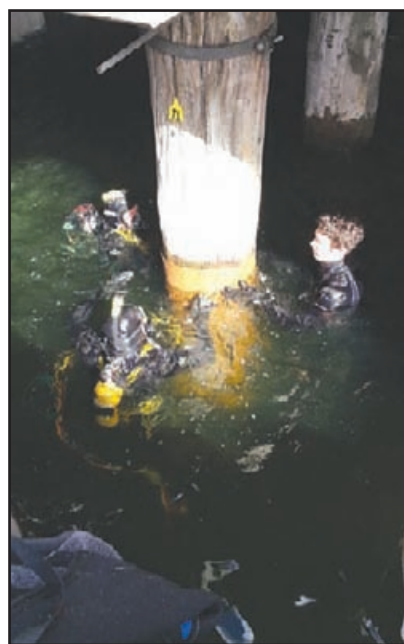
Above: Application of Denso Marine Piling Tape.

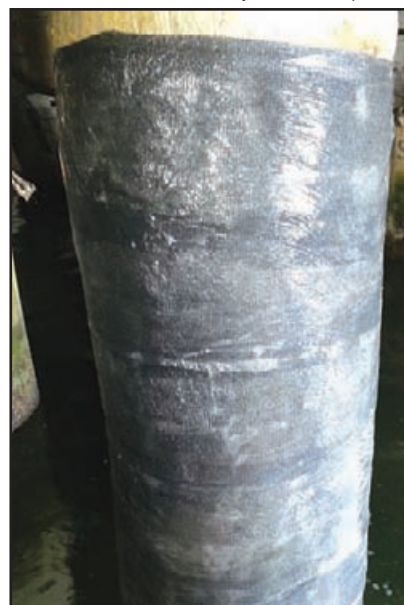
Below: The SeaShield 70 System is completed.

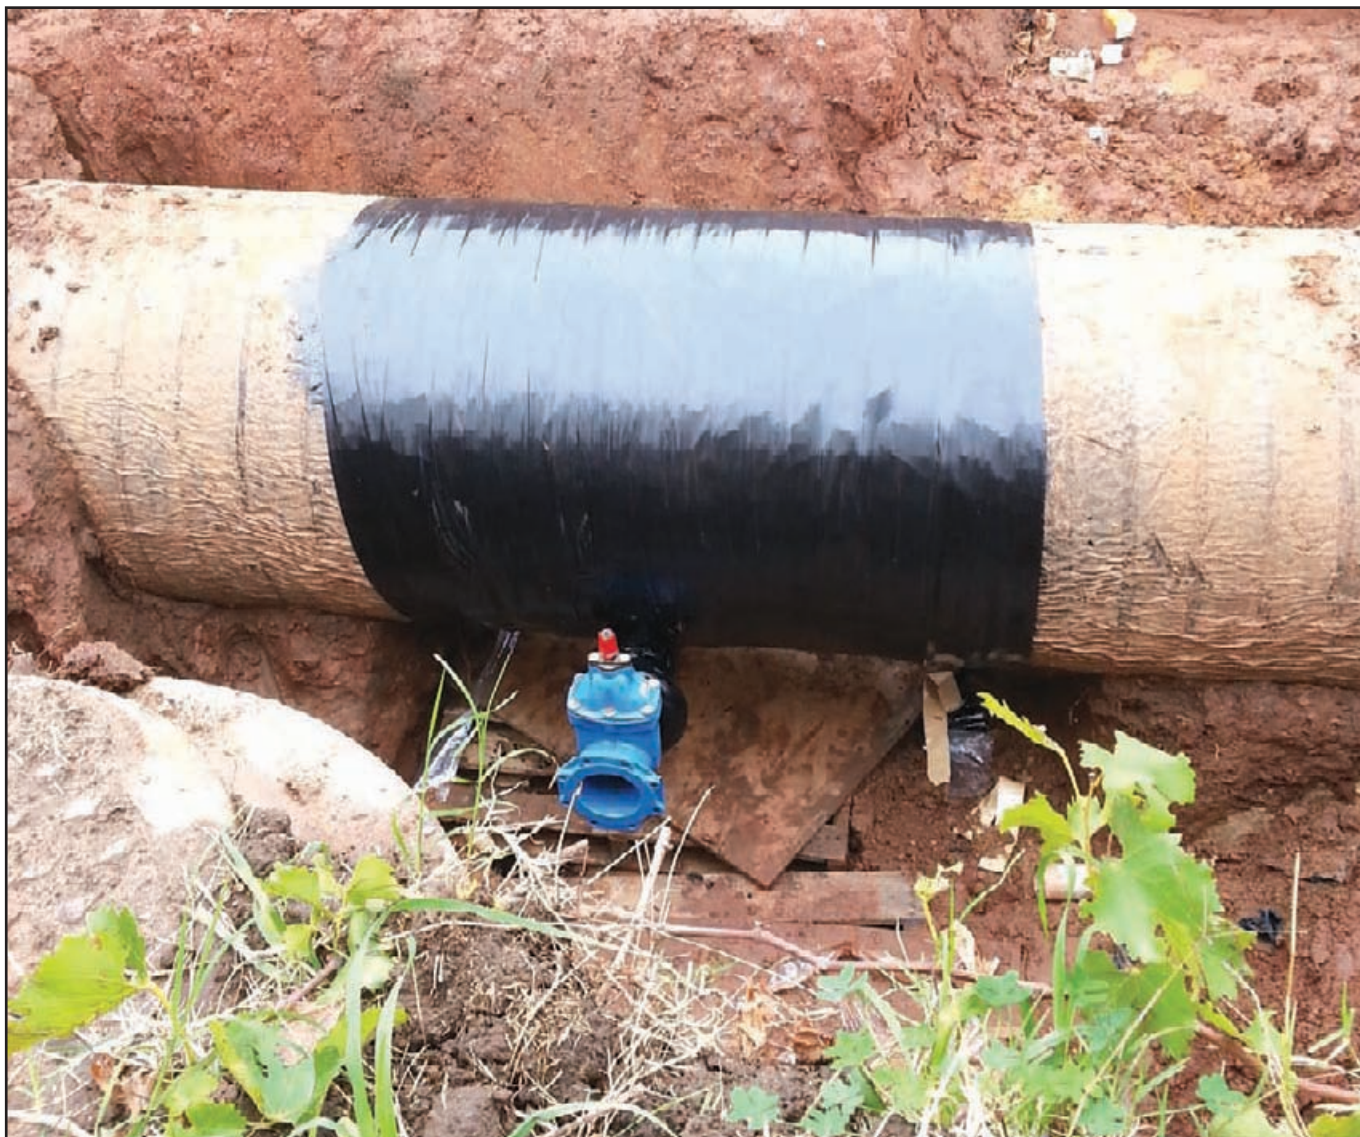
Densopol 60 Tape armoured with Denso PVC overwrap as per SA Water TS 81.

upgrade are Densopol 60 with PVC overwrap as per SA Water TS 81 for the main pipework and the Petrolatum system as per SA Water TS 29 for the flanges and new hydrant and risers.

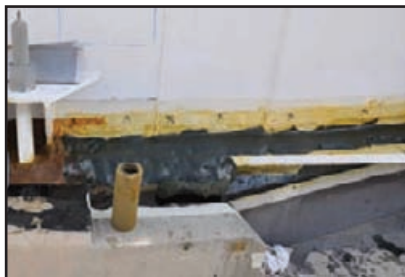
Applying the Denso Hi-Tack Primer.

Denso have developed an effective solution to this problem called the Denso Steelcoat Tank Base Protection System. The system seals the vulnerable area with a flexible but tough outer-armouring which is also highly weather resistant.

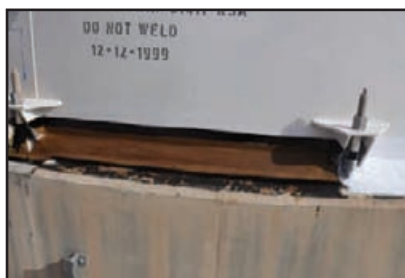
Applying Denso Primer D.

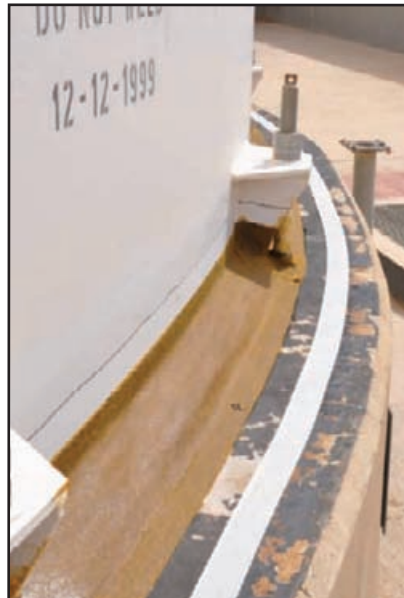
Applying the Denso Hi-Tack Tape.

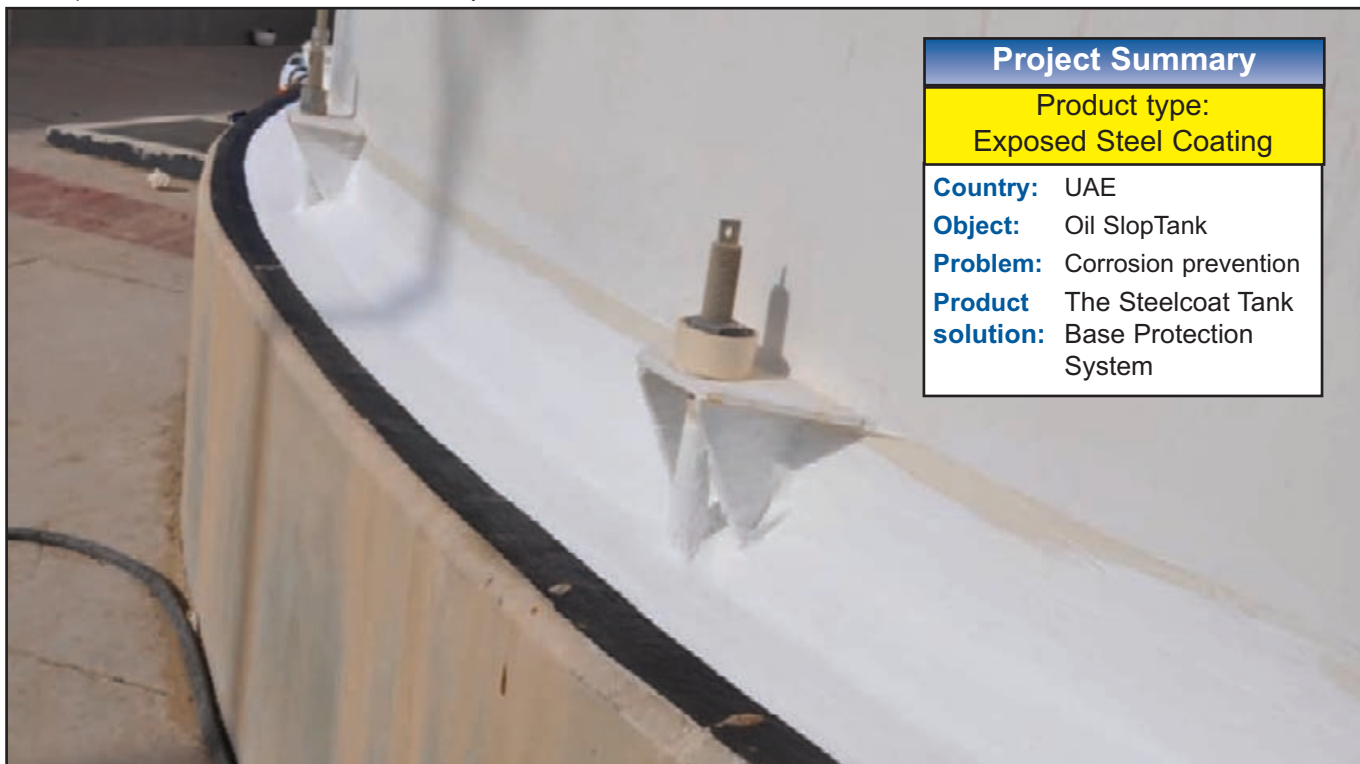
The completed Denso Steelcoat Tank Base Protection System.

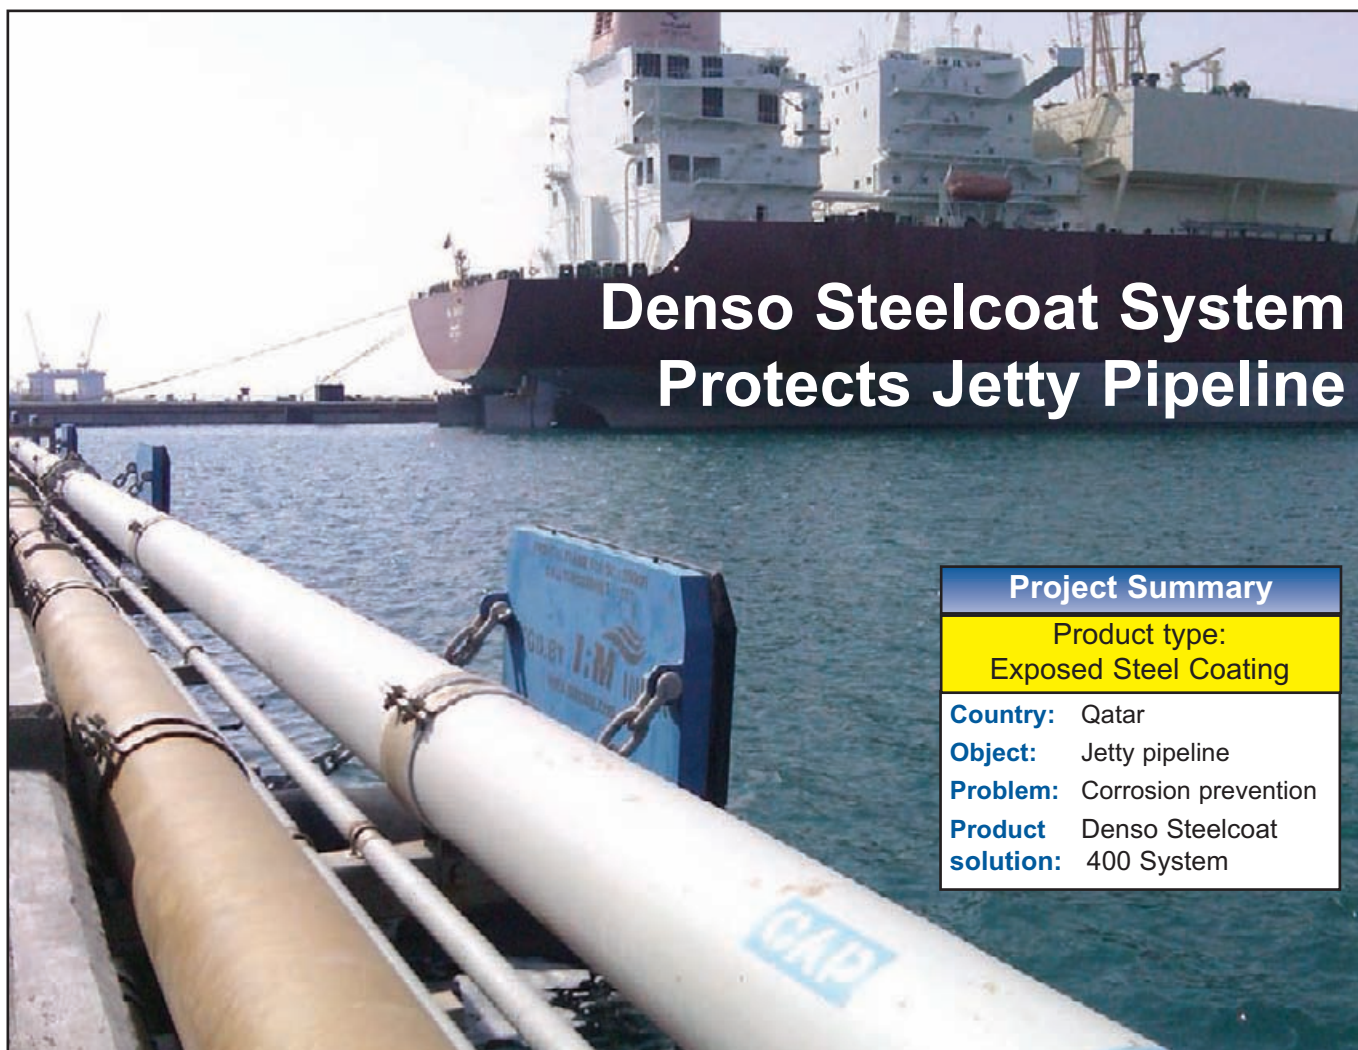
The pictures show different stages of the application of the Denso Steelcoat 400 System

The Denso Steelcoat 400 System designed especially for the elevated temperatures found in the Middle East was successfully utilised for the protection of 2 No. 2 inch diameter pipes 9km in length one carrying oxygen and the other acetylene located on the quay/pier in a Qatar Port as shown in the photos.

Due to the very harsh environmental conditions the project consultant decided that the best solution for the long-term protection of the pipes was the Denso system. The modified system comprises a coat of Denso Paste overwrapped with Densyl Tape with a 55% overlap. This was then followed with Denso Ultraseal RT Tape with a 55% overlap which was then coated with two coats of white Denso Acrylic Topcoat.

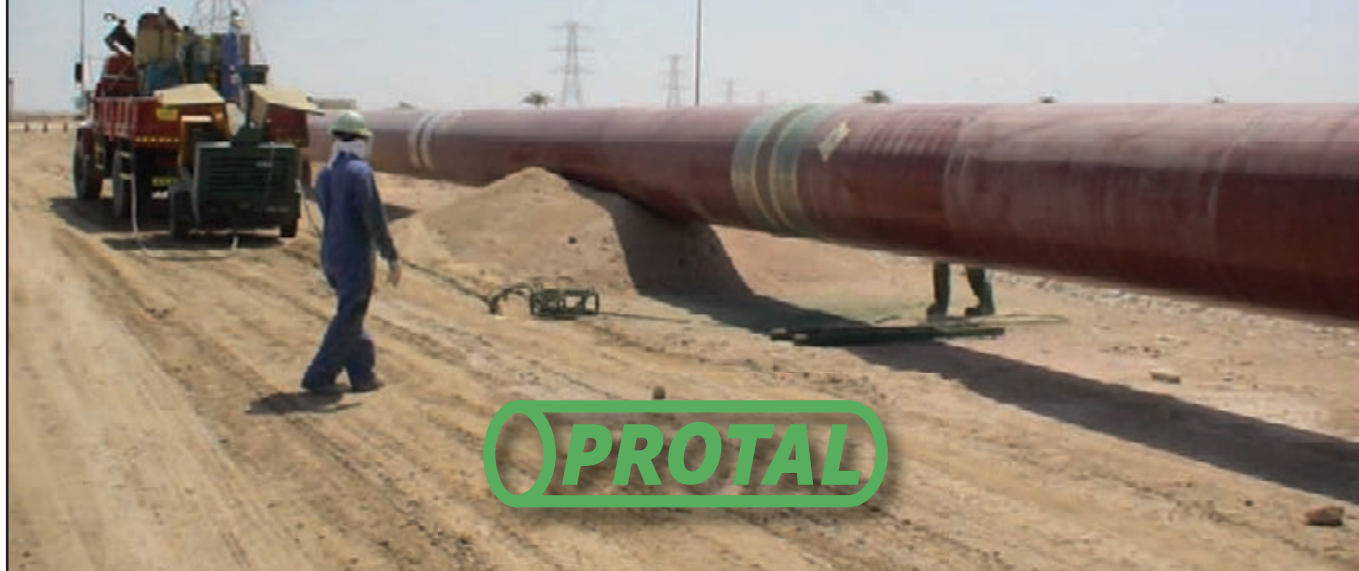
Above: The construction of the 48 inch diameter liquid fuel pipeline.

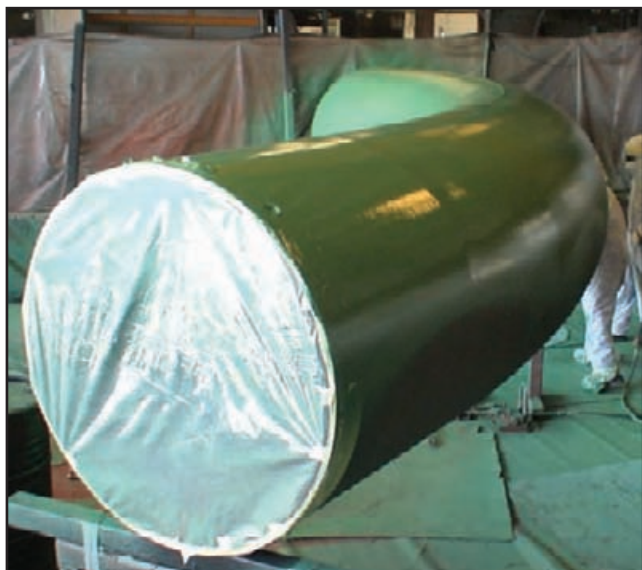
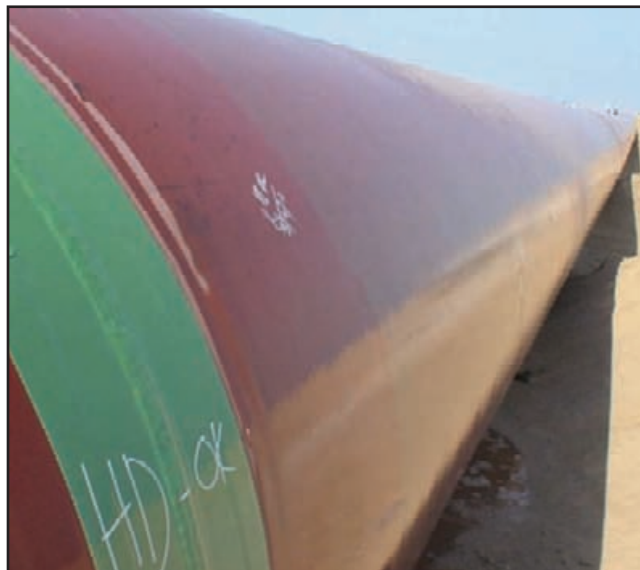
Below: Pipe bends and girth welds coated with Protal 7200

During 2013 Denso supplied approximately 11,000 Litres of Denso Protal 7200 which has been successfully utilized for the protection of the pipe girth weld joints and pipe bends on a 48 inch diameter liquid fuel pipeline. The pipeline transports gas from a port to a Power Plant.

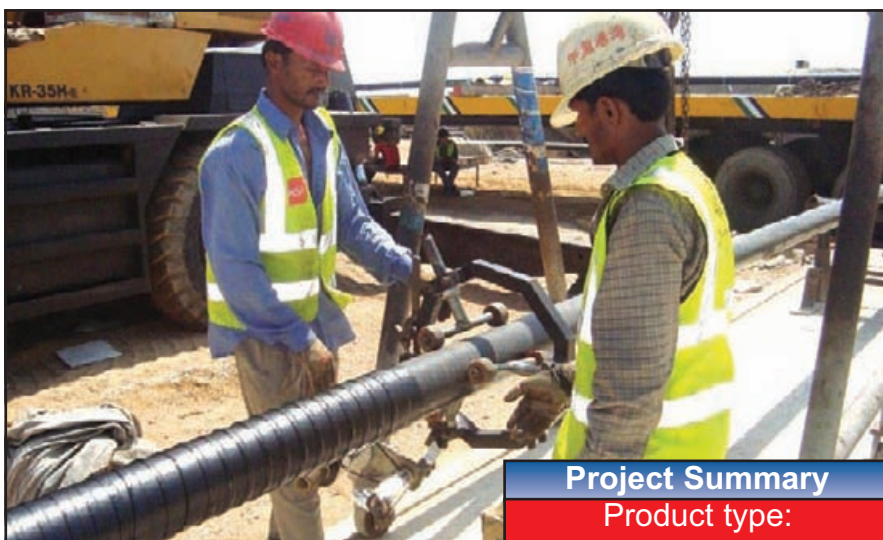
Machine wrapping the tie rods with Densopol 60HT Tape.

This project called for a large quantity of Denso materials and the system specified comprised Densopol 60HT Tape, with the large tie rod joints contoured with Densyl Mastic and overwrapped with Denso Self-Adhesive PVC Tape.

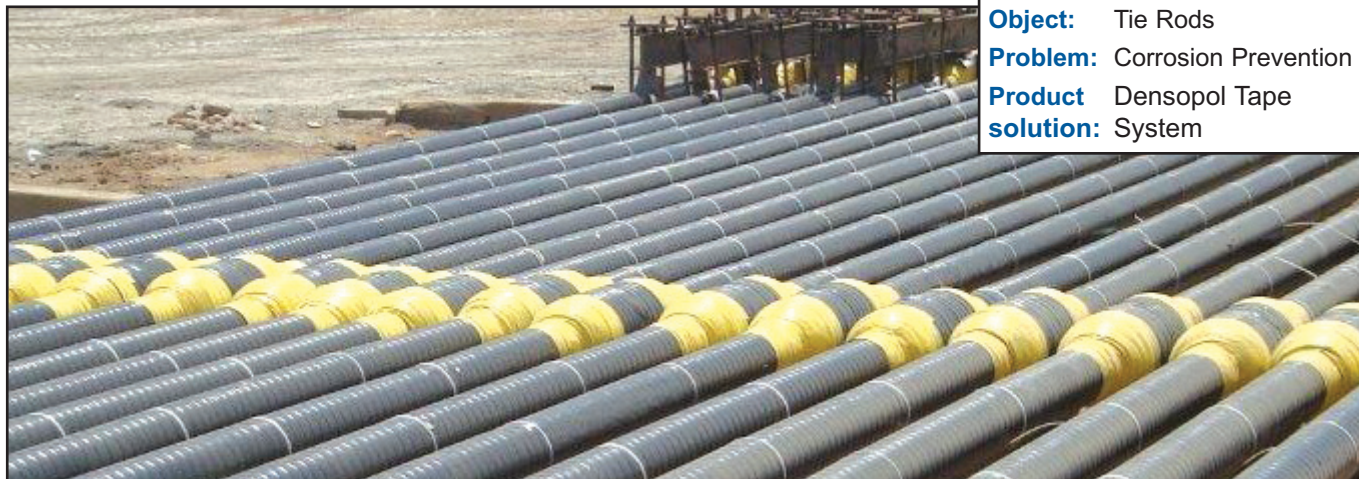
The Denso protected tie rods showing the articulated joints wrapped with yellow Denso Self-Adhesive PVC Tape.

As part of the tied bored pile quay wall design, the Denso protected tie rods were used to restrain a piled anchor beam that was positioned behind the quay wall. The anchor beam is supported by 1.6m diameter reinforced concrete piles, a design that has proven to have good earthquake resistance.
