BAYSIDE PHASE 2

CASE STUDY

Support Rods

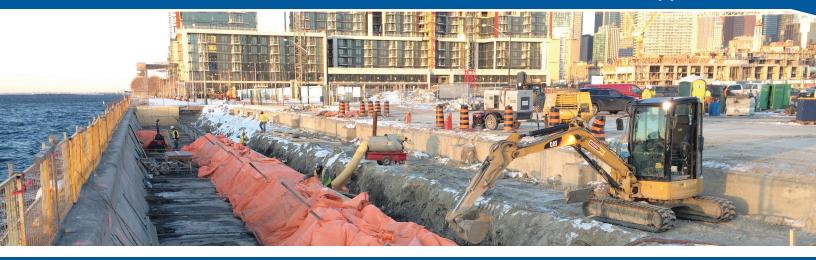
Support rod of the shoreline wall is exposed during the reconstruction phase.

A thin layer of Denso Primer is applied to the exposed substrate prior to the application of Denso Petrolatum Tape.

Denso Petrolatum Tape is spirally wrapped, with a 55% overlap, to complete this corrosion protection system.

The Denso Petrolatum System was utilized to prevent corrosion and give peace of mind to the city. The shoreline wall rods were coated with Denso Paste by hand. This primer will displace moisture, arrest existing corrosion and aid in the adhesion of the Denso Petrolatum Tape, which was spirally wrapped with a 55% overlap around the rods. These rods, with the Denso Petrolatum Tape System, will also be encapsulated in conduits and then in concrete blocks that in turn will be buried and remain under the multi-million dollar landscaping and pathways that will intersect the lakefront.
