### Project Data

<b>Location</b>	Tupman, California
<b>Completed</b>	2017
<b>Project Type</b>	Hot Pipe Coating
<b>Products / Systems Used</b>	Archco™ 453HT
<b>Contractor or Applied By</b>	Maintenance Personnel

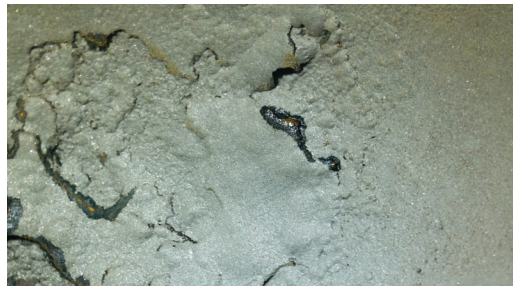
Severe corrosion and pitting was discovered when tape was removed, and the pipe was sand blasted.
