Location	Texas A&M University
Project Type	Test Program for Rehabilitation of Deteriorated Timber Piles Using the SeaShield Series 400 System
SeaShield™ Series 400 System Includes	SeaShield Fiber Form Jackets, SeaShield 510 UW Grout and C-GRID® 450 Carbon Fiber Grid

SeaShield Series 400

Structural repair system that doubles the strength of the original timber pile

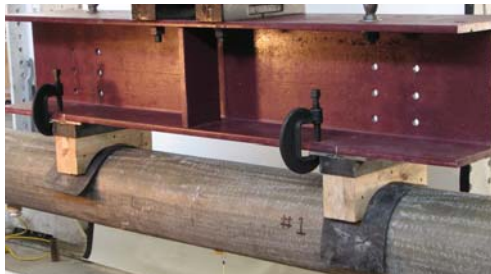
Bending test setup & actuator for the SeaShield Series 400.

Test Setup: Six each 8" diameter x 16' long timber piles were tested in bending using a four point bending setup. To simulate deterioration, five of the piles had an hourglass-shaped cut into them at mid-span. One specimen was left undamaged which was used as a baseline control specimen.

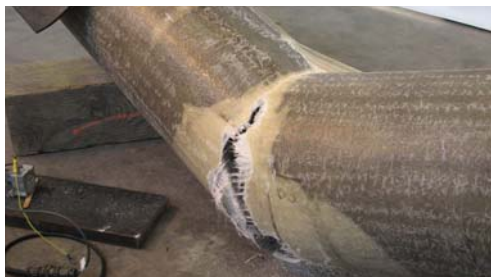
Completed bending test – all piles doubled in strength compared to the original unprotected piles.

Results: The results of the six pile bending tests proved that all repaired piles exceeded the bending strength of the baseline pile by at least double the maximum load achieved by the baseline pile.

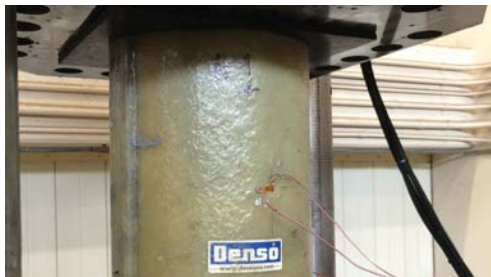
Compressive test setup.

Test Setup: Four each 8" diameter x 20" long timber piles with a fiberglass reinforced jackets, grout and carbon fiber grid. One specimen was a plain timber pile with no repairs and used as a baseline control pile. The objective was to evaluate the behavior of the repairs and quantify the additional compressive strength from the repairs vs. the baseline control specimen.

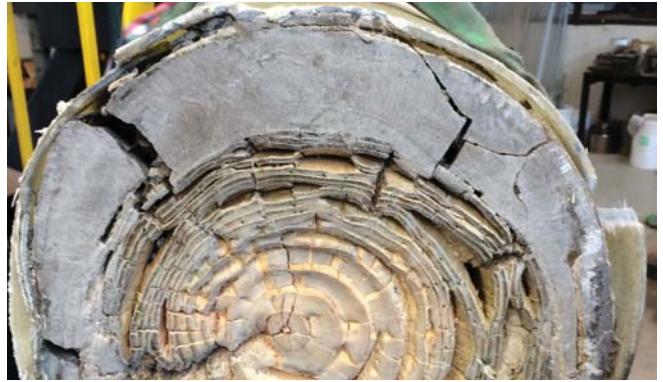
All specimens withstood 3 to 4 times the failure load of the baseline control specimen.

Results: The compressive failure loads of all four pile specimens were significantly higher compared to the baseline control specimen. The average increase in the axial compressive strength was approximately 240%. All specimens withstood 3 to 4 times the failure load of the baseline control specimen.

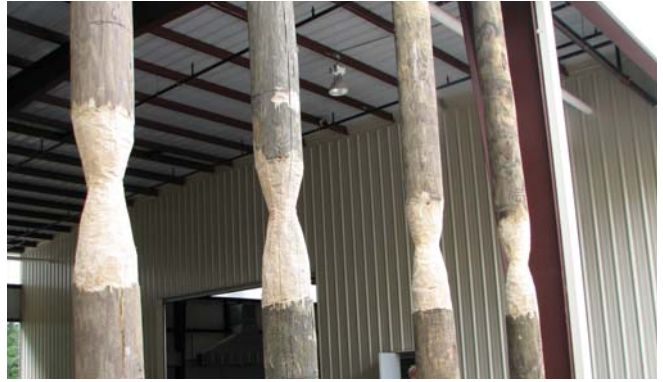
Simulated timber pile hourglass deterioration prior to having the SeaShield Series 400 System installed.

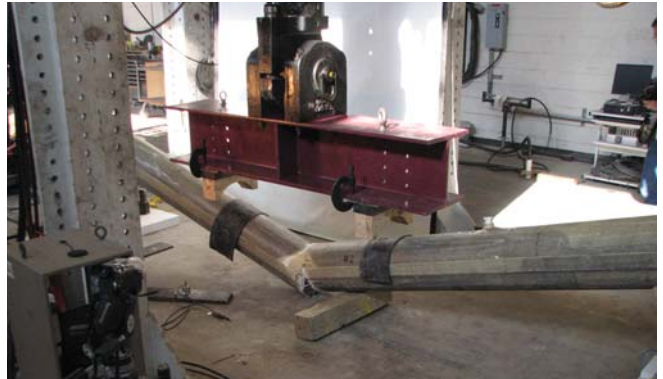
SeaShield Series 400 System at least doubles the maximum load than an undamaged, unprotected timber pile.

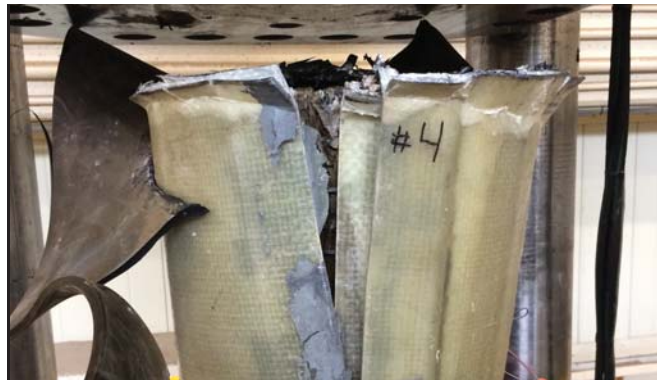
Timber piles installed with the SeaShield Series 400 System were able to withstand a maximum compressive pressure up to 466.6 kips.
