Project Data

Completion	2019
Project Type	Desalination Plant Protection
Products Used	Denso CoverCoat System™ - Denso Hi-Tack Primer™ / Denso Profiling Mastic™ / Denso Hi-Tack™ Tape / Denso D14 Scrim™ / Denso Basecoat™ / Archco 15™ Acrylic Topcoat
Contractor or Applied By	Maintenance Personnel

Project Details

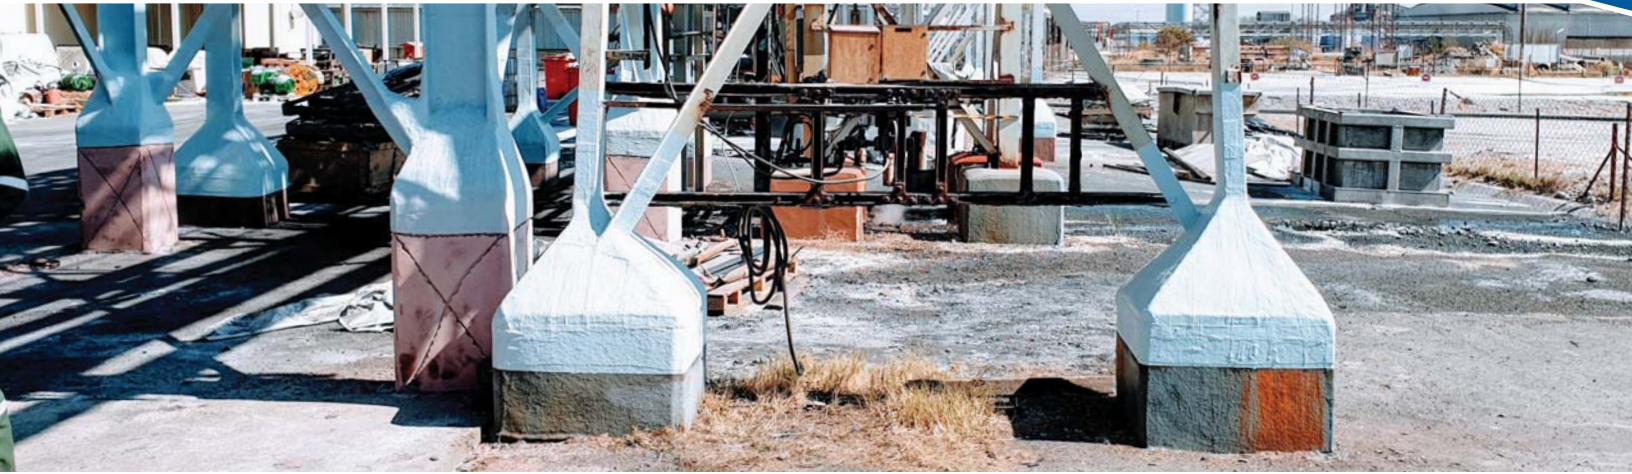
Figure 2: The surface of the structural steel one week after removing the system.

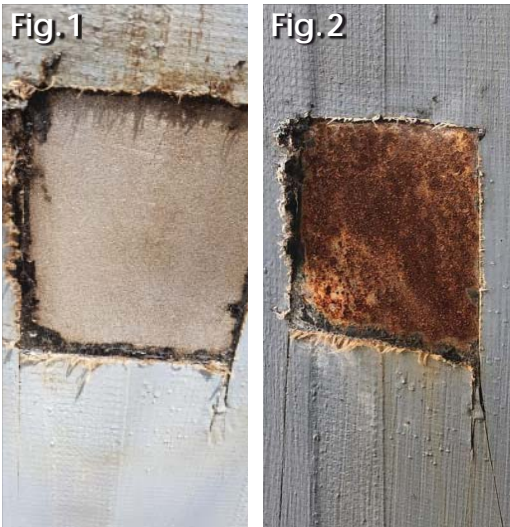
Figure 1: The surface of the structural steel immediately after removing the system that was in service for 12 months.

For this particular application the structural steel was blasted in order to better monitor the effectiveness of these systems over the course of 1 year. The structural steel column was protected by a thin coat of Denso Primer D, Denso Ultraseal Tape, Base coat, and Archco 15. The column base was protected by the Denso Hi-Tack Primer, Denso Hi-Tack Tape, Denso Profiling Mastic, D-14 Scrim, Base coat, and Archco 15. After one year each system was removed to inspect the substrate which revealed both to be in pristine near white condition, even in the harshest of environments.

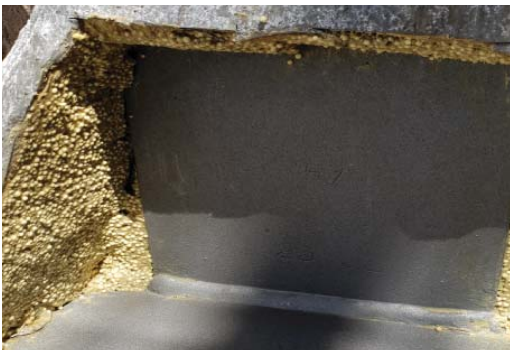
The surface of the structural steel column base immediately after removing the system that was in service for 12 months.
