### Project Data

<b>Location</b>	Houston TX
<b>Completed</b>	2017
<b>Project Type</b>	Seal Heavily Pitted Floor from Ring Out with Holidays.
<b>Products / Systems Used</b>	Archco™ 401

### Project Details

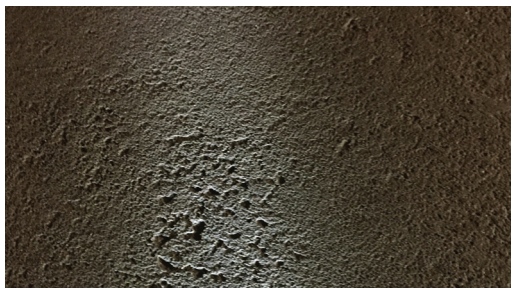
Heavy pitted floor.

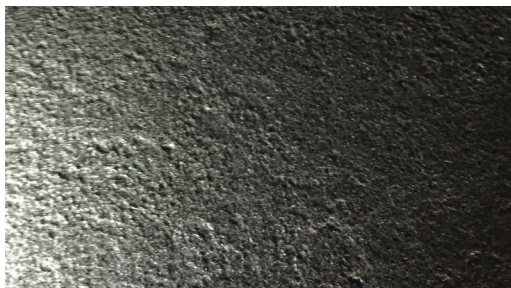
Heavy pitted floor with 401 sealer.

By using the 401 sealer, designed to have low viscosity, the coating would penetrate into the pit, and completely seal and fill the pit. Most viscous primers have a tendency to bridge over the pit. The trapped air in the pit keeps the coating from penetrating down to the bottom, and from sealing the pit. If the coating does not allow the air bubble to escape the pit, then the air is sealed over, which in turn allows the voltage of the holiday detector to penetrate through the coating film to the void and ring out as a holiday.

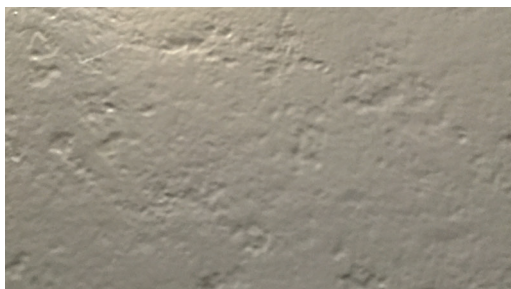
Heavy pitted floor with 401/476 pinhole free.

The major concern with the bottom of the pits not being sealed is when the tank is put back into service, moisture in the tank will permeate the coating film and fill the bottom with moisture, which in turn, creates a corrosion cell and penetrates through the steel plate, creating a leak. The 401 with the top coat will seal the steel surface, not allowing vapor to penetrate into the void and create a corrosion cell.
