OIL STORAGE TANK

CASE STUDY

Tank Lining Protection

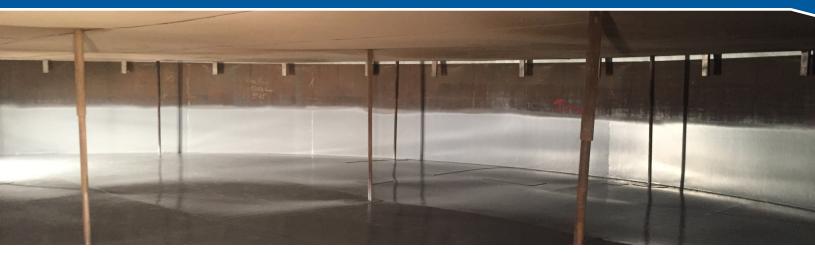
Archco 400 primer being applied to the blasted floor and side walls of the tank

Archco 476P sprayed applied over the primer to provide chemical and high temperature resistances.

Fully cured Archco 476P lining allowing the tank to return to service within 8 hours.

The internal tank floor and two feet up the sidewall were blasted to a near white finish (SSPC SP-10). The Archco 400 primer which is a two part epoxy with superior wet-out properties suitable for sealing heavily pitted floors, was easily sprayed with a single leg (68:1) airless spray unit. The following day the Archco 476P was applied using a plural component airless spray unit. This allowed for the tank to be returned to service very quickly (8 hours at 75°F / 23°C). The Archco 476P is a 100% solids, two-part, high-temperature resistant, epoxy phenolic-novolac system designed for internal tank linings. The owners can expect a service life of 20+ years with the Denso Archco Tank & Pipe Lining Systems.
