## RAILCAR BRIDGE

# **CASE STUDY**

### **Suspended Pipeline Protection**

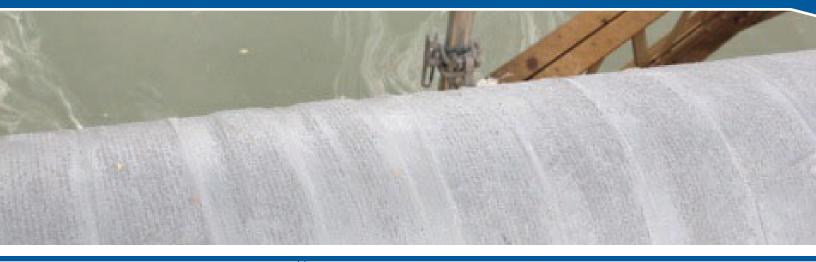
Oil pipeline suspended from a train rail bridge protected with Denso Petrolatum ColorTape.

DensoColor Tape is easy to install and requires no special training to apply.

Denso ColorTape was used as corrosion prevention measure as well as a lead encapsulation means.

Suspended from the lowerdeck of the bridge is an oilpipeline that was originally coated with a lead based paintthat had begun to flake off and subsequently fall into the pristine fresh-water river. The decision was made to use Denso ColorTape to overwrap the existing lead paint in order to encapsulate the pipeline and prevent any further lead contamination of the river, Denso Glass Outerwrap was used to mechanically strengthen the coating system in locations where the pipe was suspended by saddles.

Denso Tape was chosen because of its general properties, ease of installation and because of its resistance to ultra-violet rays. This coating system was also chosen because the surface preparation requirement is minimal and allowed the contractor to wrap the pipeline without abrasive blasting and therefore having to forego the immense and costly task of not only involving blast equipment and additional manpower but also structuring a ead containment system to be suspended under the bridge.

Fortunately the existing coating failure was in the very early stages so very little contamination ever entered the waterway. The work was accomplished by building a temporary scaffolding system that was suspended from the bridge allowing workers to access the full length of the pipeline crossing and successfully coat the pipe as the occasional train rattled across the upper deck of the bridge.
