# CASE STUDY

## SOUTH TEXAS TANK

## Tank Lining Protection

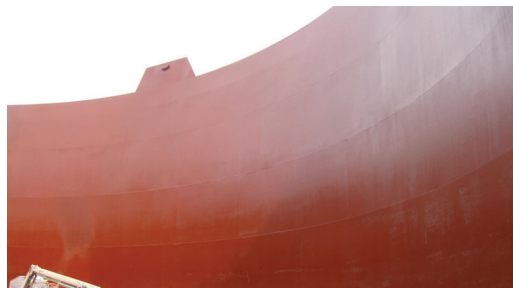
Open top tank, side walls primed with 400.

The project consisted of two open top/internal floater tanks with the sidewalls coated with Archco 400 high solids epoxy primer and then over coated with Archco 450, 100 % solids epoxy, glass flaked filled lining. All coatings were sprayed with a 68:1 single leg airless unit. The Archco 450 was sprayed at 25 to 30 mils in one coat. The coating was applied prior to the insulation of a new internal floating roof. The Archco 450 will give the tank the chemical resistance, plus the added benefit of the glass flaked filled lining to withstand the abrasion of the floating roof seal, rubbing up and down, as the tank is filled and emptied. The tank floor linings will be installed after the insulation of the floating roof using the Archco 450. The owners can expect 25+ years of internal corrosion protection from the Denso Archco Lining System.

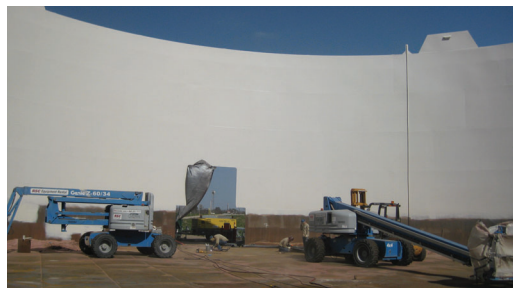
Open top tank, side was coated with 400 and 450 gray.

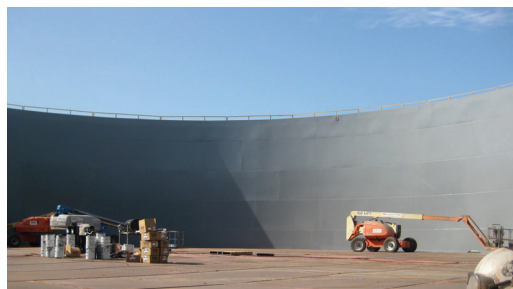
Open top tank, side was coated with 400 and 450 gray.
