Wedge Tower - 2016

CASE STUDY

Cooling Tower Protection

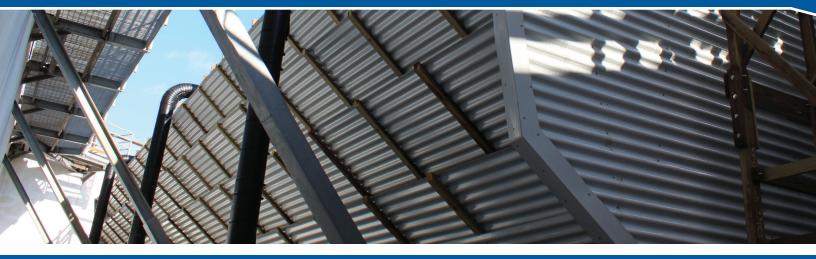
Piping protected with an HDPE Outerwrap and Smartband Strapping system.

Overview of the complete Denso corrosion protection system for cooling towers for pipes, valves and fittings.

Weathershield 15 brushed applied onto Densyl Tape protecting a valve flanged as a top coat.

After a short on-site training session with a Denso representative, the contractor MFR Fluid & Air was able to install the Denso Petrolatum Tape system quickly and easily much to their satisfaction. The scope of work consisted of minimal surface preparation (SSPC SP-2/SSPC SP-3), followed by the application of a thin layer of Denso Paste \$105, Densyl Tape with a 55% overlap, and a protective layer of HDPE Outerwrap with SmartBand Strapping. For irregular areas such as flanges and valves, the Denso Profiling Mastic was also applied to provide a smooth profile to tape over and then top coated with the Denso Weathershield 15 in place of the HDPE Outerwrap. Another successful application gave the developer and contractor confidence the life of their cooling tower piping will be extended while preventing corrosion for many years to come.
