Project Data

Location	Kenora, Ontario, Canada
Completion	2020
Project Type	Structural Repairs and Pile Protection
Products Used	SeaShield Series 2000HD™ System / LT Tape/ Glass Outerwrap
Contractor or Applied By	Dominion Divers

Project Details

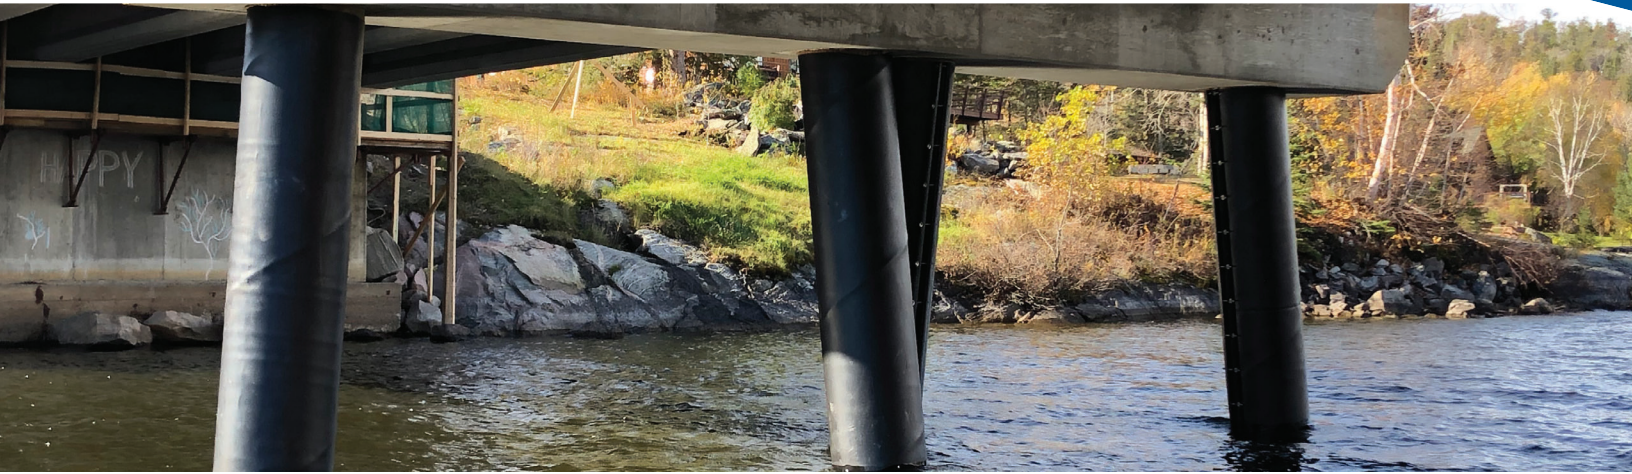
Cleaned steel pile below the waterline. Note the visible spiral weld. Installation of the LT tape and Glass Outerwrap at the structural cross-connection area.

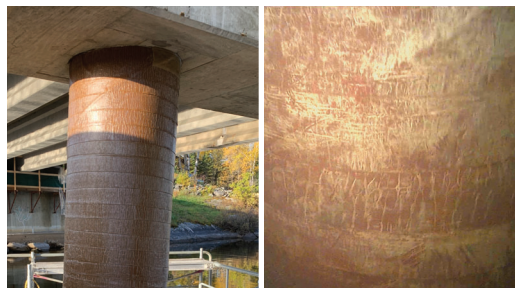
Installation of the Marine Piling Tape above and below water. Note the visibility of the spiral weld indicating a nice tight application of the tape.

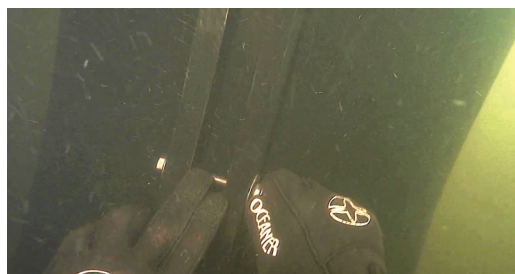
Installation of the HDPE outerjacket below water.
