Special
SeaShield Issue
Celebrating
50 Years
of Protecting
Marine Structures

DENSO DIGEST

Volume 36, Number 3

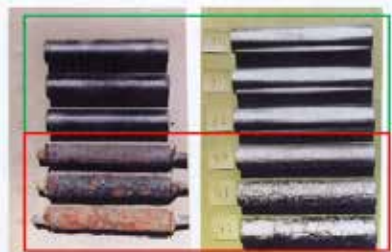
Testing - Japan

Picture showing samples after immersion for 30 months. The top 3 rows (green box) were protected with Petrolatum Tape (left side before cleaning, right side after cleaning). The bottom 3 rows (red box) were unprotected (left side before cleaning, right side after cleaning).

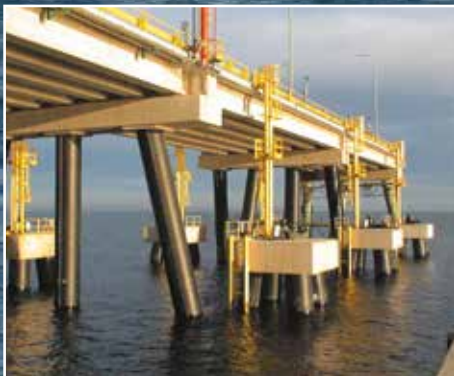
SeaShield System protecting jetty support piles - Libya.

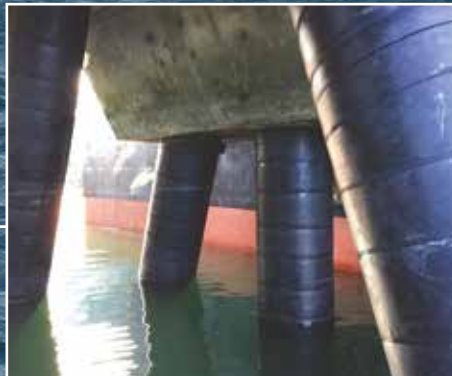
SeaShield System protecting wood pellet export facility support piles - Canada.

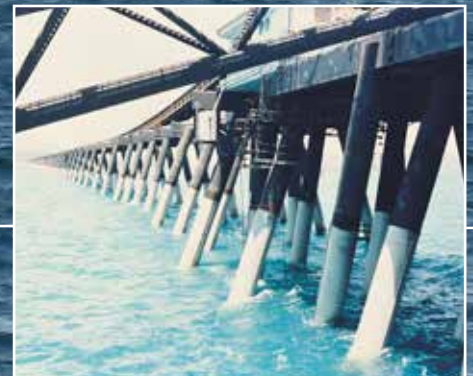
SeaShield System protecting coal loading jetty support piles - Australia.

Country:	Australia
Object:	Steel piles
Problem:	Corrosion Prevention
Product Solution:	SeaShield 2000FD™ System

Denso's SeaShield Series 2000FD™ system was selected as the preferred option for the long-term corrosion protection for DBI's marine assets following a rigorous evaluation process.

To-date, over 1000 piles have been protected with the SeaShield 2000FD System in this ongoing project.

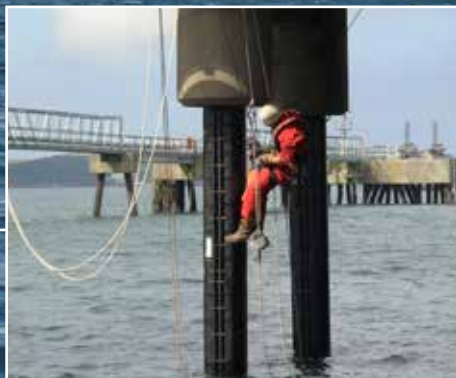
SeaShield System protecting loading jetty support piles - UK.

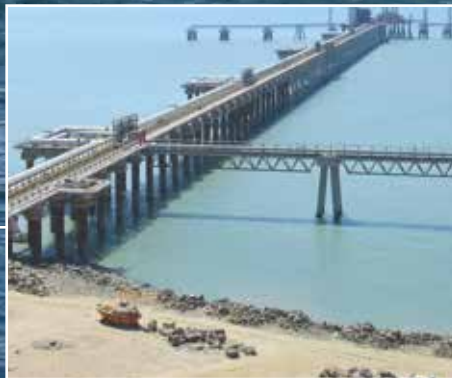
SeaShield System protecting LNG jetty support piles - India.

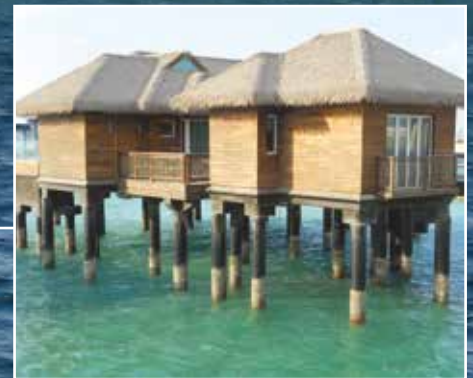
SeaShield System protecting holiday villa support piles - Qatar.

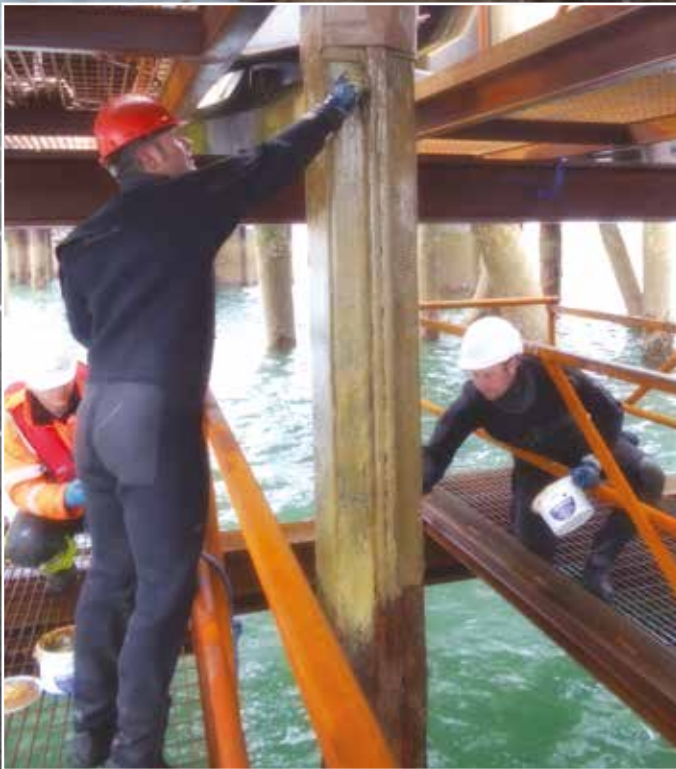
Applying the SeaShield Paste S105™ to a cleaned jetty pile.

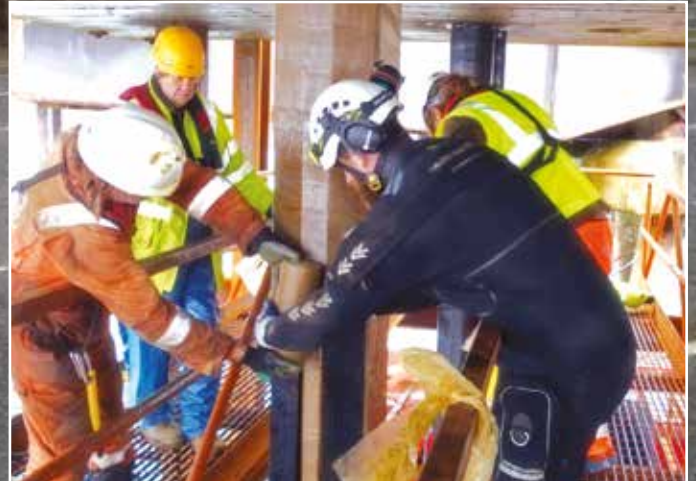
The application of SeaShield™ Marine Piling Tape.

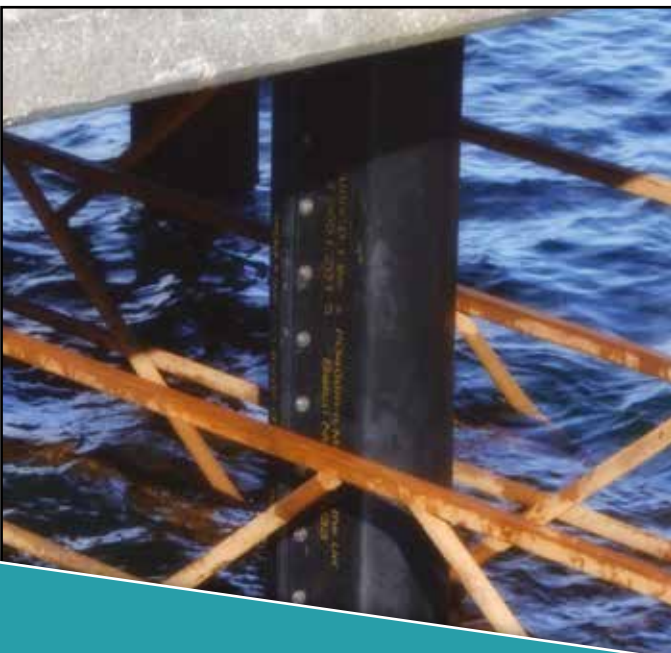
Below: The fitted SeaShield 2000FD™ Jacket completes the system.

Winn and Coales (Denso) Ltd proposed the use of the Denso SeaShield 2000FD™ System with additional fillet pieces to accommodate the awkward shape of the piles. The Denso SeaShield 2000FD system, which had been used on a similar application previously, provides long term corrosion prevention without the need for intensive surface preparation, thus providing an effective solution for use on the piles in their exposed environment.

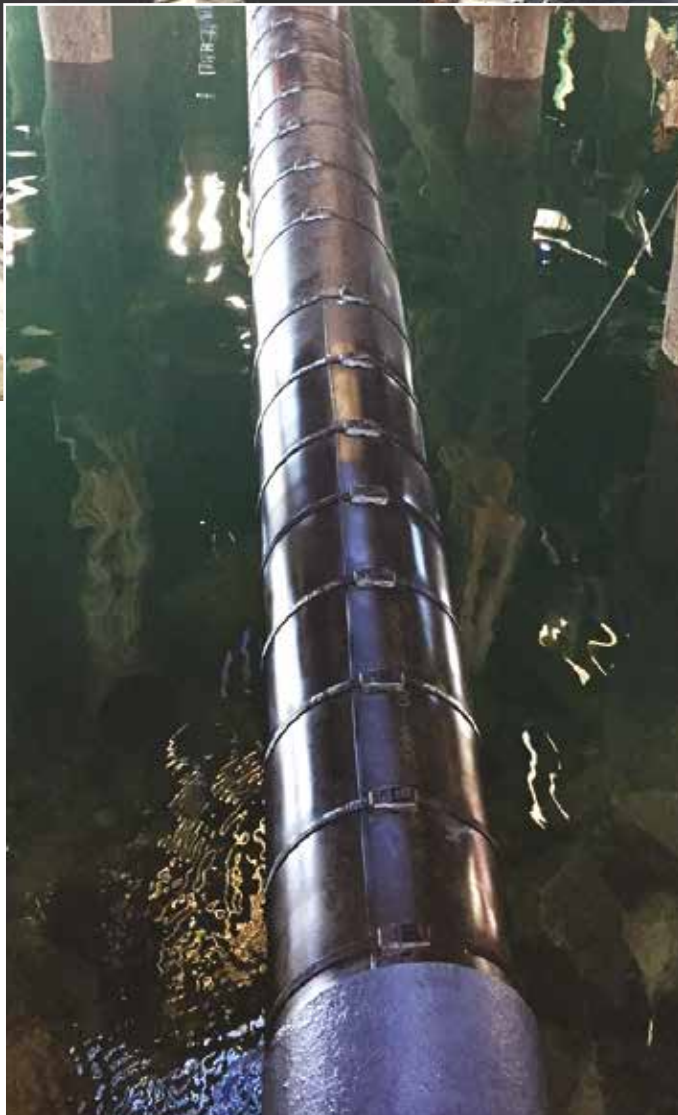
Above: SeaShield 2000FD™ protection for support piles on the new pier.

Sixteen support pipes on the old pier have been protected with SeaShield 100™ and nine SeaShield 2000 FD™ jackets have been applied on the new pier. The materials were applied on both piers using rope access.

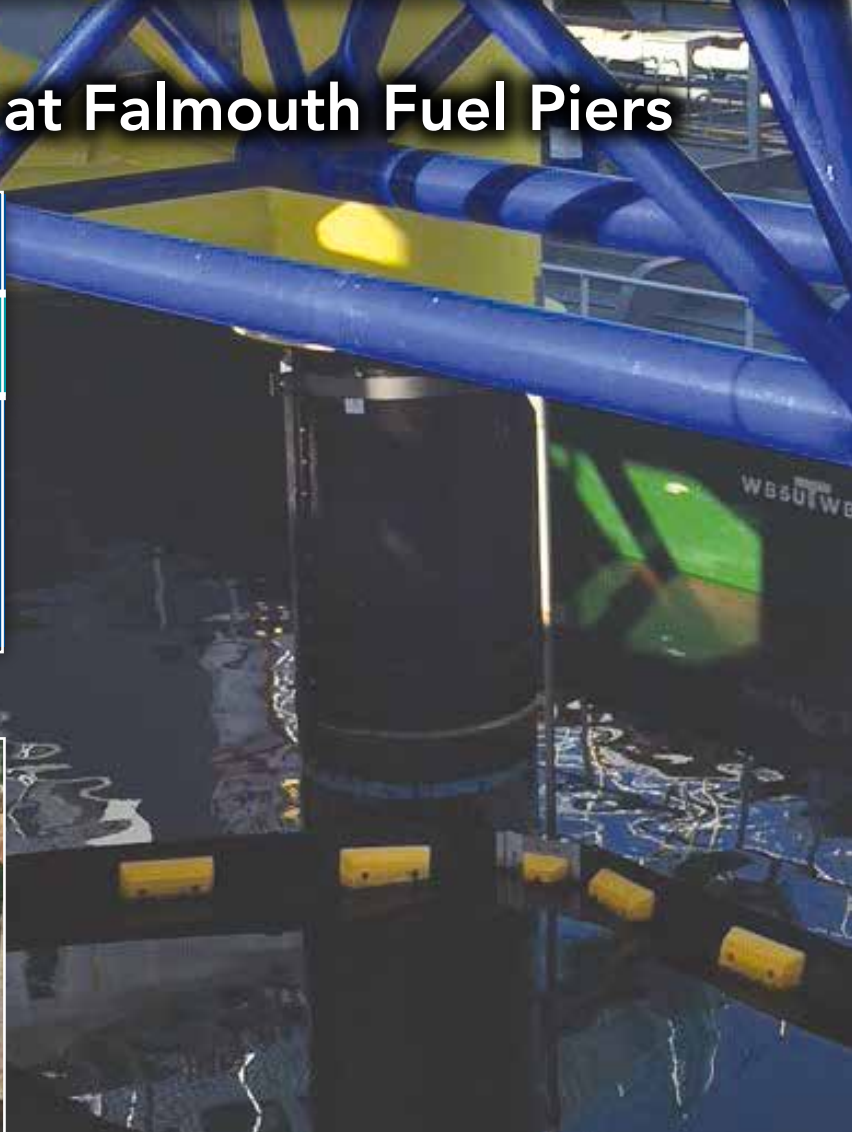
Opposite: SeaShield 100™ protection for pipework on the old pier.

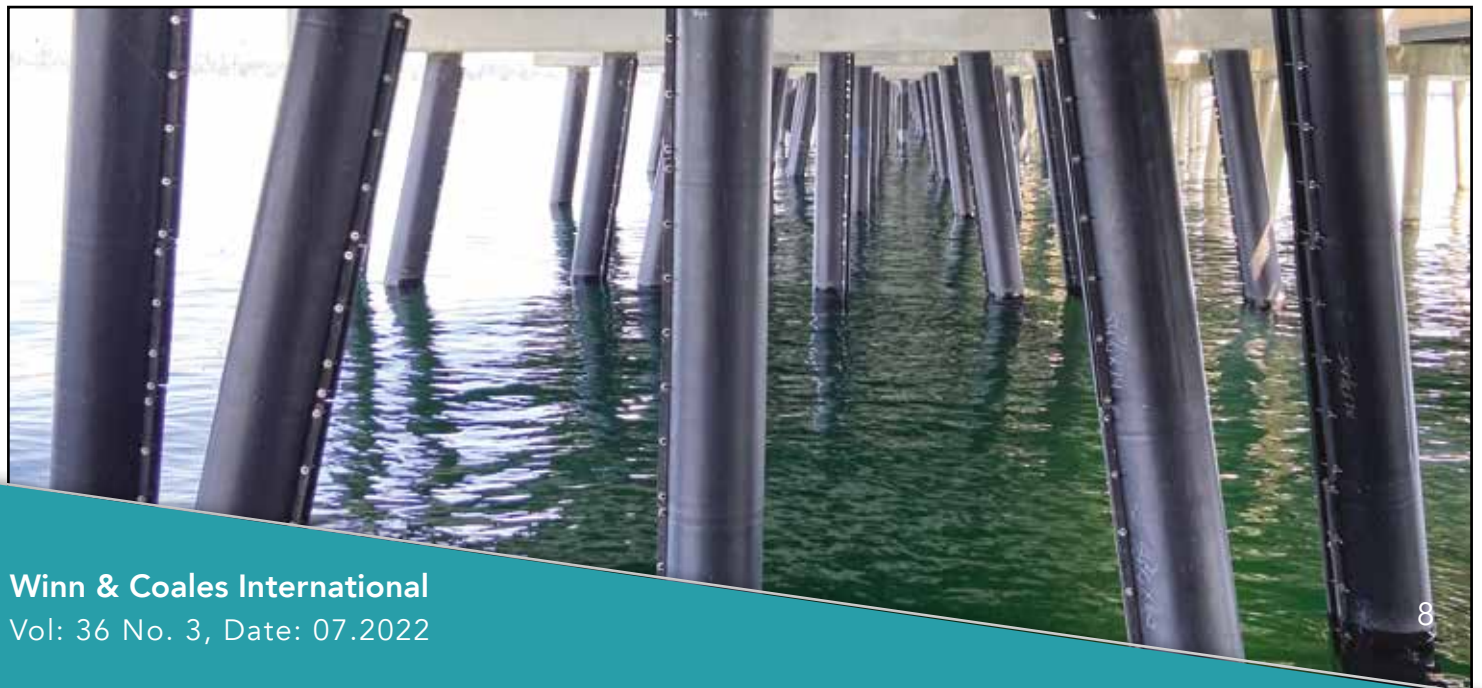
Completed 16" & 18" Dia. Cylindrical Piles fully protected with the SeaShield Series 2000HD System.

After the piles received proper surface preparation which mostly included hand tool cleaning and pressure washing, the Dive Contractor, Harbor Offshore, applied Denso Paste S105™ as needed, Densyl™ Tape wrap with a 55% overlap and the Series 2000HD Outercover (80 mil HDPE) to the full length of all piles.

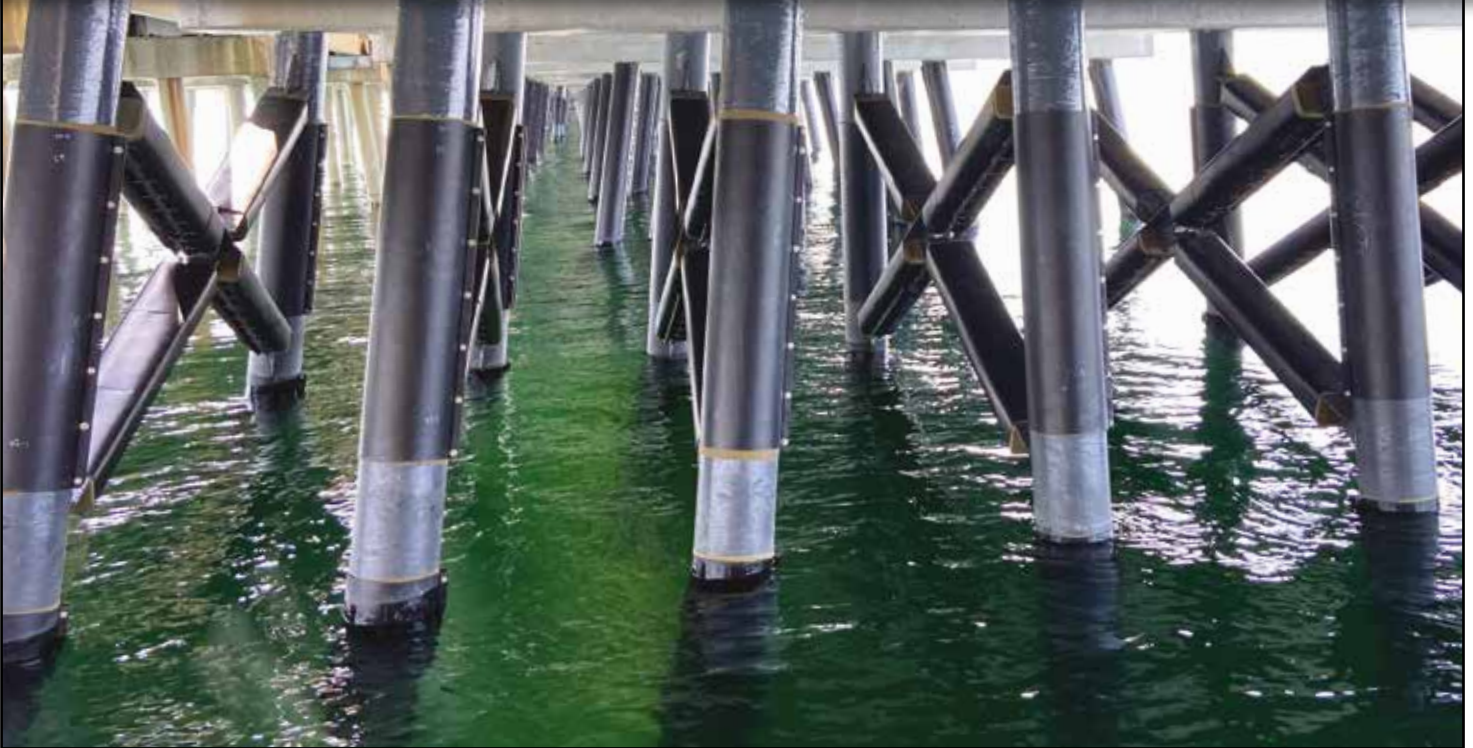
Above: Completed Cross-Bracing fully protected with the SeaShield Series 2000HD System as well as SeaShield 525 Epoxy at node areas.

In addition to the cylindrical piles, there was extensive L and 2L shaped cross bracing, which received a combination of the Series 2000HD™ System and Denso™ Glass Outerwrap UV in lieu of the 80 mil HDPE Outercovers (Series 70 System). Additionally, the node or connection areas received combination of SeaShield 525™ Epoxy (above water) and SeaShield SZ UW™ Epoxy (under water).

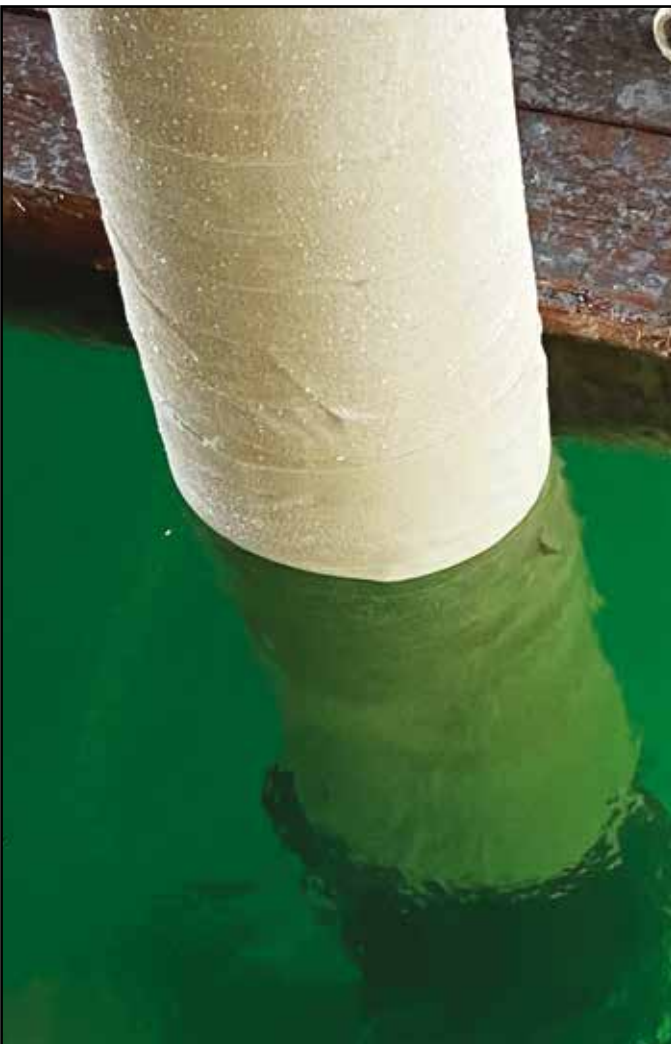
Left: Series 2000HD Outercover being installed underwater.

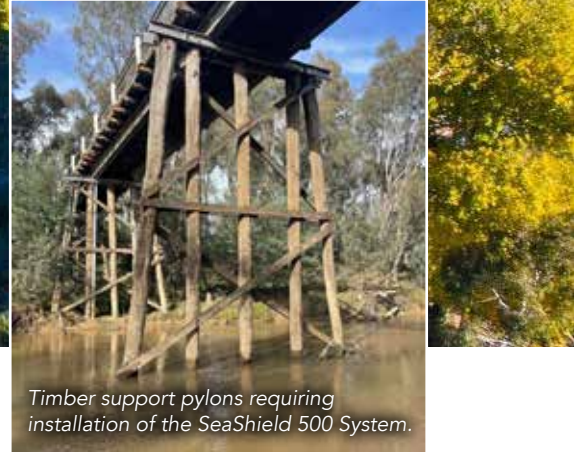
Timber support pylons requiring installation of the SeaShield 500 System.

Denso's SeaShield 500™ System was installed on Piers 1-4 as well as the Mooroopna and Kialla abutments. 90% of the repairs were above water with access made easy through scaffolding. The repairs will enable the bridge to carry up to ten tonnes and extend its serviceability window until 2031.

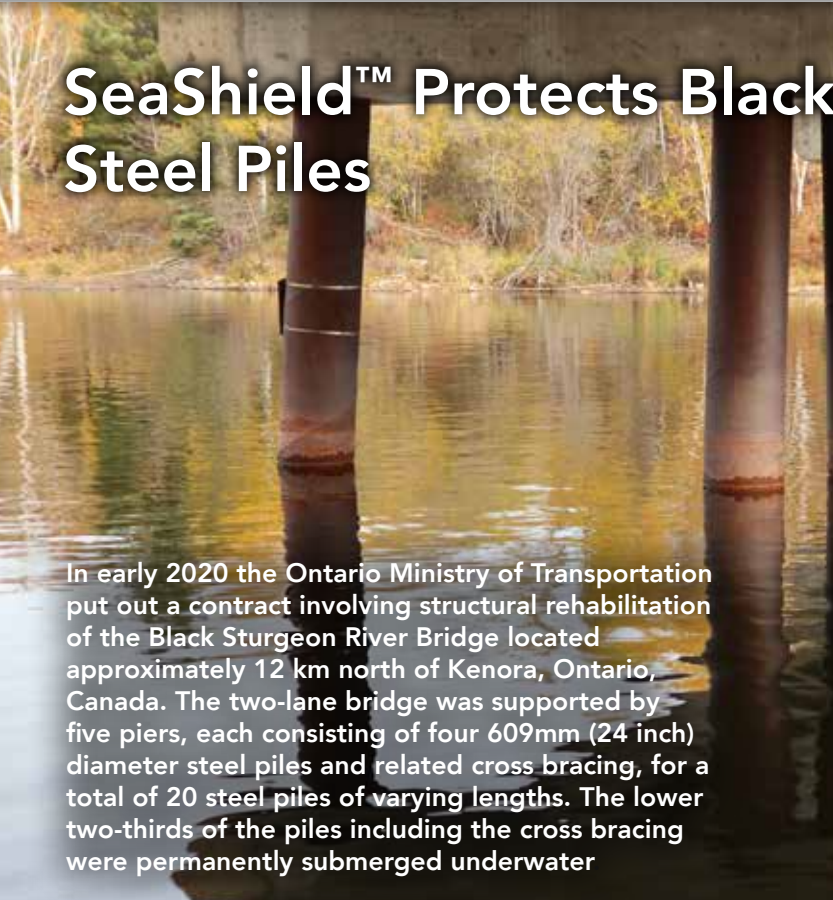
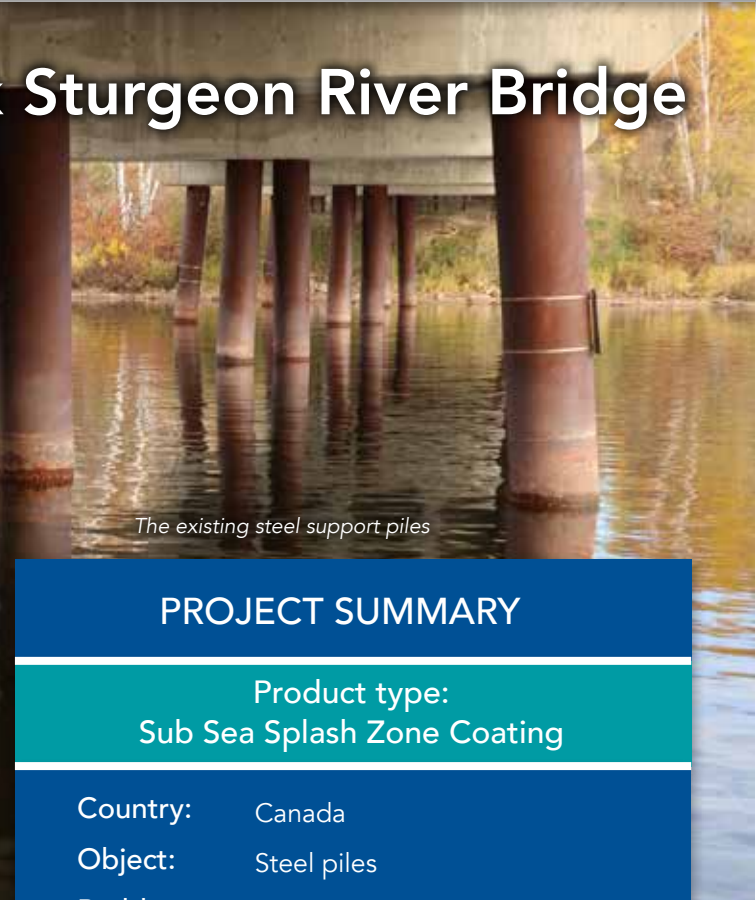
The existing steel support piles

In early 2020 the Ontario Ministry of Transportation put out a contract involving structural rehabilitation of the Black Sturgeon River Bridge located approximately 12 km north of Kenora, Ontario, Canada. The two-lane bridge was supported by five piers, each consisting of four 609mm (24 inch) diameter steel piles and related cross bracing, for a total of 20 steel piles of varying lengths. The lower two-thirds of the piles including the cross bracing were permanently submerged underwater

Country: Canada
 Object: Steel piles
 Problem: Corrosion Prevention
 Product Solution: SeaShield 2000HD™ System

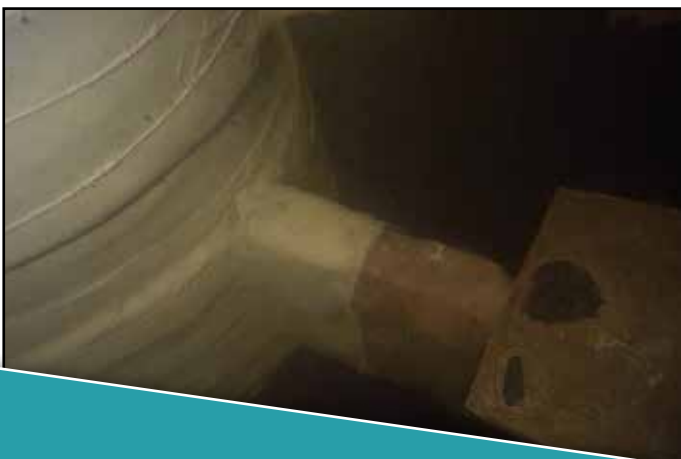
Denso™ LT Tape and Glass Outerwrap was applied around the cross-bracing area.

The contract called for the encapsulation of the steel piles from mud level to the underside of the bridge deck with Denso North America Inc's SeaShield 2000HD™ pile protection system. This system consisted of Denso's S105™ paste, Marine Piling Tape, and HDPE outer jacket for the piles as well as S105 paste, LT Tape and Glass Outerwrap at the cross bracing connections.

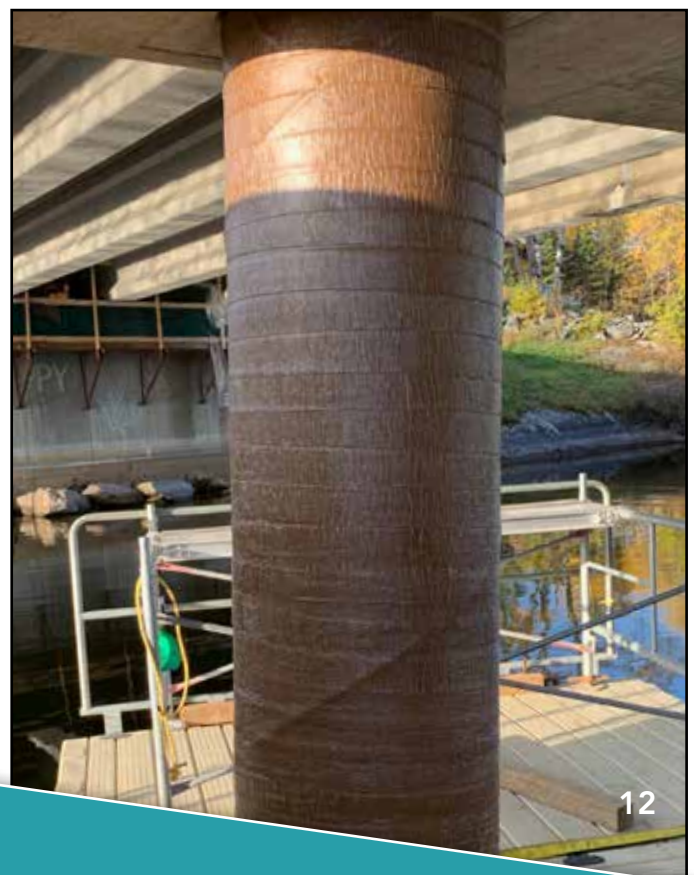
Marine Piling Tape is applied prior to 2000HD Jacket application.

1. Installation of the paste below the waterline speeded up as soon as Divers established a system where one crew member pre-applied the paste to the marine piling tape on-deck while the remaining one to two crew members (divers) were applying the tape under water. This approach proved effective while providing the same corrosion protection results for the customer.

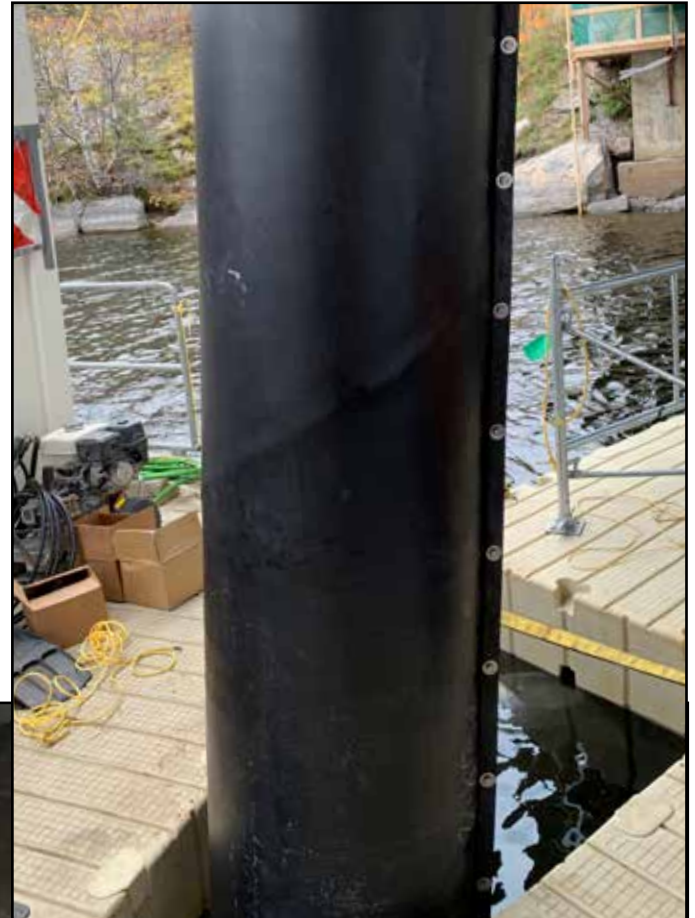
The completed SeaShield 2000HD™ pile encapsulation system.

2. Because of the direction of the river current, the bolted seams of the HDPE outer jackets were installed facing inward on each pile to provide some level of protection against ice build-up and potential damage in the future from ice flow.

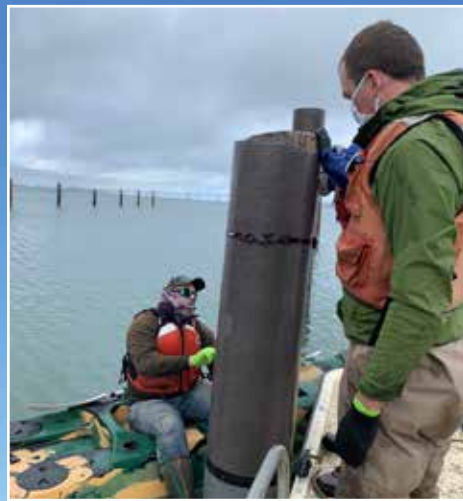
The SeaShield Fiber-Form™ System is applied to the wooden piles.

The US Geological Survey carried out the installation and were more than thrilled with the results. The team in Denso North America provided step-by-step instructions to assist with the installation, which consisted of wrapping the piles with Denso™ Marine Piling Tape, followed by the application of SeaShield Fiber-Form™ jackets to encapsulate the piles. The jackets were constructed in a special brown colour to closely match the existing piles. Ipe Hardwood deck tiles were then applied to the top of the piles, to serve as a platform for the birds.

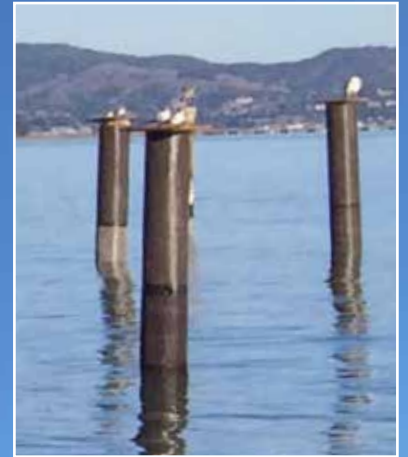
The birds enjoying their new perches.

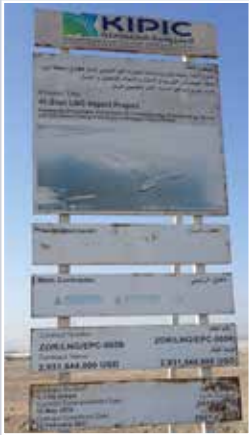
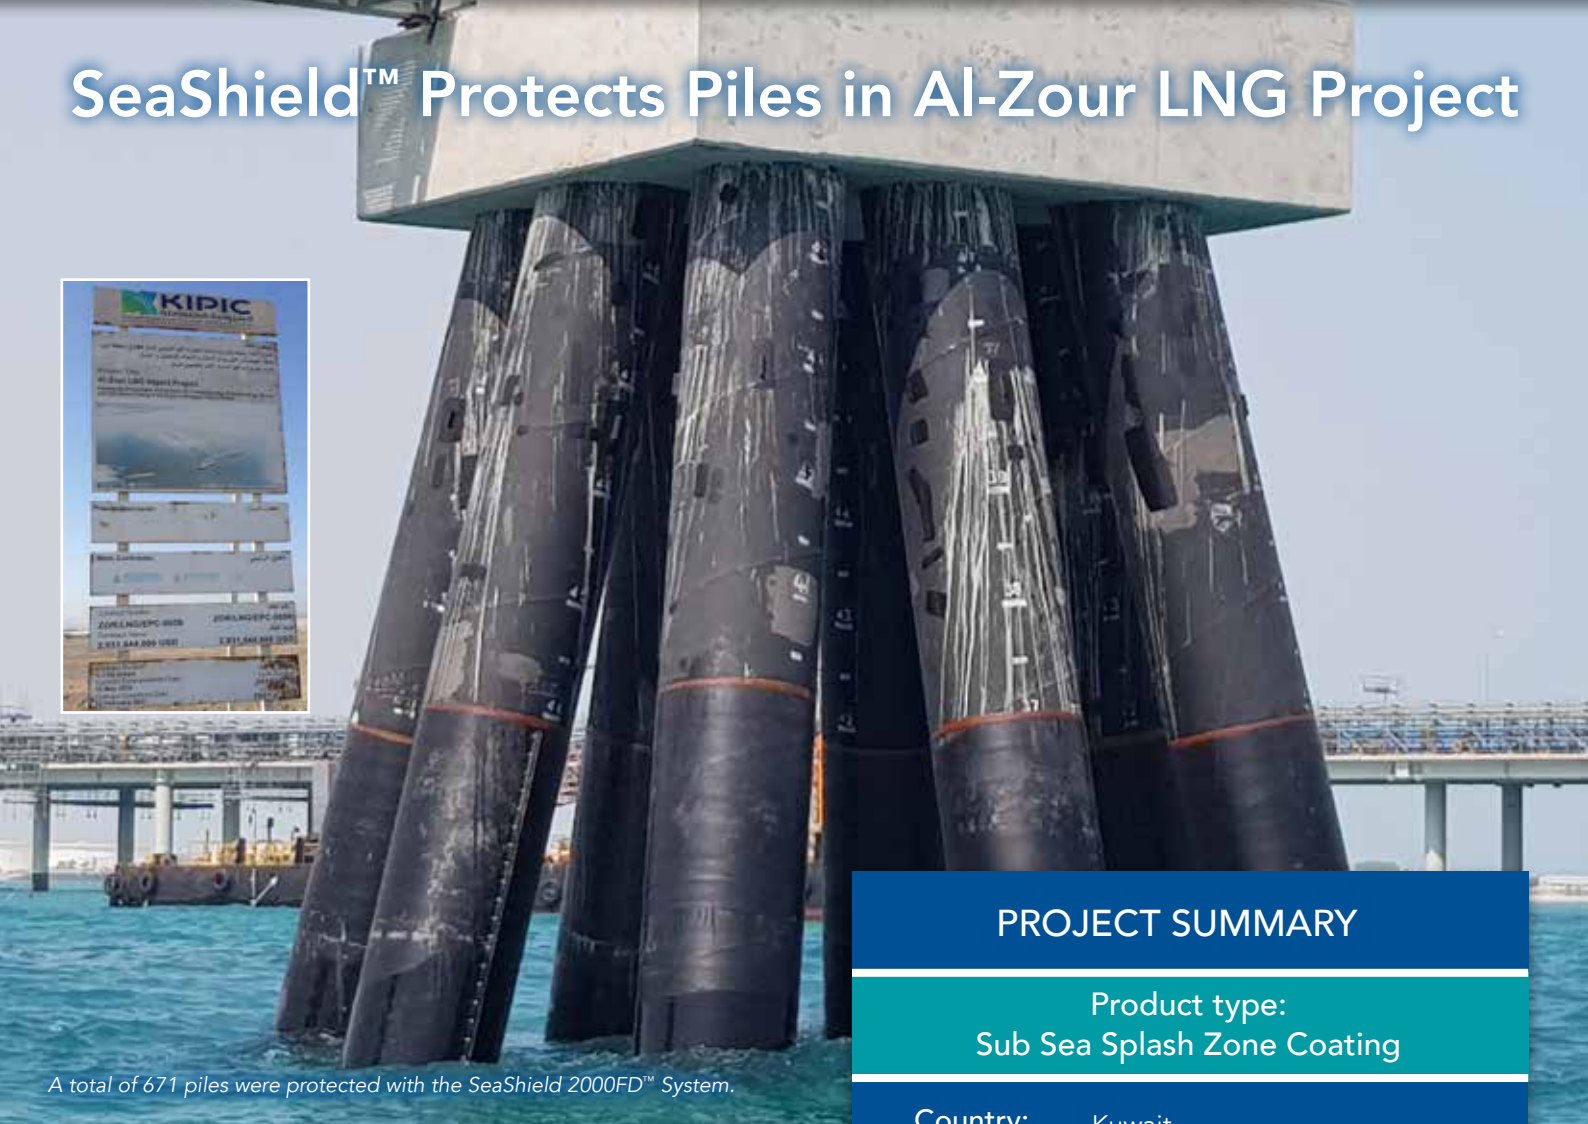
A total of 671 piles were protected with the SeaShield 2000FD™ System.

Country: Kuwait
 Object: Steel piles
 Problem: Corrosion Prevention
 Product Solution: SeaShield 2000FD™ System

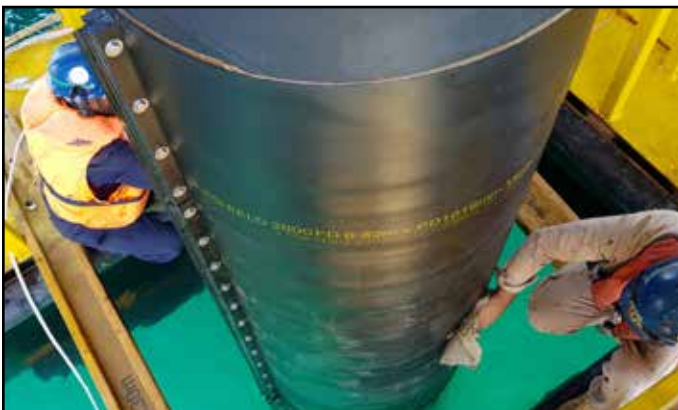
Installation of the SeaShield 2000FD pile protection system.

The SeaShield 2000FD™ System was selected for the long-term protection of all 671 jetty piles within the tidal splash zone, based on its success with numerous similar projects around the world. The protection provided per pile ranges from 4 to 4.5 meters high with pile diameters ranging from 1,016mm to 1,321mm in diameter.
