# CASE STUDY

## GULF COAST FIREWATER LINE

#### Firewater Pipeline

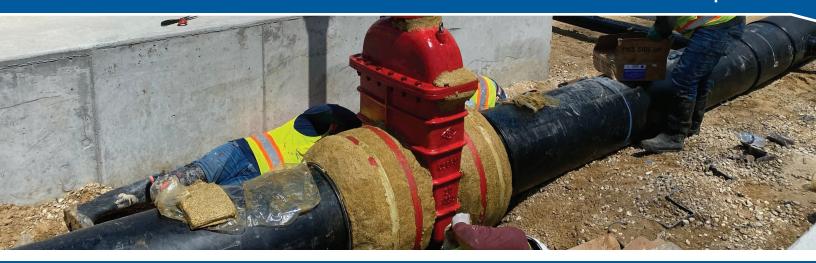
Denso Paste is easily applied to the substrate by gloved hand or brush as the initial application step.

A smooth profile is achieved with Denso Profiling Mastic prior to the application of Densyl Tape.

Large water valve completely encapsulated with the Denso Petrolatum Tape System will provide decades of corrosion prevention.

The Denso<sup>™</sup> Petrolatum Tape System was specified by the design engineer to ensure the firewater lines would be in pristine working condition for years to come. The Petrolatum Tape System is comprised of 3 main components and typically has an outerwrap for mechanical protection. This application uses Denso<sup>™</sup> Paste, Denso<sup>™</sup> Profiling Mastic, Densyl<sup>™</sup> Tape, and Denso<sup>™</sup> Glass Outerwrap for mechanical protection. This system is easily applied by hand without requiring specialized training or equipment. Furthermore, the application can commence with minimal surface preparation of SSPC-SP 1/2. First, the Denso Paste is applied as the first defense layer of corrosion prevention. This petrolatum primer helps fill in any pitted areas where the Densyl Tape may not come into contact with the surface and contains moisture-displacing corrosion-inhibiting compounds. The second step is application of Denso Profiling Mastic on the flanges and valve's irregular and sharp corners, to create a smooth profile across these areas before applying the Densyl Tape. The Densyl Tape, a petrolatum wax tape, is then spirally wrapped by hand over each flange and valve to completely seal out oxygen and water.
