### Project Data

<b>Location</b>	Springs - SA
<b>Completion</b>	April 2024
<b>Project Type</b>	Column Base Protection
<b>Products Used</b>	Denso Hi-Tack Primer, Denso Profiling Mastic, Denso Hi-Tack Tape, Denso D14 Scrim, Denso Basecoat, Archco 15

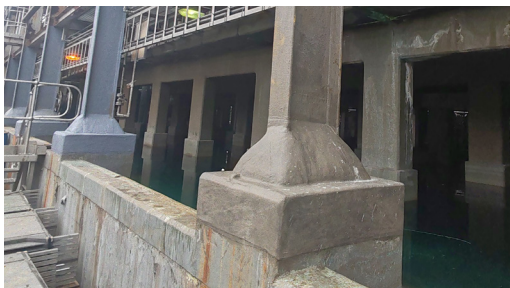
Denso Covercoat System applied to a column base before the Archco 15 topcoat is applied.

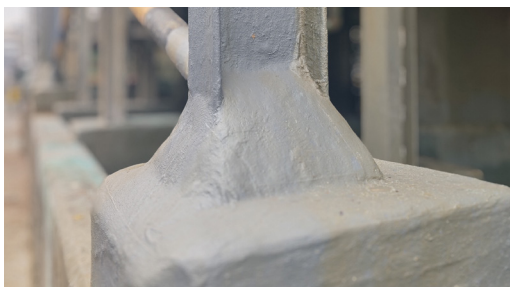
Full column base encasement system installed with Archco 15 flexible topcoat.

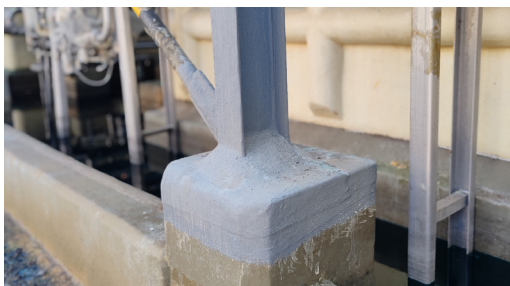
Completed Denso Covercoat System applied for column base protection.
