# CASE STUDY

## BROOKLYN BRIDGE PARK

## Timber Pile Rehabilitation

Location	Brooklyn, NY
Completion	2021
Project Type	Timber Pile Rehabilitation
Products Used	SeaShield Series 500 System

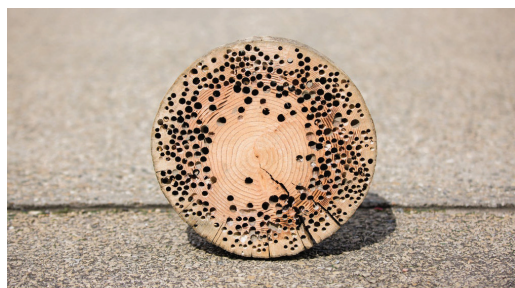
Marine borer damage to timber piles.

In 2019, Denso's SeaShield Series 500 System was selected as the products to encase approximately 6,500 timber piles underneath Brooklyn Bridge Park Piers 3 and 6. Over the course of the next 2 years, Denso supplied over 110,000 LF of SeaShield Fiber-Form Jackets and 80,000 gallons of SeaShield 550 Epoxy Grout. The contractor was able to complete the work ahead of schedule and the project was completed in 2021.

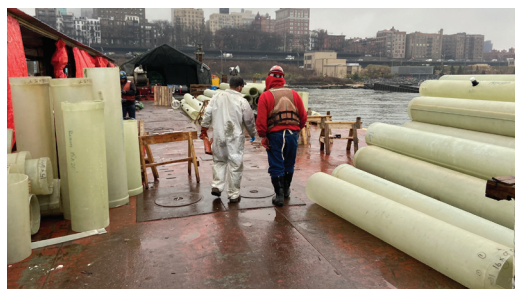
SeaShield Fiber-Form Jackets staged on barge.

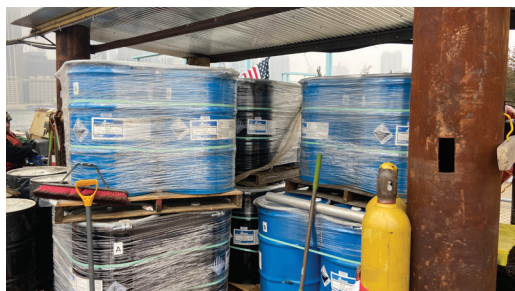
SeaShield 550 Epoxy Grout (165 gallon kits).
