DENSO DIGEST

Winn & Coales International Ltd

Volume 38, Number 4

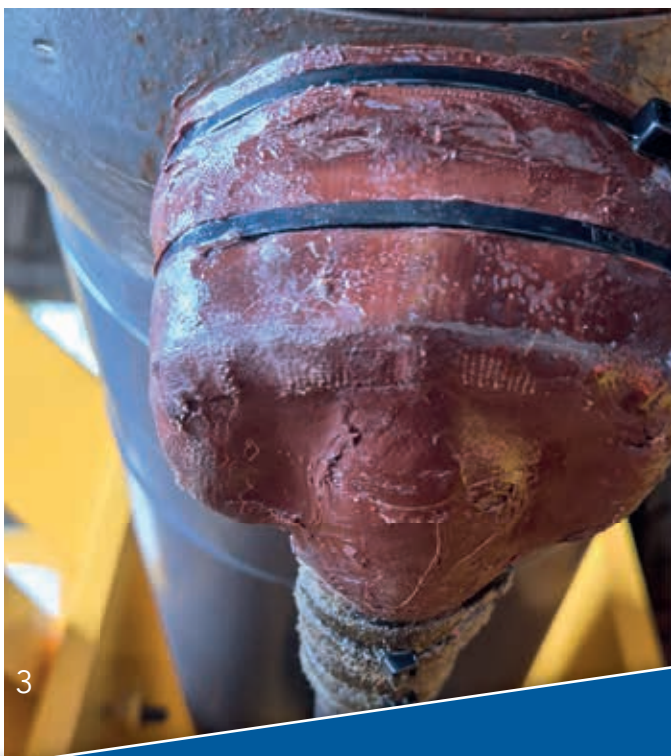
Below and right: Some of the vulnerable areas on the mechanical equipment that benefit from Denso protection.

The use of Denso™ Tape, Densyl™ Tape and Denso Hotline™ Tape which cover a wide range of temperature requirements have proved highly successful even when the equipment is used by industries which handle very aggressive corrosive materials such as polyhalite and rock salt.

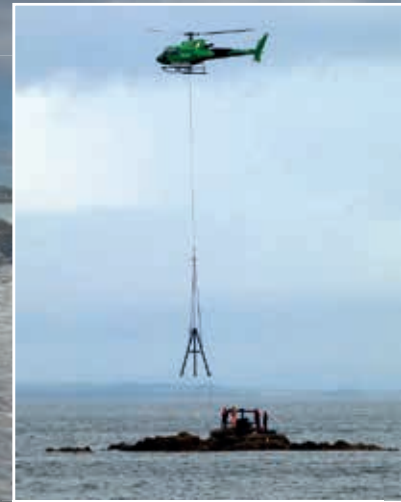
The new light structure being airlifted into place by helicopter.

To maximise the life of the structure the Steelcoat 100/400™ System was applied to all the bolted joints on the structure, which due to the remote location was then airlifted in sections by helicopter and bolted into position on site.

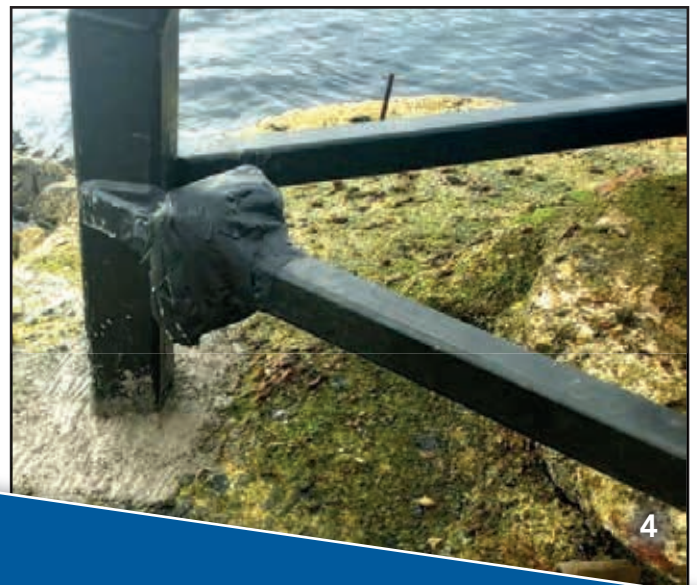
The Steelcoat 100/400 System which consists of Denso Hi-Tack™ Primer, Denso Profiling Mastic™, Denso Hi-Tack™ Tape, Denso™ Ultraseal Tape and Denso™ Acrylic Topcoat has a proven track record in providing protection for above ground structures."

The bolted joints on the new light structure were protected with the Denso Steelcoat 100/400™ System.

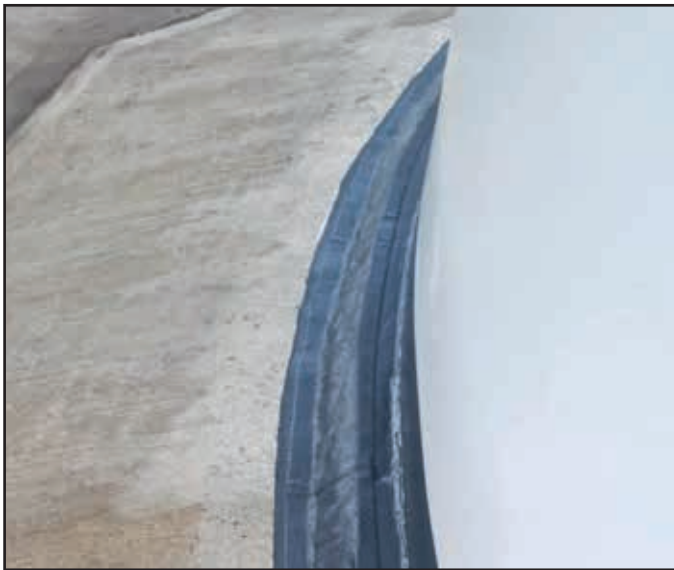
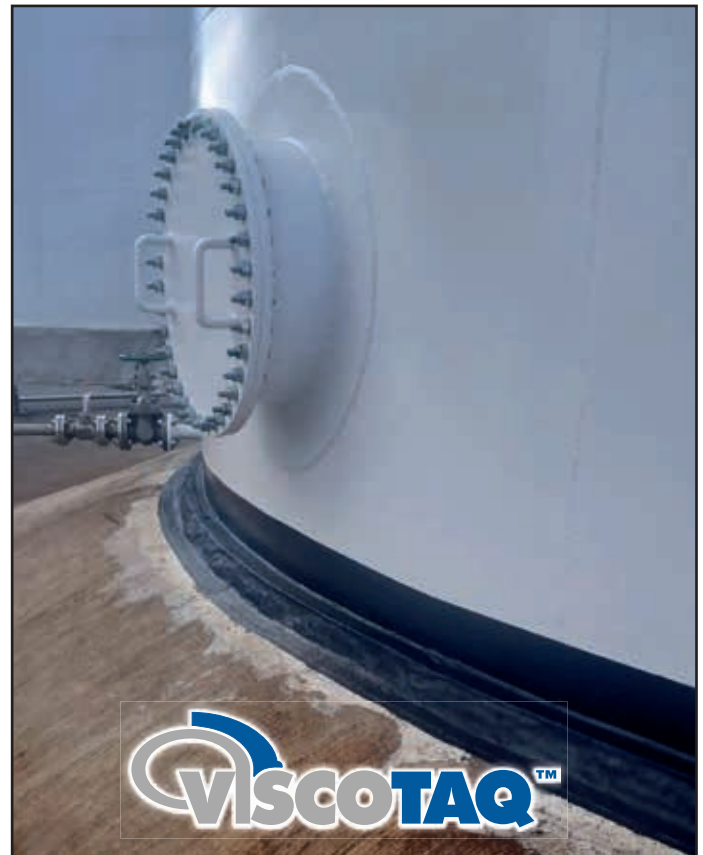
The Viscotaq™ Chime Sealing System applied to the fuel storage tank.

The Viscotaq™ Chime Sealing System was used to prevent water infiltration at the concrete ring wall interface of the tank, a place where corrosion normally occurs. The Viscotaq System can be installed on new and existing facilities, can be painted immediately after installation, and does not interfere with any future paint, inspection.

The Viscotaq Tank Chime Sealing System comprises Viscosealant™, or ViscoPutty™ and Viscotaq™ EZ Wrap.”

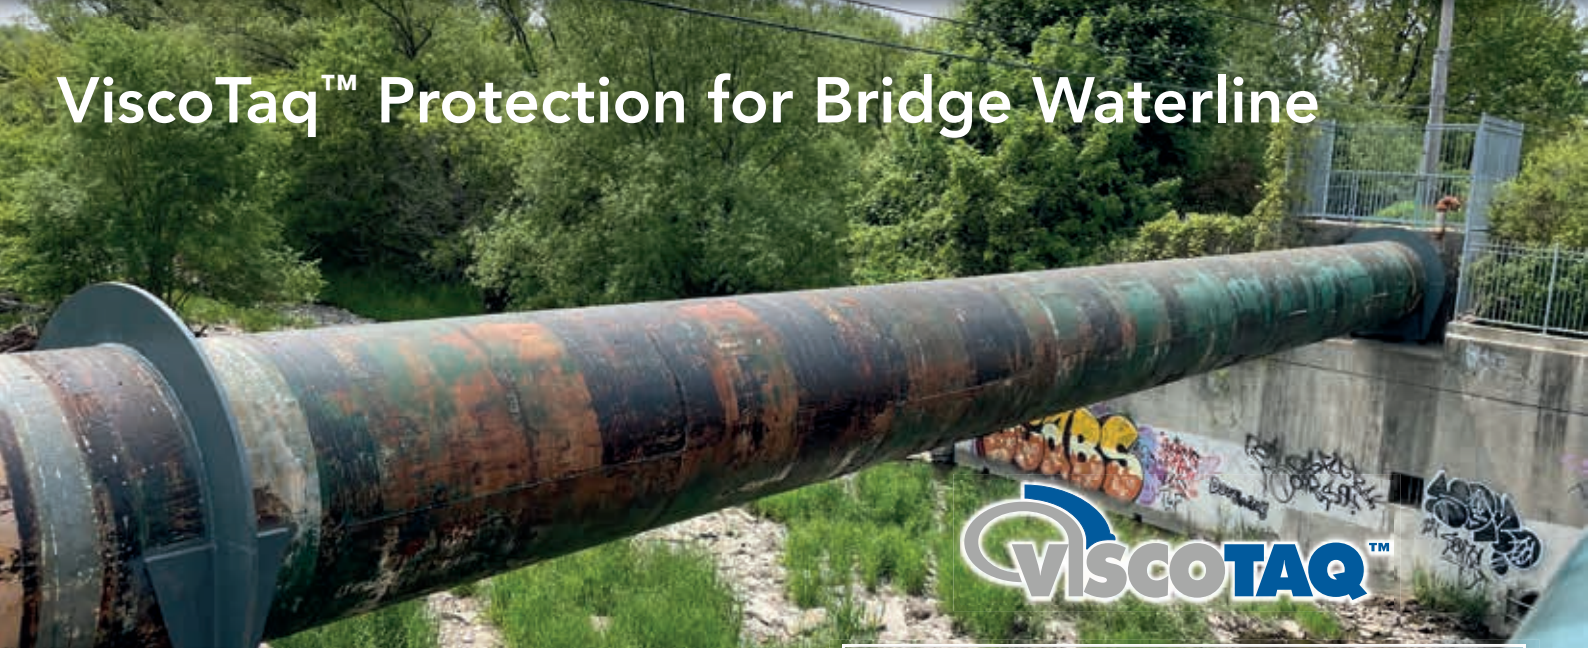
The bridge waterline cleaned and ready for the ViscoTaq System.

The Region of Peel located in Ontario, Canada had a critical water infrastructure project in urgent need of an anti-corrosion solution to protect a 5'-0" diameter x 170'-6" long above-ground bridge waterline. The impressive pipeline runs alongside a bridge and plays a vital role in transporting water. With an exposed setting, ensuring long-term protection from environmental factors was crucial. The region turned to GEI Consultants Canada, who served as the project's engineering partner, and Michels Canada, the general contractor, to deliver a solution that combined a robust design, skilled execution, and protective materials with a history of proven success.

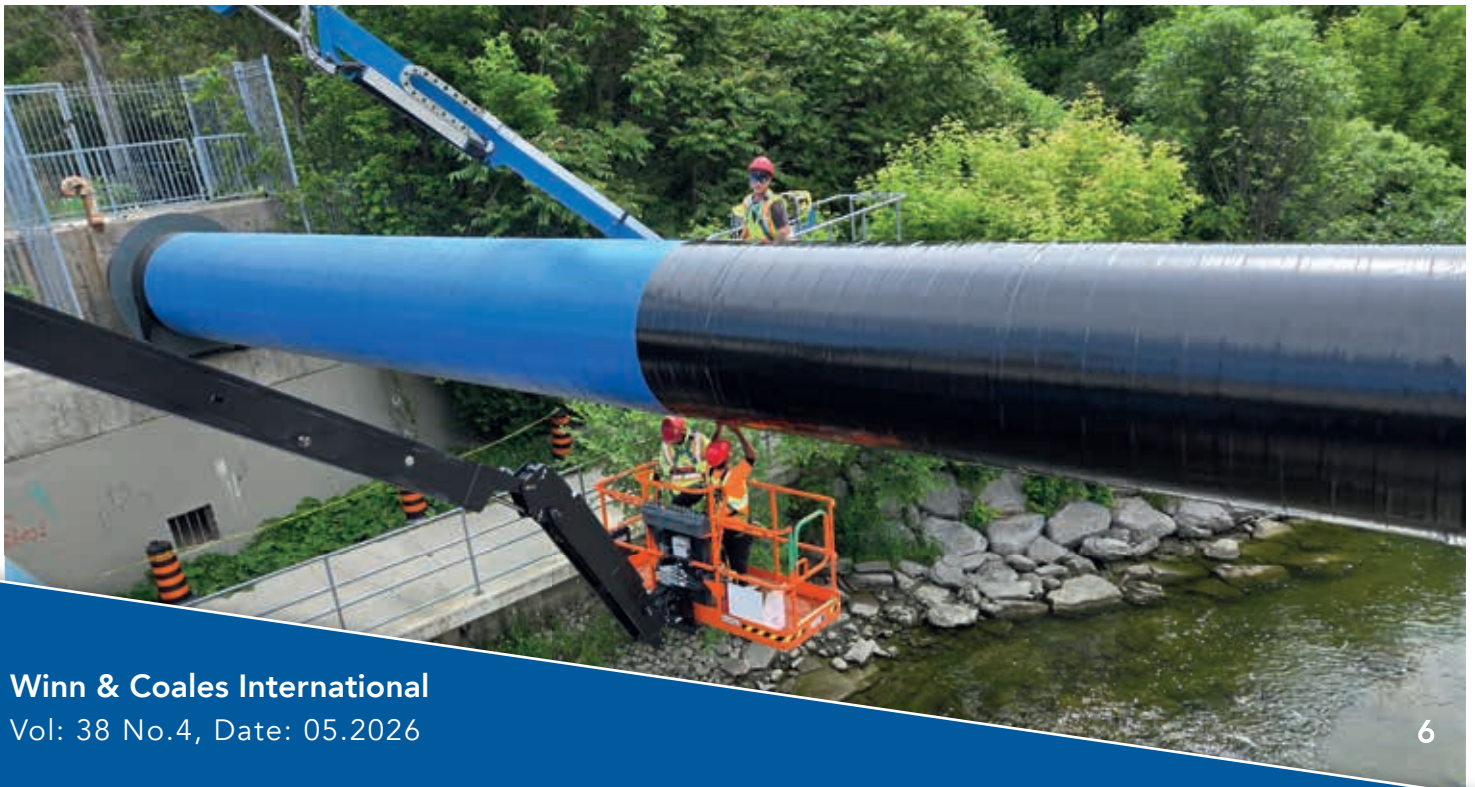
Below and top of page 9: A wrap of ViscoWrap™ ST (blue) is followed by a wrap of ViscoWrap™ PE (black).

To meet the challenge, Denso was chosen to provide its industry-leading corrosion prevention technology. After thorough consultation and technical review, Denso recommended its Viscotaq ViscoWrap™ ST along with ViscoWrap™ PE Outerwrap solution. This combination provided a high-performance, robust protective tape system, paired with a PE Outerwrap to deliver an additional layer of UV and mechanical protection. This solution allowed for an effective, easy-to-apply, and maintenance-friendly system perfectly suited for exposed steel in challenging outdoor environments. The project required precision and expertise, with teams carefully applying the Viscotaq system using various lifts to ensure complete coverage and application along the pipe's entire length.

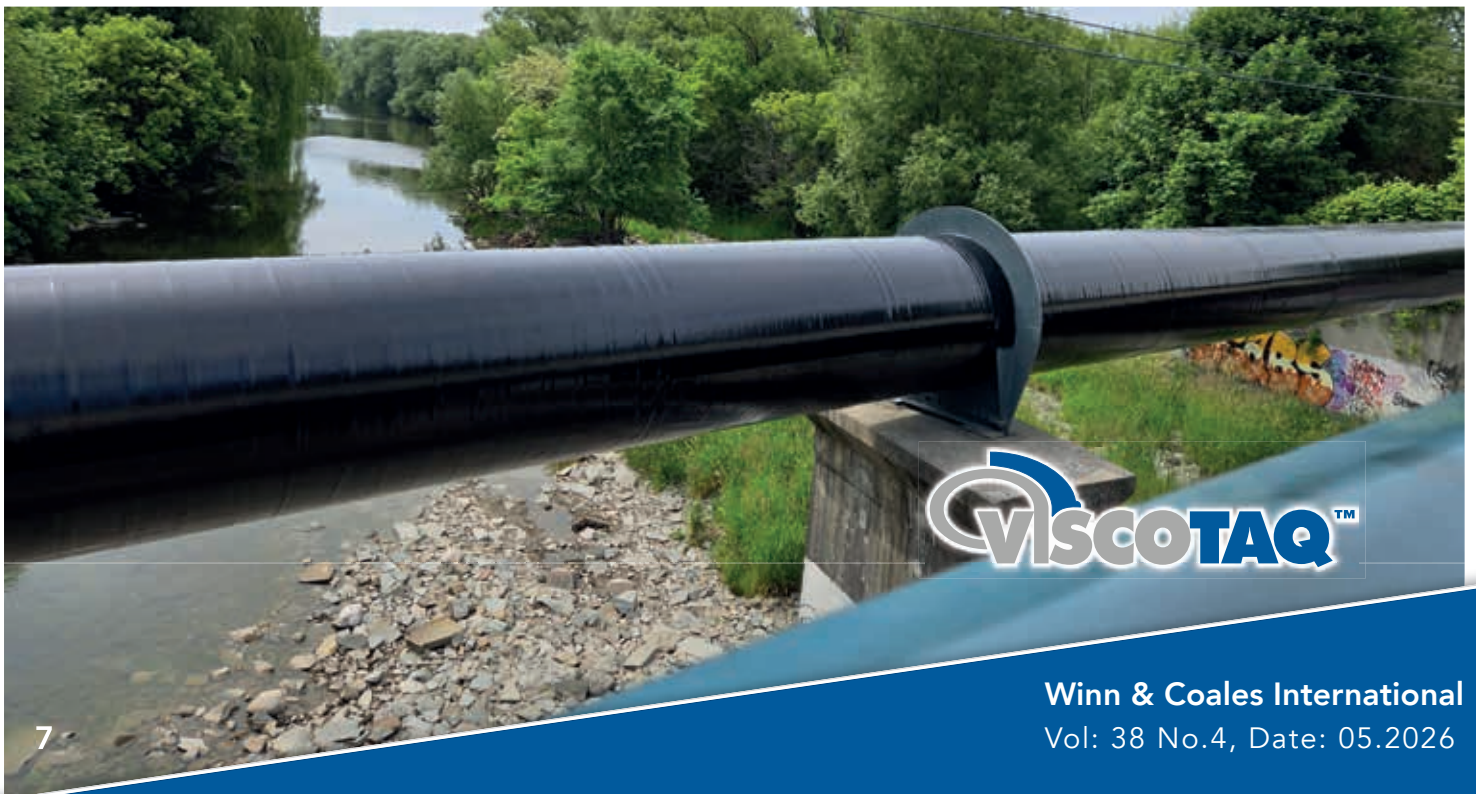
Below: A wrap of ViscoWrap™ PE Outerwrap completes the protective system.

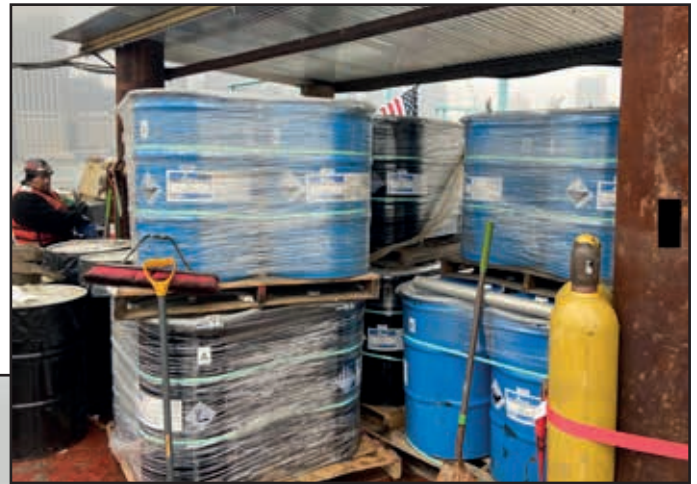
Above:
SeaShield 550™ Epoxy Grout
(165 gallon kits).

Left:
SeaShield™ Fiber-Form Jackets
staged on barge.

In 2019, Denso's SeaShield Series 500™ System was selected to protect and rehabilitate approximately 6,500 timber piles beneath Brooklyn Bridge Park Piers 3 and 6. Over the next two years, more than 110,000 linear feet of SeaShield™ Fiber-Form Jackets and 80,000 gallons of SeaShield 550™ Epoxy Grout were installed, forming a robust barrier against future marine borer attack.

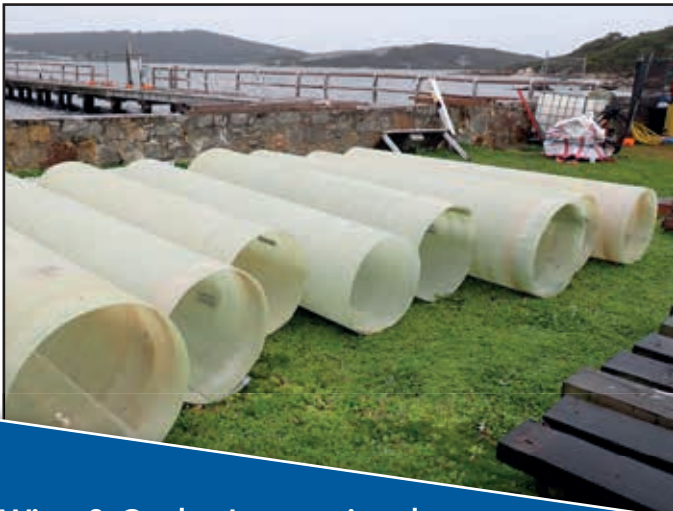
SeaShield™ Fibre-Form Jackets ready for installation.

SeaShield Fibre-Form jackets, each with a 6m length were supplied and installed to restore structural strength to deteriorated timber piles and provide protection from further decay.

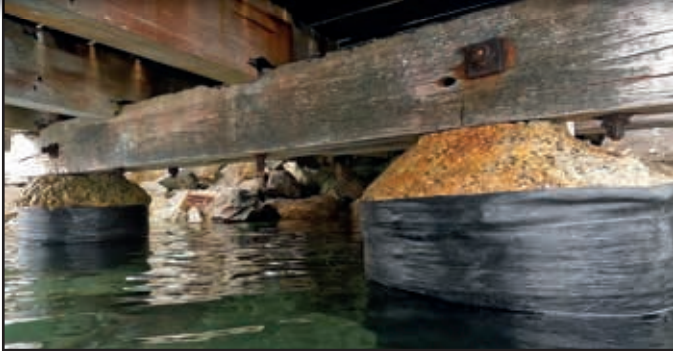
SeaShield 70™ System - SeaShield™ Primer, Denso Marine Piling Tape™ and Denso™ Glass Outerwrap UV. Applied to new and existing timber piles each with a 500mm OD and a length of 3.2m. On existing timber piles, this system was selected to protect the pile from further deterioration (primarily through worm and borer infestation) while they were still structurally adequate. For new piles, the SeaShield 70 system provided immediate defence against the aforementioned erosion factors.

The completed SeaShield 70™ System.

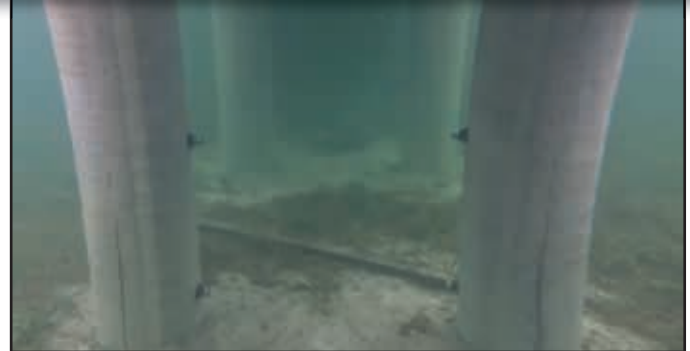
SeaShield 400™ System - C-Grid 450, SeaShield™ Fibre- Form Jackets, and either SeaShield 510UW™ (cementitious underwater grout) or 550™ Epoxy Grout was used to fill the annulus between the pile (and any reinforcement or grid) and the inside of the jacket, restoring structural strength and ensuring the pile is encased.

Underwater view of the completed SeaShield 400™ System.

Jackets were installed sequentially, filled with cementitious grout, and sealed. Translucent jackets allowed divers and applicators to visually monitor grout flow, ensuring complete coverage. Where visibility was poor, grout was pumped until it exited at the next port, thus providing applicators with another means of confirming sufficient coverage. Contractors reported straightforward installation and grout pumping, aided by the lightweight jackets and intuitive sequencing.

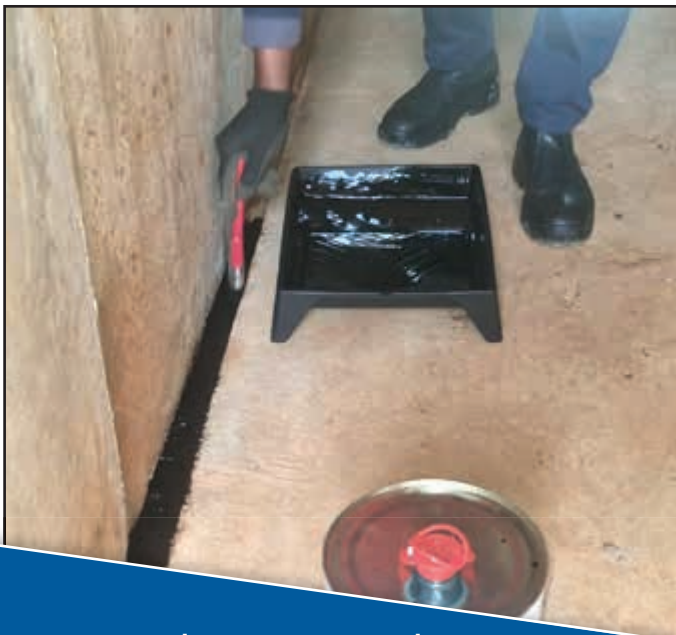
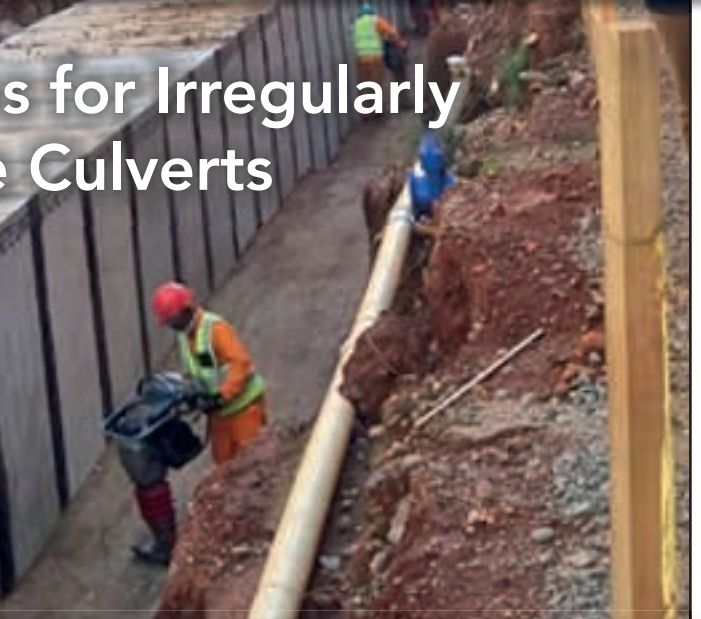
Denso recommended Denso Primer D™, combined with Butyl mastic and Densotherm HD Tape™, as the most suitable system for sealing the internal joints of the culverts.

Denso Primer D™ and Denso™ Joint Sealer being applied on the inside of the culverts that have already been stacked.

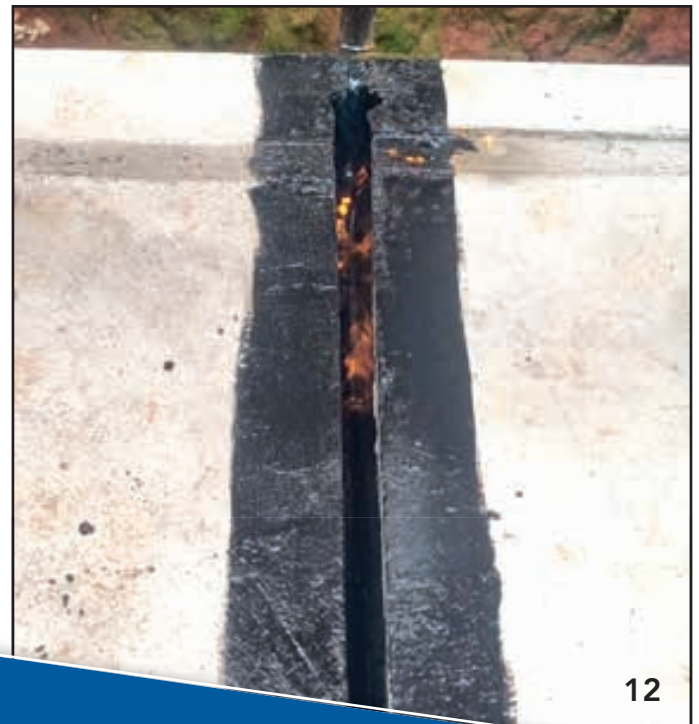
For the external sections, with flatter surfaces, Denso proposed the Denso Premseal 100™ tape system. Denso Premseal 100™ is a durable sheeting made from cross-laminated, orientated high-density polyethylene, coated with a strong adhesive polymer-modified bitumen compound.

Denso Primer D™ & Denso™ Joint Sealer applied for all new concrete bases placed forward (external section).

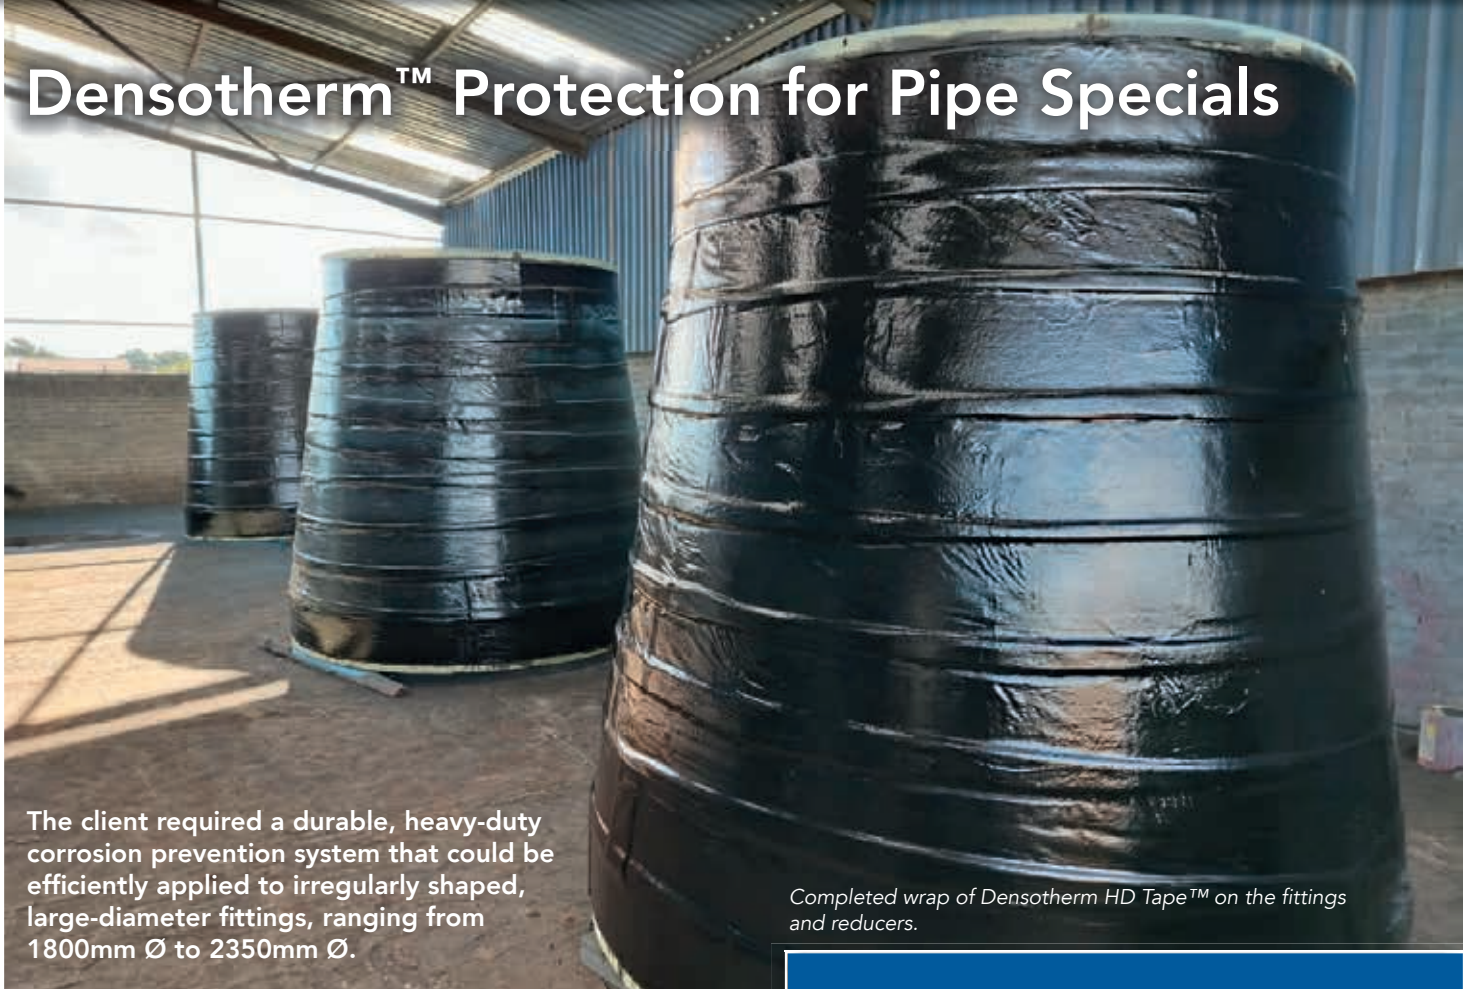
Completed wrap of Densotherm HD Tape™ on the fittings and reducers.

Denso proposed a 5mm heavy-duty, torch-applied Densotherm HD Tape™ system, incorporating Denso™ Butyl Profiling Mastic filler to accommodate the irregular shapes and sharp edges of the fittings.

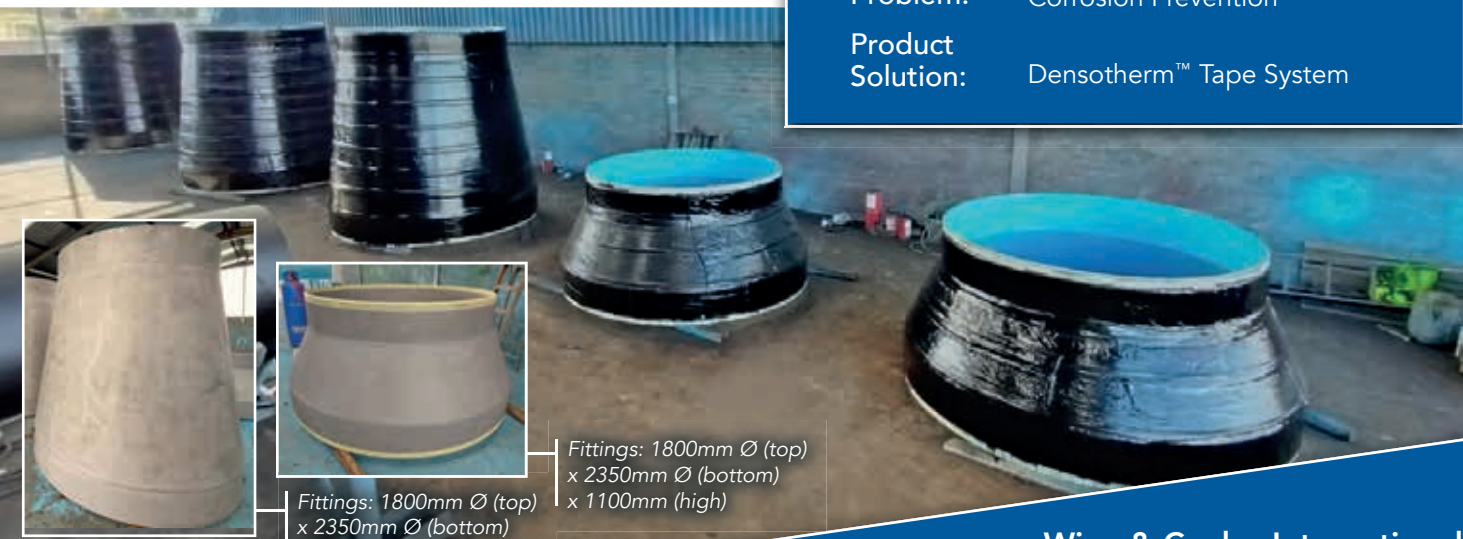
Fittings: 1800mm Ø (top) x 2350mm Ø (bottom) x 1100mm (high)
 Fittings: 1800mm Ø (top) x 2350mm Ø (bottom) x 2350mm (high)

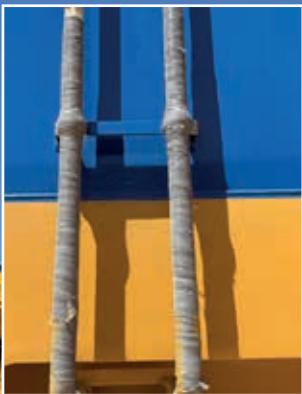
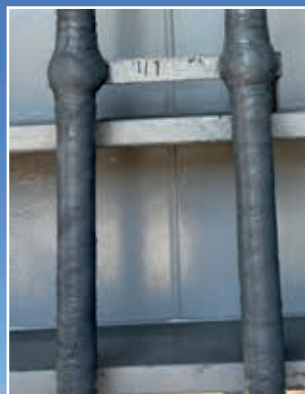
Inset pictures: various gas and water pipes protected with the modified Steelcoat 100/400™ System

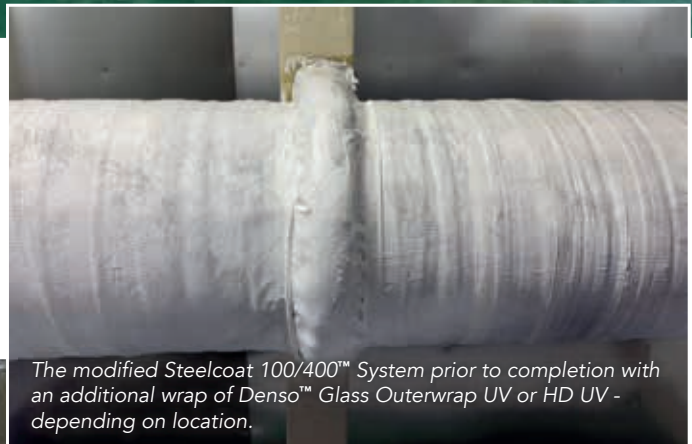
Secondly, the system has been modified for this application to include an additional wrap of Denso™ Glass Outerwrap UV (for exposed pipelines only situated above the water line) and Denso™ Glass Outerwrap HD UV (for submerged/splash zone pipelines alternating between above and below the water line). This enhanced system gives excellent impact resistance, capable of withstanding various potential collisions and impacts during operation, thus ensuring long-term reliable performance.

The modified Steelcoat 100/400™ System prior to completion with an additional wrap of Denso™ Glass Outerwrap UV or HD UV - depending on location.
